# Metallographic study of end plates of a damaged pakistani fuel bundle irradiated at Karachi nuclear power plant (Kanupp)

\*Muhammad Sajjad Zaheer, Muhammad Saleem, Syed Mukarram Hussain, Muhammad Zafarullah,  
\*Senior Principal Engineer, Pakistan Institute of Nuclear Science & Technology,  
P.O. Box No. 1356, Islamabad, (Pakistan)

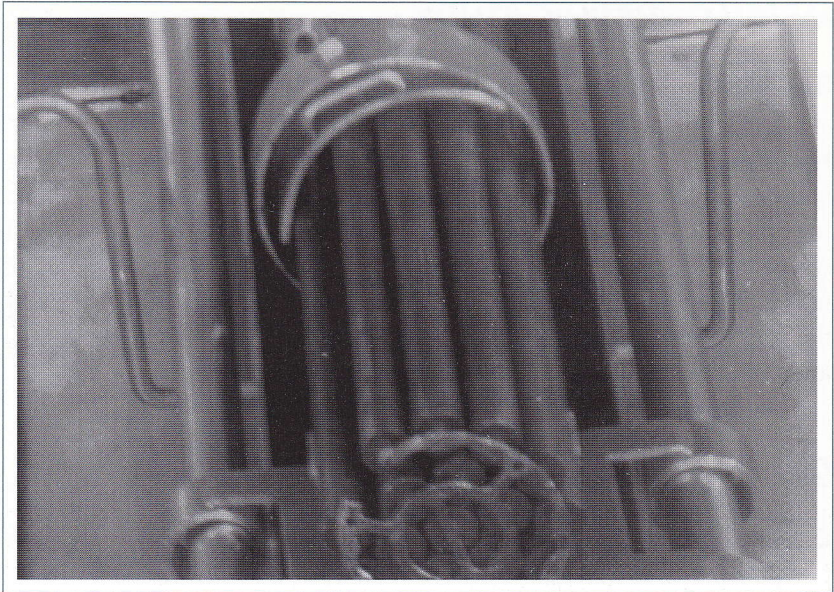
The end plates of fuel bundle were designated as end plate No. I and end plate No. II respectively. Both the end plates were found in severely damaged state (fig. 1 and 2). Some fuel pins of outer most layer of bundle were in loose condition as well. Some macrocracks were apparent at the welded joints of various fuel pins with end plate material (fig. 3). Some fretting mechanical scratches were present at various portions of end plate material.

Figure 1: Photograph showing damaged end plate of fuel bundle

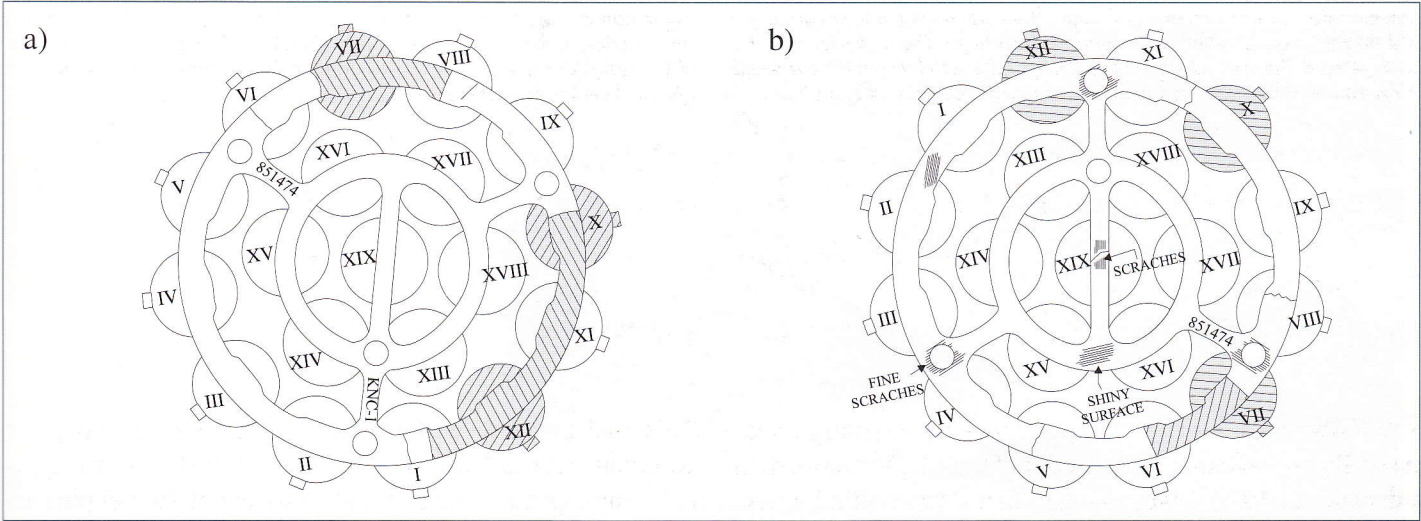
Figure 2: The end plates of fuel bundle  
a) End plate No. I (Having KNC-I engraved on it)  
b) End plate No. II

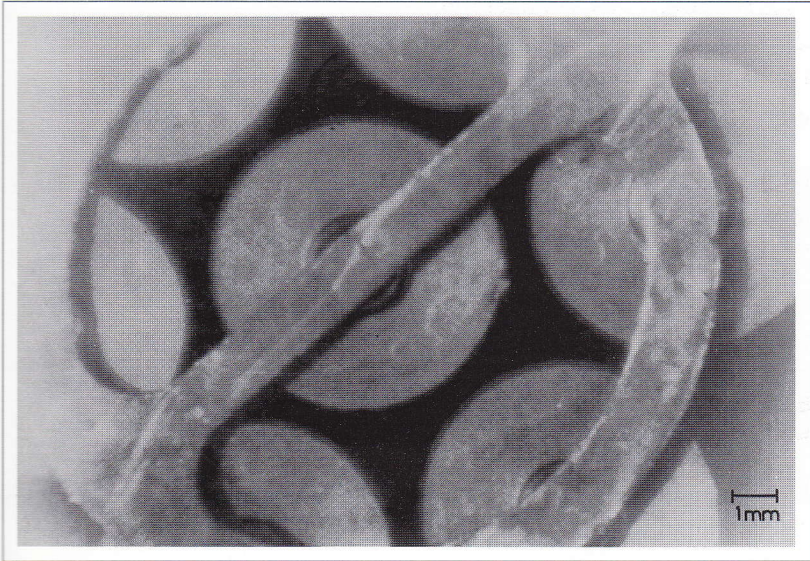
Figure 3: An example of presence of a macrocrack at the welded joint of central fuel pin with end plate No. 2

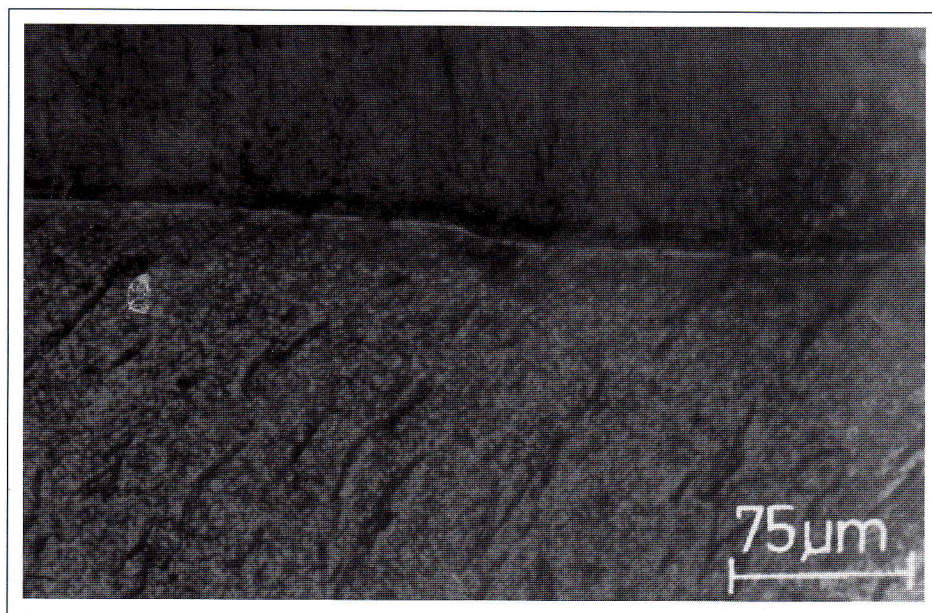
layer of oxidation was found to be in the range from 17 to 45 microns in thickness (Table 2 and fig. 4).

Figure 4: Photomicrograph showing the presence of oxidation layer on end plate material \_\_\_\_\_

The thick oxide layer in the various transverse sections of end plates and the higher radial hydride orientation factor up to more than 0.3 clearly depicted that the end plate had the chances of failure during irradiation. From the literature study it has been known that factor greater than 0.3 is susceptible to cause failure [2]. Similarly the oxidation layer of 45 micron thickness might have added influence on embrittlement of end plate and which might have resulted in its failure.

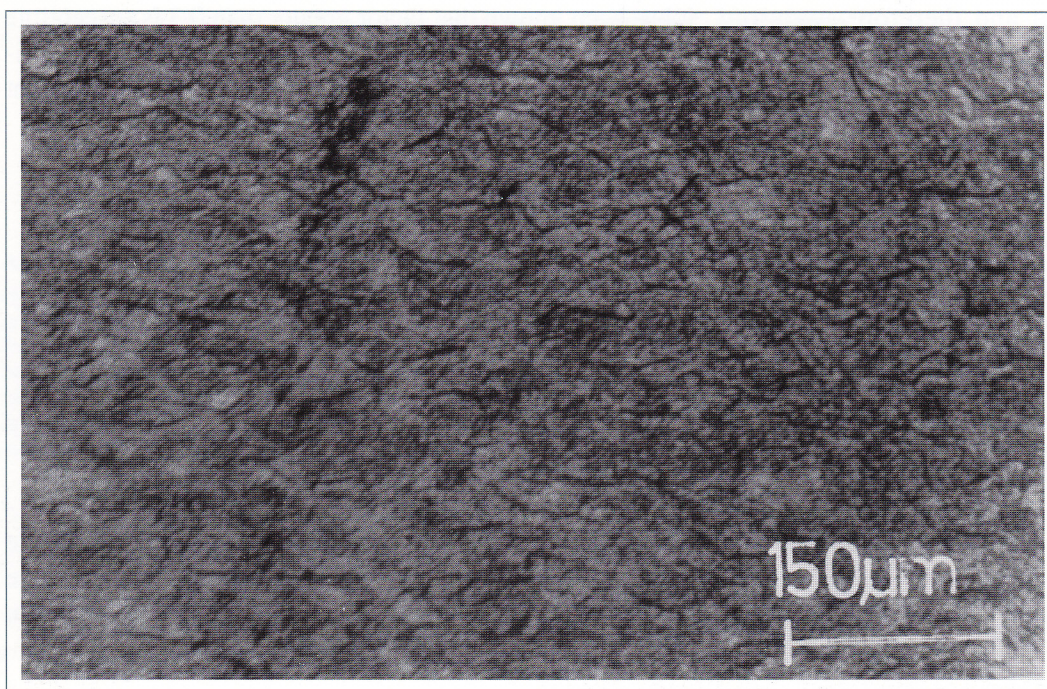
The visual inspection and metallographic study of end plate material revealed that the material had undergone severe embrittlement due to hydridation effect and it caused failure of end plates during irradiation.

Method No. B-353 [1]. The observations have been recorded in Table 3 (fig. 5). The Fn factor was calculated to be in the range from 0.28 to 0.361.

Figure 5: Photomicrograph showing hydrides in the end plate material
