Tests and Examinations of the Old Hône-Bard Railway Bridge

W. NICODEMI, M. BONIARDI - Istituto di Chimica Fisica Applicata - Politecnico di Milano

Mechanical and metallographic tests were run on surviving fragments of the late-19th-century Hône-Bard railway bridge demolished in the Sixties to assess the characteristics of the « agglomerated » (similar to « wrought ») iron used in their construction. An explanation is also offered of the surprising discrepancy between the lab data for this iron and its brilliant service record.

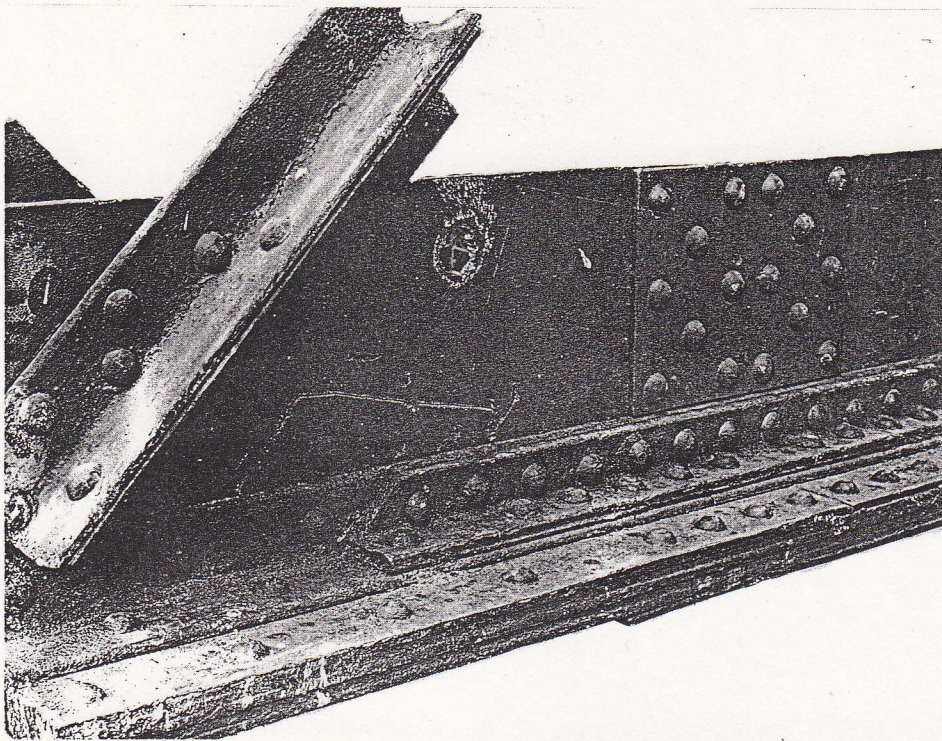
Fig. 1 (b): Part of the lower longitudinal member on which the metallographic analyses and strength test were performed.

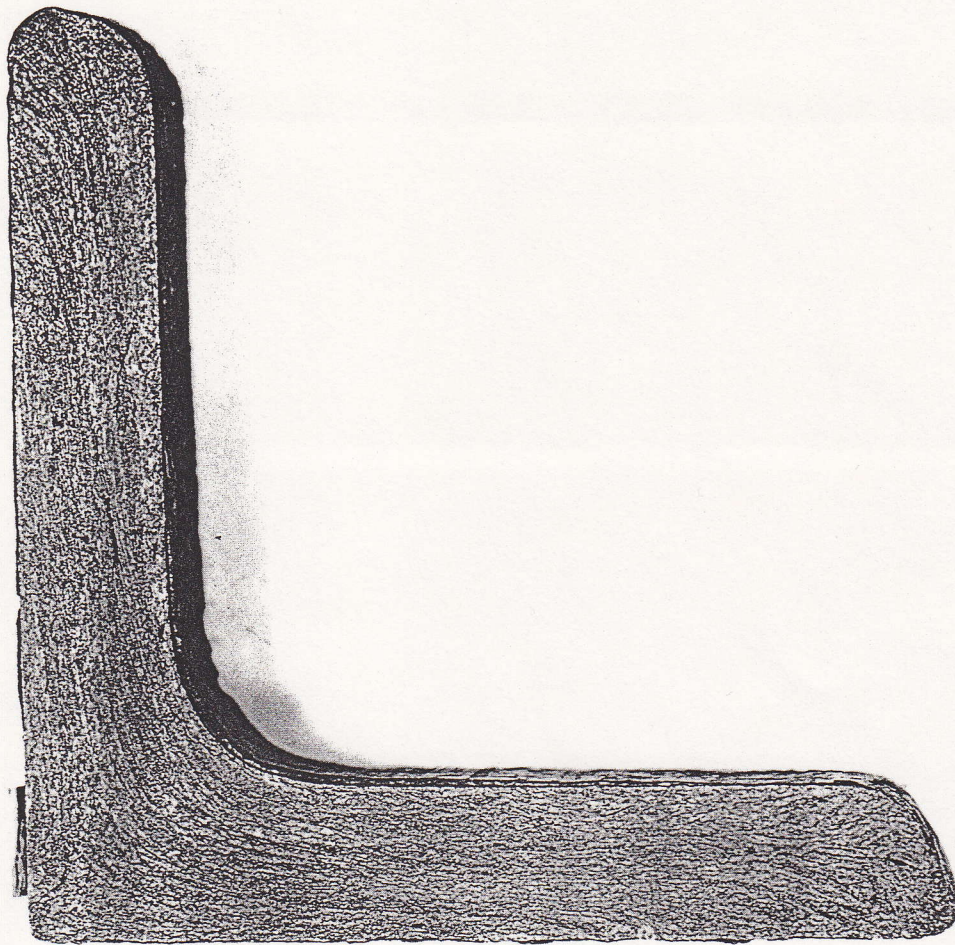
The origin of the steel used to build the Hône-Bard bridge (fig. 1) has not been recorded. We feel, however, it was made of what the Italian State Railways then called «agglomerated iron» (i.e. not cast). Evidence in favour of this view is provided in fig. 2 showing the macroscopic appearance of an angle piece and a plate after etching with 2% Nital.

(a) angle peice $62 \times 62 \times 10$ cm - cross-section (2% Nital etching)

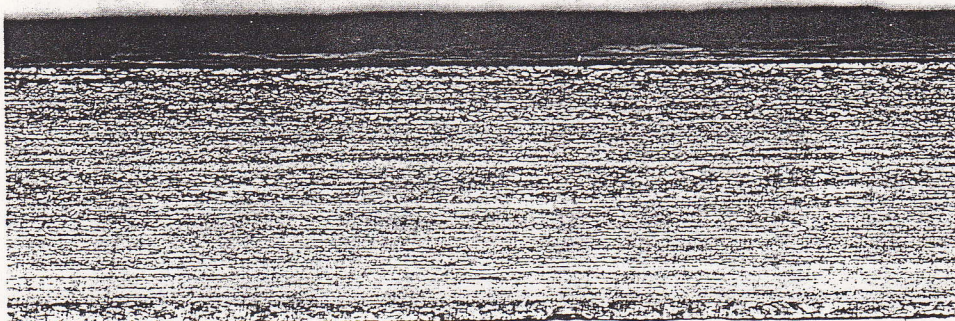
(b) part of plate 300×20 cm - longitudinal section (2% Nital etching)

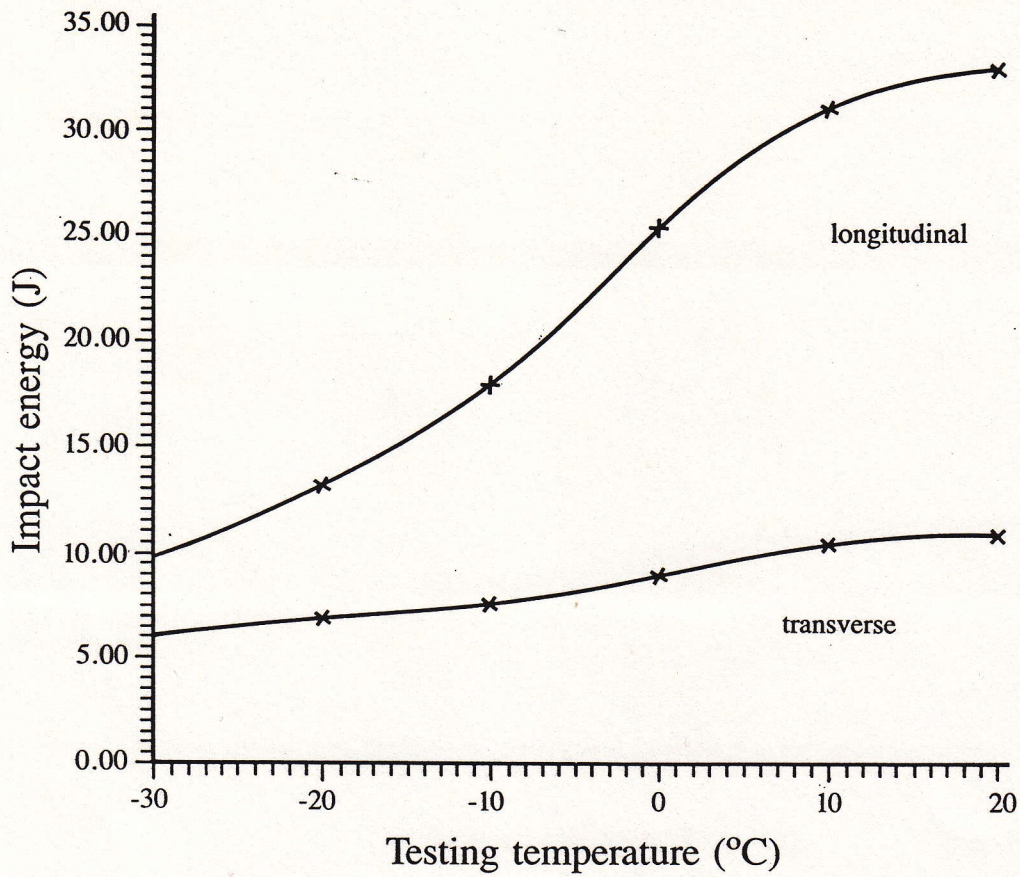
A series of impact tests was also performed to evaluate the toughness of the material. This procedure, of course, was not contemplated in the 1908 specifications, as it had not yet been introduced. The transition curves for both longitudinal and transverse test specimens from one of the plates are shown in fig. 3.

The transverse specimens, on the other hand, are marked by frequent premature failure with low ultimate elongation and area reduction percentages. The transition interval in the impact test is around -10°C . This, however, is associated with particularly low energy absorption values.

Fig. 3: Transition curves for longitudinal and transverse test specimens from plate 250×18 cm.

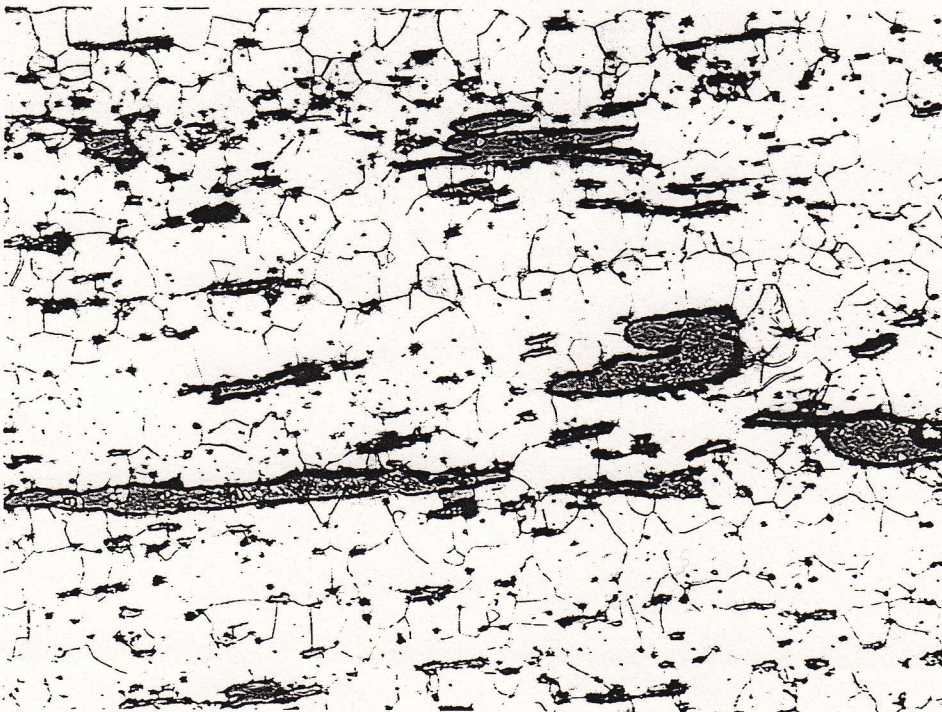
Metallographic examination of a series of specimens from both flat and angular sections showed that their microstructure consisted of ferrite with a normal crystalline grain not oriented in the rolling direction (fig. 4).

Fig. 4: Microstructure of plate 300×20 cm after 2% Nital etching (cross-section ×100)

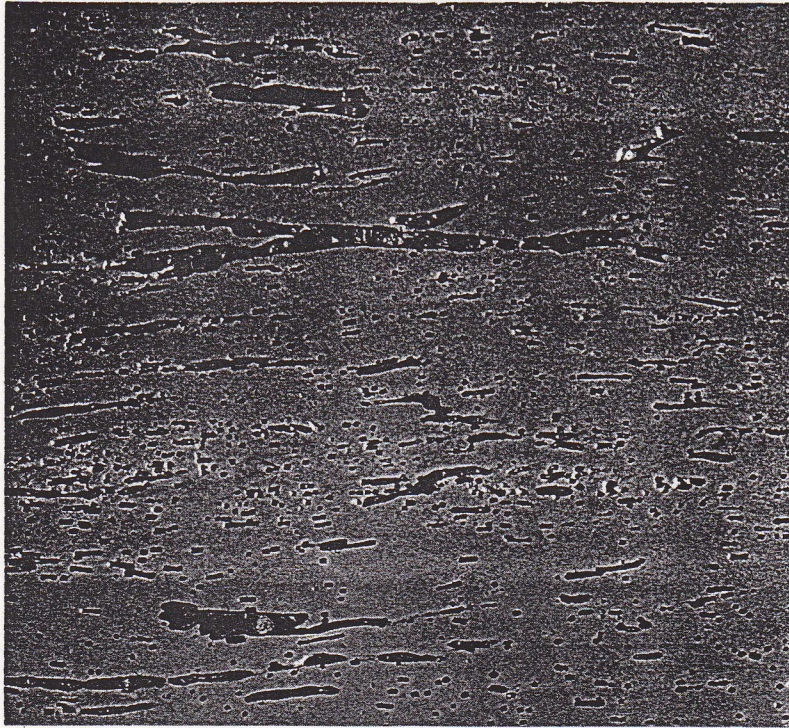
agglomerated iron was a Fe alpha ($0,01 \div 0,02\%$ C) with appreciably higher than usual O and P contents (fig. 5). Three types of inclusion were observed:

- nodular inclusions measuring 5-10 μm , consisting of iron oxides rich in Ca, S and P;
- compact, elongated inclusions measuring up to 400 μm composed of Fe and Mg phosphates, silicates, together with Fe sulphide, Ba sulphate and Fe carbide microinclusions;
- elongated, fragmented inclusions measuring up to 1-2 mm composed of Fe, Mg and Al oxides, phosphates and silicates.

Fig. 5 (a): a) Microstructure of nonmetallic inclusions ($\times 100$)

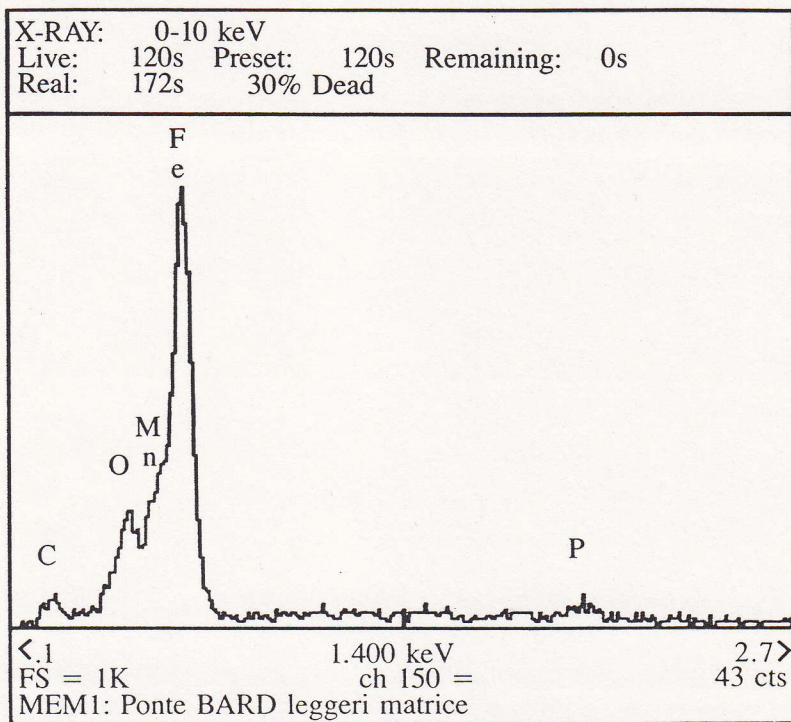
Fig. 5 (b): Microanalysis of the light elements of the basic metal

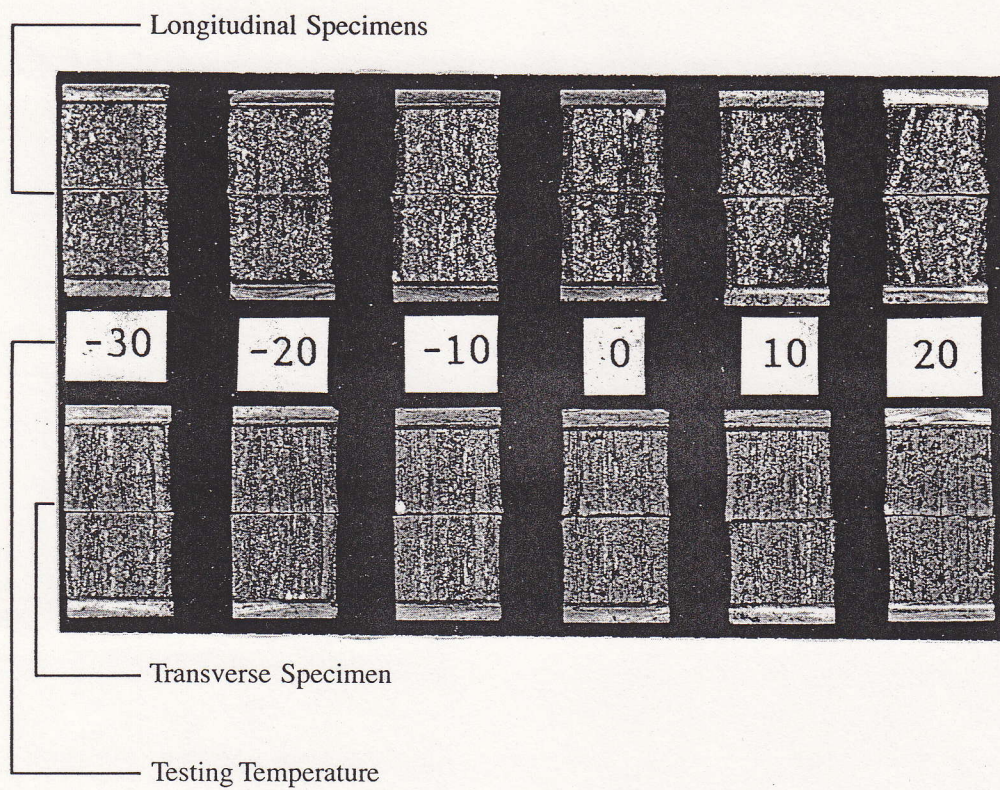
An SEM study was then made of the fracture surfaces of impact test specimens. Macrographic inspection revealed a distinctly «woody» appearance with apparently fragile crack tip propagation unaccompanied by plastic creep or area reduction (fig. 6). This is referable to the marked anisotropy of the matrix brought about by both the many inclusions oriented in the rolling direction and the large amounts of nodular oxides observed earlier. Microscopic examination, on the other hand, showed ductile yielding over nearly the whole surface in the form of extensive «dimples» that had formed around the inclusions (fig. 7). Elsewhere, a typical brittle fracture behaviour (cleavage) was noted, with separation along crystallographic planes and formation of the so called «river patterns».

Fig. 6: Fracture surfaces of some of the impact test specimens used to determine the transition curves.

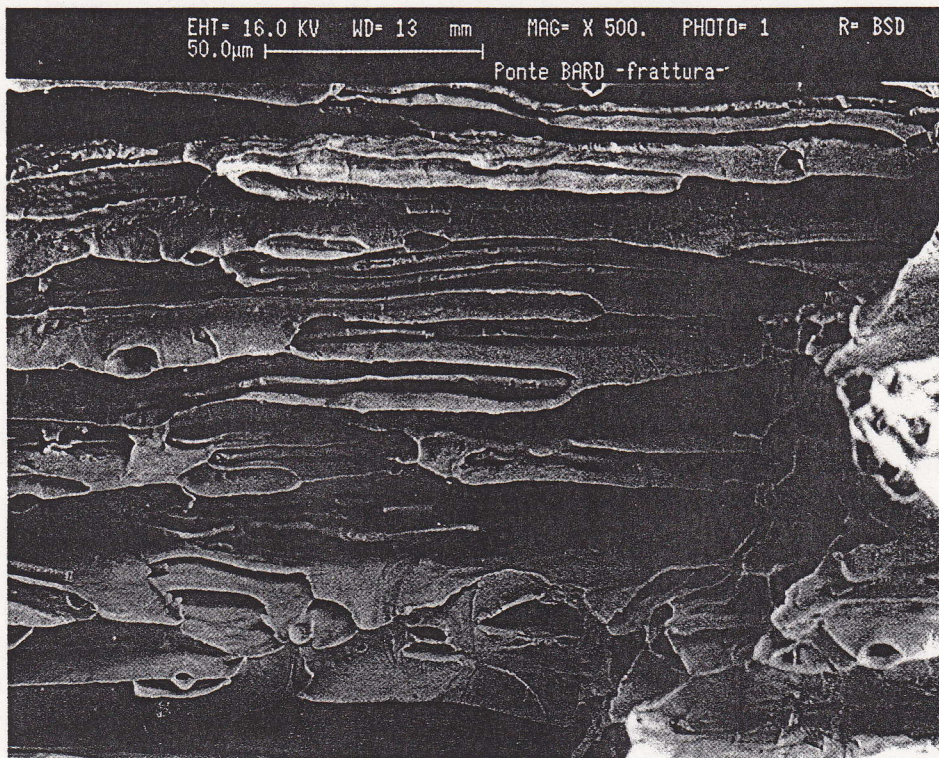
The excellent service behaviour of this iron, therefore, can be related to another phenomenon, namely the high degree of microductility of the ferrite structure as shown by the SEM findings. An intrinsic resistance to fracture thus enabled this metal to survive without disastrous yielding under arduous conditions and for many years, even though its tensile characteristics were not sufficient to ensure it a proper degree of reliability.

(a) ductile fracture (dimples)

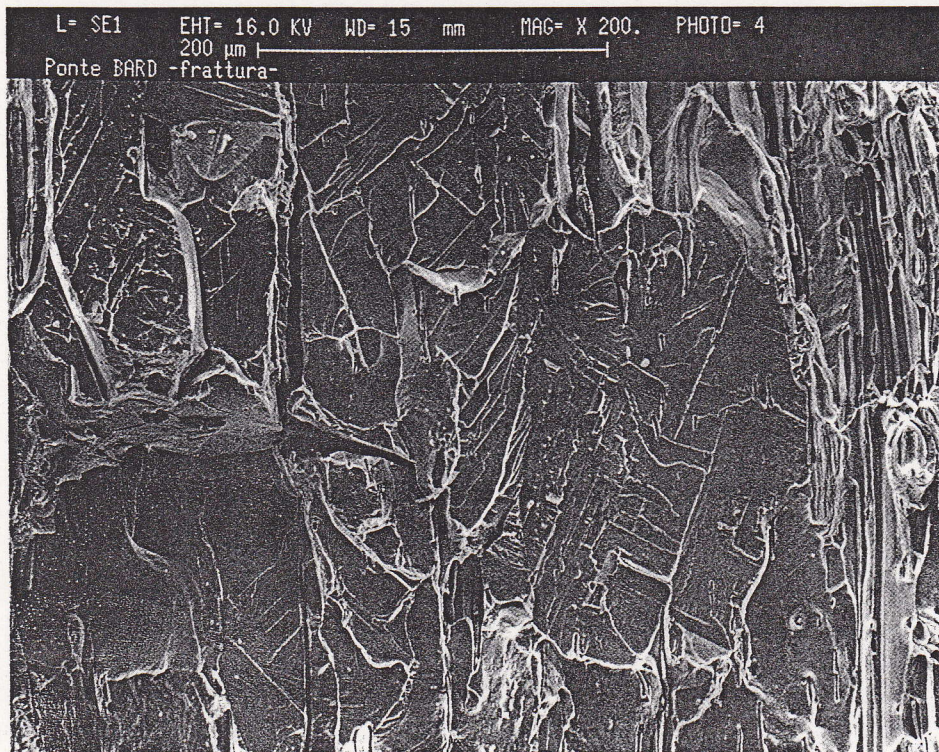
(b) brittle fracture (cleavage)
