Considerations over the Italian road bridge infrastructure safety after the Polcevera viaduct collapse: past errors and future perspectives

Fabio Bazzucchi, Luciana Restuccia, Giuseppe Andrea Ferro

Politecnico di Torino, Turin, Italy

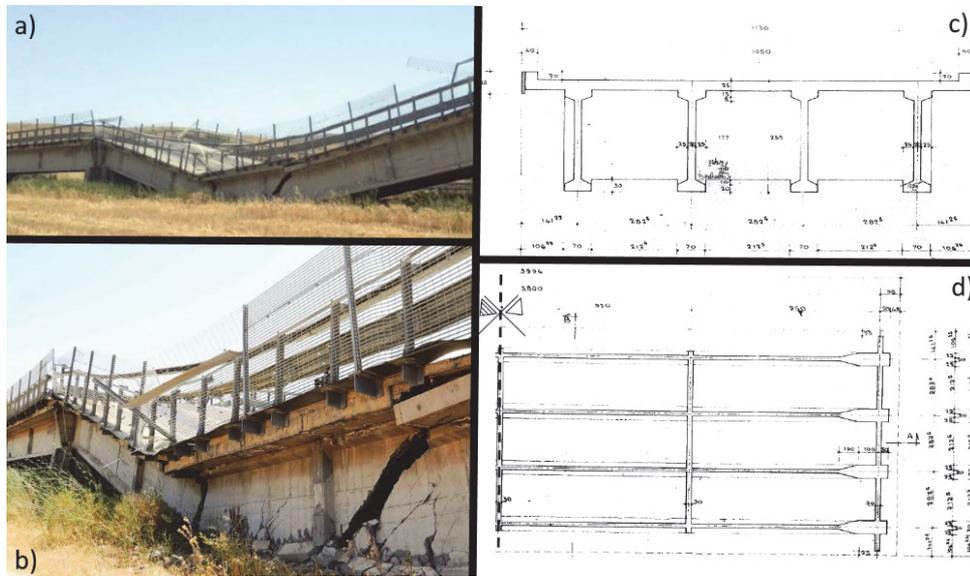
The Petrulla viaduct is situated along the S.S. 626 "Valle del Salso", at km 4+500, in Sicily. The viaduct consists in a series of 12 simply supported beams, each of them with a 40 m span (Fig. 1(a)). On July 7, 2014, one span collapsed, injuring 4 persons. The breakage occurred in mid-span circa, and then, shear failure occurred where the deck impacted ground (Fig. 1(b)). The deck, 11.30 m wide, was made of 4 precast and prestressed concrete I-beams equally spaced by 2.850 m. Five transverse beams realized the girder that supported the pavement slab (Fig. 1(c)). The investigation, conducted after the collapse, evidenced an exceeding state of material decay for the steel components: diffused oxidation in the prestressing cables, severe corrosions of the metallic sheathing and large absence of the protective grout inside the cables (Fig. 2(a), Fig. 2(b)). Since the bridge was built in the mid-80s, this degradation pattern was not compatible with 30 years of service life, especially because the concrete exhibited good signs preservation (Fig. 2(c)). The investigations have evidenced several construction flaws, in particular related to finishing operations of the prestressing. The grout injection was superficially carried out and the vent pipes were not accurately sealed (Fig. 2(d)). Under these circumstances, humidity found a preferential way into the cables, and its continuous content variation generated an aggressive environment for steel oxidation. Other additional deficiencies for this particular degradation scenario were addressed to:

Figure 1: Overview of the Petrulla viaduct (a); collapsed structure (b); original design of the deck (c,d).

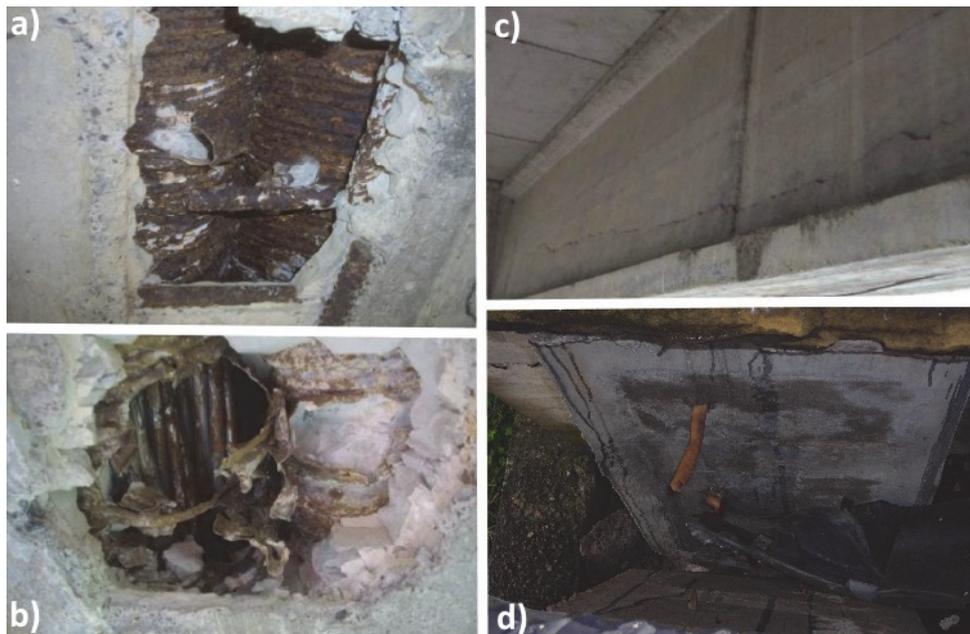
- not sufficient cover due to malposition of the prestressing cables;
- not adequate workability and fluidity of the concrete;

- inadequate waterproofing covering of the joints.

Figure 2: Steel components corrosion, strands (a), metallic sheathing (b); concrete condition (c); unsealed vent pipes (d).

Petrulla Viaduct characteristics have been discussed in section 1. The oxidation of the reinforcing and of the prestressing cables (Fig. 2(a), Fig. 2(b)) occurred due to an inadequate protection by carbonation and water seepage. Through the results of the vulnerabilities, four different restoration interventions have been proposed, corresponding to the observe damage degree (Fig. 3(a), Fig 3(b)). For the level one (G), the removal of the actual concrete coverage and corroded bars, followed by their complete refurbishment, was suggested (Fig. 15(a)). Considering the second level (Y), to assure the adequate safety factor, the installment of a metallic plate was suggested to reinstate the base of the I-beam. This plate was supposed to be connected to the web through two lateral bolts and a glued to the base of the I, previously abrase. The injection of epoxy resins realized the final sealing and the protection from further corrosion. For the third level (B), the intervention is the same of the discussed previous one with the additional injection into the prestressing cables with low-viscosity epoxy (Fig. 15(c)). Concerning the worst damage case (R), the corroded section area of the strand must be recovered to fulfill the safety factor. In order to do so, an external prestressing was suggested, connected to the sealing steel plates and the cable header (Fig. 15(d)).

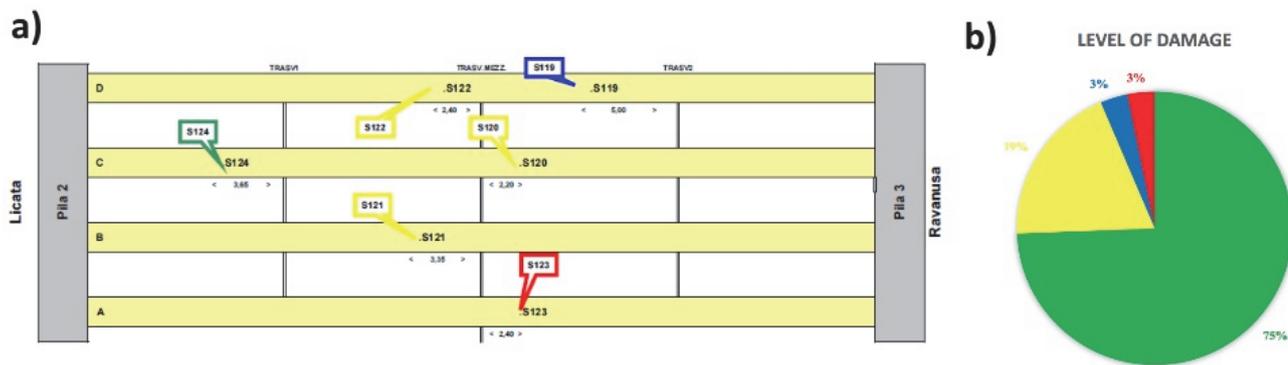
A visual inspection campaign was carried out for all the others remaining beams that constituted the Petrulla viaduct. Four level of damage degree were defined, from no noticeable damage (green) to exposed prestressing cables with visible signs of oxidation (red). In Fig. 3(a), the visual inspection location with its relative degree of damage for the bridge n. 2 has been reported. In Fig. 3(b), results for the entire viaduct have been summarized. It is worth to note that, even if less than 7% of the cases had a high degree of damage (blue and red), they represented 8 different visual inspections, which meant 8 possible beams with no active prestressing forces. This viaduct has been object of reparation and after four years has become operative again. It is reasonable to say that the investigation, repair, and public costs due to the inoperable structure are significantly higher than the ones associated with careful construction procedures. The adopted safety solutions are discussed in the next section (par 6).

Figure 3: Example of the deck visual inspections (a); damage degree results survey (b).

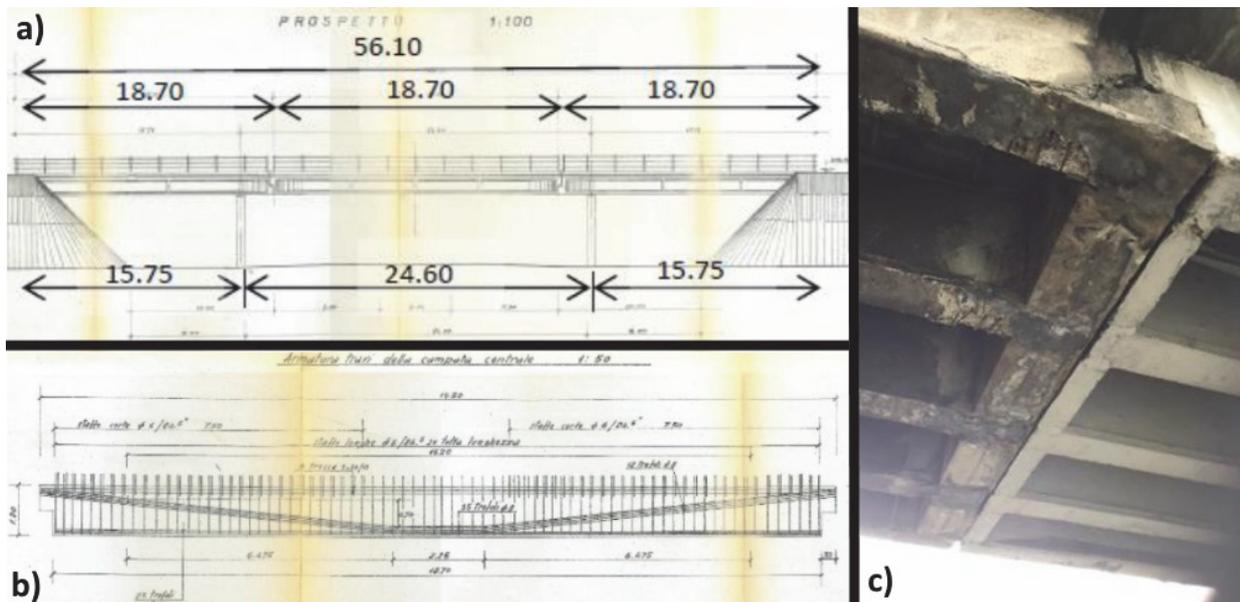
The collapse of the Annone overpass, Lecco, at km 42.000 along the S.S. 36 “del Lago di Como e dello Spluga”, occurred on October 18, 2016. The failure had a high impact on the Italian society since it caused the death of a car driver and several wounded. The bridge was built between the 1960 and 1962, with a Gerber scheme deployed over 4 supports (Fig. 4(a)). The central deck, 24.60 m long and 4.40 m wide, was constituted by 5 precast and prestressed I-beams. Gerber supports were 0.575 m high, with an ordinary reinforcement as shown in Fig. 4(b) and Fig. 4(c). Before the collapse, the bridge was subjected to several impacts by underlying moving vehicles [1]. This was due to a non-adequate free height of the overpass (< 5 m). After these events, the saddle was repaired with rebars and CFRP installments (Fig. 5(a)). However, those interventions could not renovate the shear fracture propagated over the saddle and significant presence of humidity was often detected when inspected (Fig. 5(b)). This was mainly due to the produced misalignment in the dapped-end (2.5 cm) due to the repairs, which constituted a stagnation point for running water [2].

Figure 4: Overview of the Annone overpass [1] (a); Gerber support reinforcement, design (b) and investigation (c).

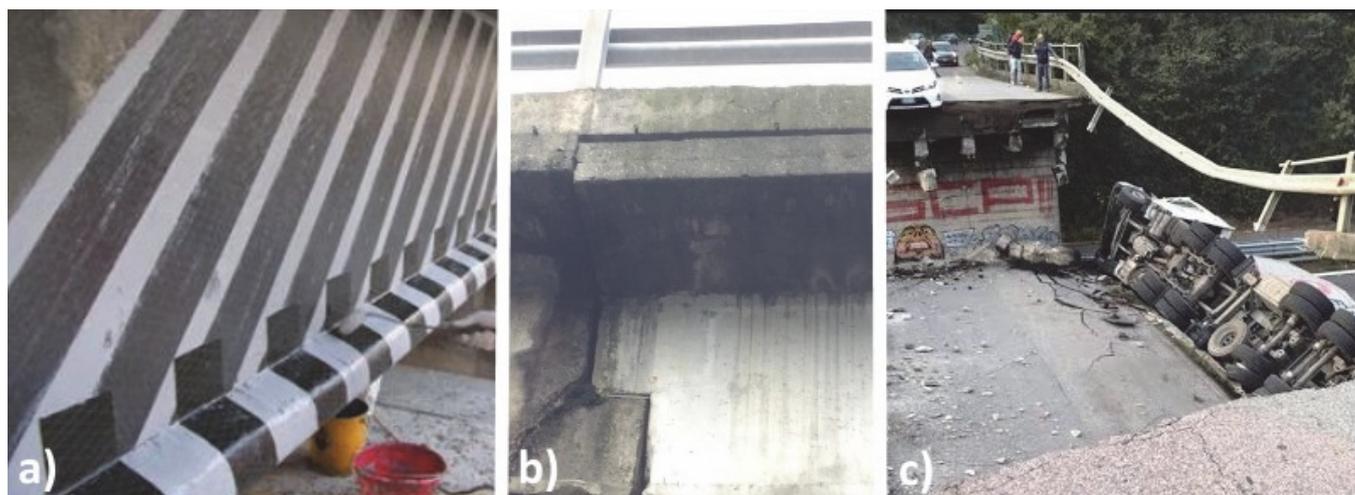
The collapse occurred when a 107.6 t heavy 8-axels truck went across the deck with a low moving speed (Fig. 5(c)). Once the load was carried entirely by the central beam, the external repaired dapped end corbel collapsed due to the vertical reaction established for supporting the beam. Total weight on the structure was approximately 172 t, which is 10 % higher than the maximum design load adopted equal to 155 t. However, this excess should have been overcome in the safety factor. This bridge was catalogued as category II by Italian Building Codes [3], but the safety requirements were not fulfilled by the structural properties. Investigation [1] have demonstrated that this failure was compromised by:

- an initial design flaws in the dapped-end corbel that significantly reduced the ultimate load;

- reinforcement in the precast beams was not enough to ensure a category II bridge classification;
- the presence of a shear fracture along the dapped end corbel promoted the oxidation of the reinforcement bars in the joint;
- the passage of II category loads (more than 100 per year) puts frequently the structure close to its ultimate bearing capacity.
- the eccentricity produced by a transit misaligned by the carriageway central line significantly increased the loading in the external dapped end joint.

Figure 5: Dapped end corbel conditions before the collapse (a); humidity presence and water stagnation (b); failure loading configuration (c) [1].

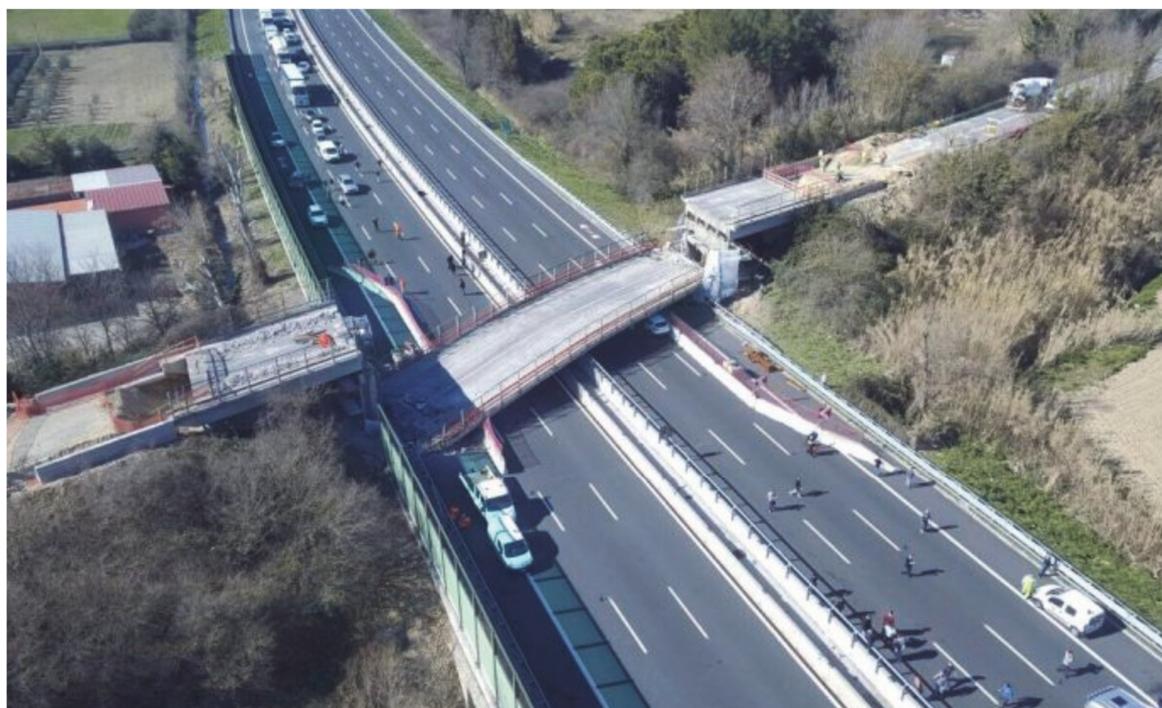
Figure 6: Ancona overpass after the collapse (from web site www.cronacheancona.it).

The case of the collapse of the overpass on the A14 motorway near Ancona is quite different from the others and was caused only by a resounding error during the execution phase. The works involved the adjustment of the altimetric height of the overpasses, consisting of raising the decks, creating an extension of the support structures and the re-profiling of the associated ramps. The lifting took place through the use of hydraulic jacks with few centimeters steps, after positioning of steel plates for distribution. The appointed subcontractor to perform this specific process decided to replace the supporting steel plates with similar plates in neoprene, much lighter to move. Numerical analyses conducted during investigations by prof. Tarantino highlighted how a difference between the temporary supports of a few millimeters generates horizontal forces not compatible with the shear deformability of the numerous neoprene plates stacked on top of each other. This generated an unexpected bridge horizontal displacement and the collapse occurred. Further details are under investigation.

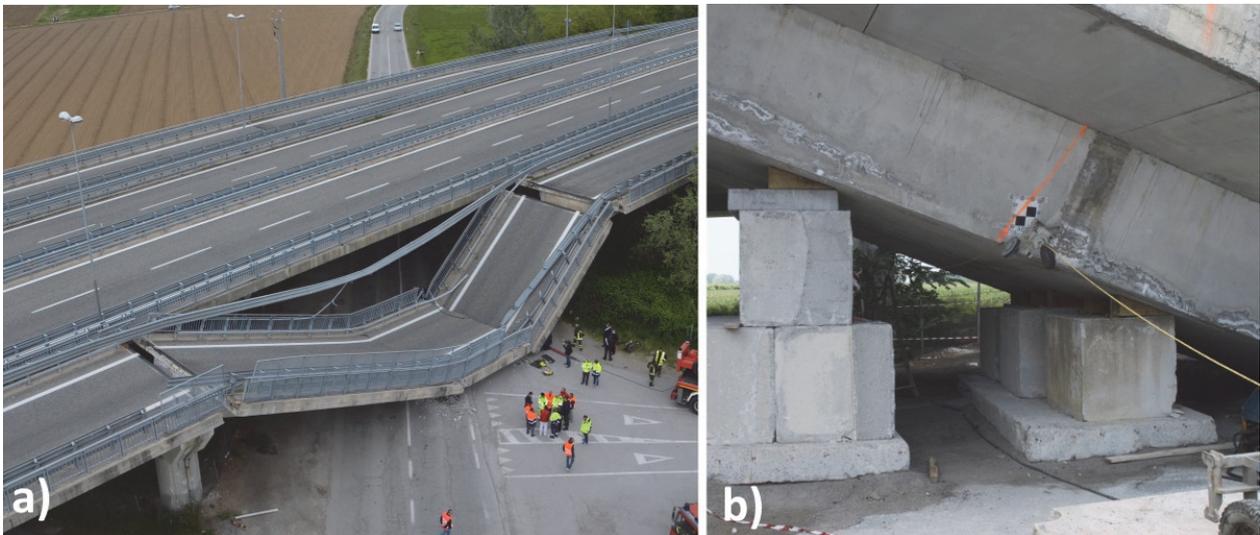
Figure 7: Overview of the collapsed Fossano bridge (a) and structural scheme (b).

The collapsed overpass is one of the 108 that constitutes the Fossano (Cuneo) bypass road. This road has several viaducts, and the one involved in the failure is one of the ramps of La Reale Viaduct, where it crosses the S.P. 165. The collapse occurred on April 18, 2017, and luckily (2.45 p.m.) no vehicles were going across or underneath the structure. The sudden collapse took place without out-of-plane displacements (Fig. 7(a)). A modest slip ahead in one of the bearings has been identified in the collapsed configuration. The structure was a simply supported beam, 30.80 m long and 8.90 m wide, constituted by a multiple-box post-tensioned beam and by a in-situ casted slab. The section was realized by connecting two concrete precast U-elements by a shear-key casted in situ. In the longitudinal direction, the bridge was built in 3 segment, the central one 11.50 m long and the lateral ones 9.35 m long. The connection between the segments was realized by an in-situ casted concrete joint 0.5 m wide (Fig. 7(b)). Post-tensioning system constituted in 8 parabolic cables, each of them made by 19 0.8" strands. Total weight of the structure was about 400 t. The collapsed structure evidenced an intact joint and a collapsed one, together with an evident shear failure where the bridge impacted the ground. For this event, several information can not be given at the moment due to secrecy related to the running investigations. Visual inspections consented to affirm that the collapse mechanism was triggered by a shear failure in one of the joint due to the absence of the equilibrating action of the prestressing (Fig. 8). This means that in some part between the support and the intact joint, the cables were damaged. Visual inspections immediately also demonstrated that the cables did not have sufficient grout protection in the collapsed joint area (Fig. 9(a)). The damage was not compatible with a 20 years old

Considering now the case of La Reale Viaduct (Fig. 7(a)). Durability problems are overcome by the peculiar shape of the deck and its modular assemblage. To avoid a fragile collapse, the structure must improve its robustness. Since the analyses of the safety of the infrastructure are still under exploitation, different levels of intervention are suggested towards the observed damage pattern. For the spans that will evidence lack of cable protective grout, epoxy injection would be necessary to stop di advancement of corrosion. This operation could result particularly difficult to do because of the inaccessible boxed section. A frequent problem in bridge concrete walls is concrete spalling and exposure of reinforcement. This situation is particularly dangerous when the exposed reinforcement realizes the primary load carrying system, i.e. dapped-end corbels (Fig. 5(a), Fig. 5(b)). Under this circumstances, health of the steel is essential to exclude a sudden collapse due to shear failures. Considering the numbers of the existing artifacts, sometimes just blocking the advance of corrosion represents a good strategy to keep reasonable safety factors while retrofitting is pending. This strategy can be implemented by the use of sacrificial anodes (galvanic protection) directly connected to exposed reinforcements (Fig. 16) [24]. These anodes, usually realized in zinc-based compounds, guarantee local protection to the

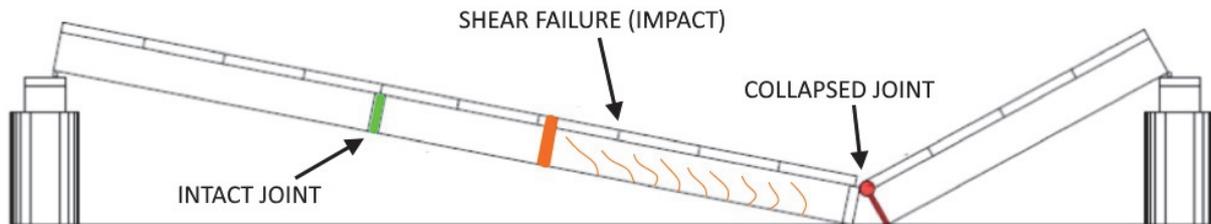
Figure 8: Collapse mechanism.

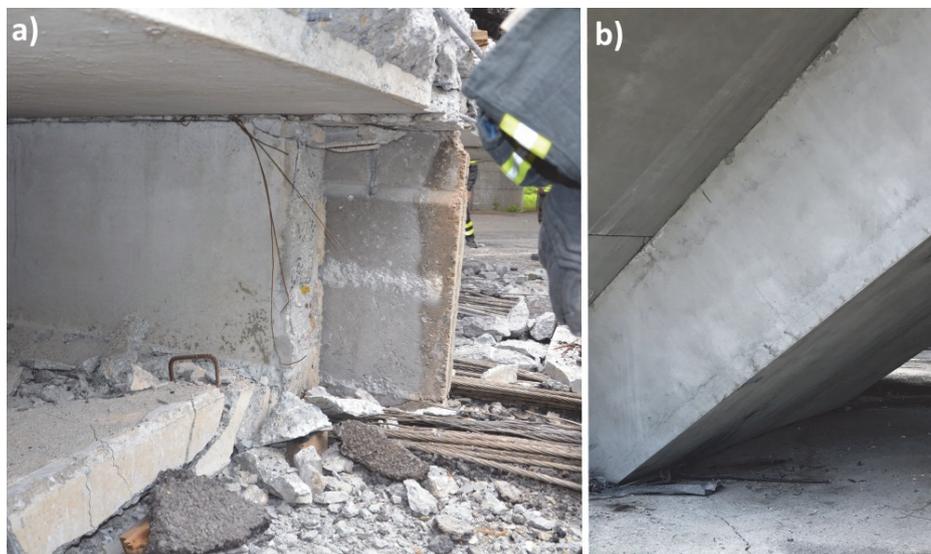
concrete structure damage scenario, and moreover, the overall external condition appeared healthy (Fig. 9(b)). This unusual structural failure, and the fear of a systematic bias, has been followed by detailed analyses and the structure has been dissected in order to establish the causes. To date, the vulnerabilities of this structure can be summarized as follows:

- absence of ductility and structural robustness, there is no redundancy in the prestressing device;
- inadequate grout injection inside the cables, which led the water to a preferential way inside the sheathing;
- total non-accessibility for structural inspections.

Figure 9: Prestressing cables in the collapsed joint area (a); external concrete conditions (b).

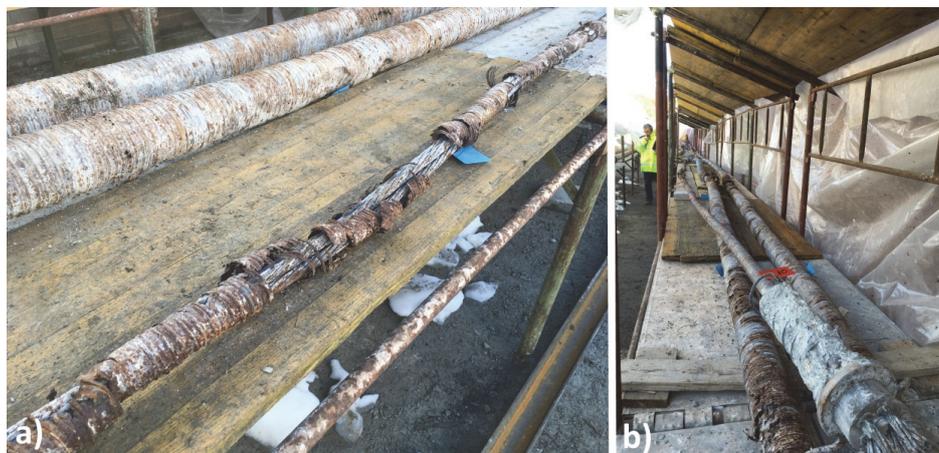
Figure 10: prestressing cables, extracted and analyzed. It is possible to note the direct correlation between grout content and oxidation rate of both sheathing and strands.

The number of the analyses that have been carried on investigating this collapse was enormous: simulated rain tests to locate the water gateways, chemical tests for the crystallized residuals and molds, and each segment was carefully demolished and each cable was extracted and inspected (Fig. 10). A complete autopsy was conducted on the bridge. When the investigations will be finished, the civil engineers will learn a lot from the final reports of the investigation committees.

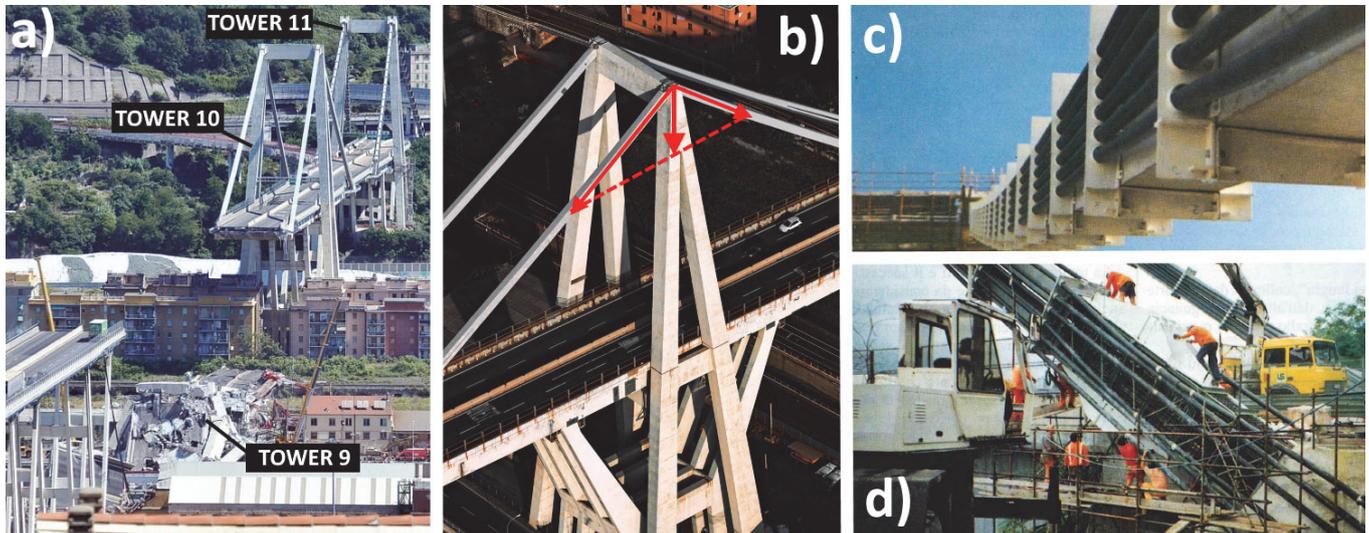
Figure 11: overview of the Polcevera bridge collapse (a); structural scheme of the tower (b); stay cables replacement intervention (1993) (c,d) [4].

On August 14, 2018, the Tower 9 of the Polcevera bridge, abruptly collapsed on the underlying industrial hub, Polcevera river and rail track of the city of Genoa (Fig. 11(a)). This collapse represents a categorical failure for the Italian Structural Engineering community. Whatever the causes of the collapses would be addressed to, object of the undergoing investigations, it is evident how there have been errors in the check procedure. Starting from the design (1960), the structural system (“*cavalletto*” [4]) that realized the tower relied on the balanced compressive force along the lateral columns (Fig. 11(b)) coming from the stays. The assembled framed tower, plus a four-point supported deck, exhibits a complete absence of robustness and structural redundancy, which means that in case of failure of one of the components, there was no control in preventing a catastrophic collapse [5]. Many colleagues affirmed and condemned the designer for the collapse. As written in the introduction, we can affirm that the lack of robustness was normal for the typological structures of that era and consequent to the available tools in the 60'. It is easy today to perform analyses for highly indeterminate structures by using computers, but it was not at that time. The structures were designed by using the simplest possible schemes, in order to have easier calculation to be made. Consequently, no ductility expedient, at any scale, was adopted to exclude fragile collapse [6]. Robustness and ductility are two design control parameters for structural safety in the ultimate state of collapse. Moving forward along the chain, maintenance and monitoring are two control activities that usually go along with an important bridge structure. Because of its audaciousness, Polcevera bridge has been continuously investigated and consolidated over the years. Along the 70s, the designer himself, started with regular visual inspections [7], while over the '80s a distributed restoration of the concrete components was carried out [4] starting from the towers and then moving through the deck. In 1993, a detailed inspection through the insertion of an endoscopy inside the stays of the Tower 11, evidenced a severe oxidation of the metallic protective membrane and of the strands themselves. Additionally, significant presence of humidity and absence of grout were reported. Moreover, some of the strands appeared slacked or sheared, sign of a tensile rupture due to steel cross-section reduction [7,8]. This preoccupying scenario advised the entire structure management authorities over the risks of material decay due to micro-cracking in the prestressed concrete. In fact, the concrete section of the stays was designed to be subjected to light but continuous decompression-compression cycles due to live loads. The peculiar cables disposition, core of the M5 patent [9], had the aim to avoid large stress variations in the steel strands, but this was possible only with a magnitude of the tendon force close to the ultimate one. All the described conditions led the structure to a quickened state of material decay and the entire sets of stays of the Tower 11 were replaced with an external prestressing system (Fig. 11(c), Fig. 11(d)). After this massive intervention (12 cables $\phi 150$ mm with 22 0.6” diameter strands for each stay and 4 months of work with reduced

traffic), many other maintenance and monitoring activities have been performed over the viaduct [10]. Most of the monitoring regarded the health condition of the strands of the remaining towers [11], while the repairing affected the carriageway slabs. When Tower 9 collapsed, a replacement intervention of its strands was planned for the following two months, and ongoing maintenance was present on the deck.

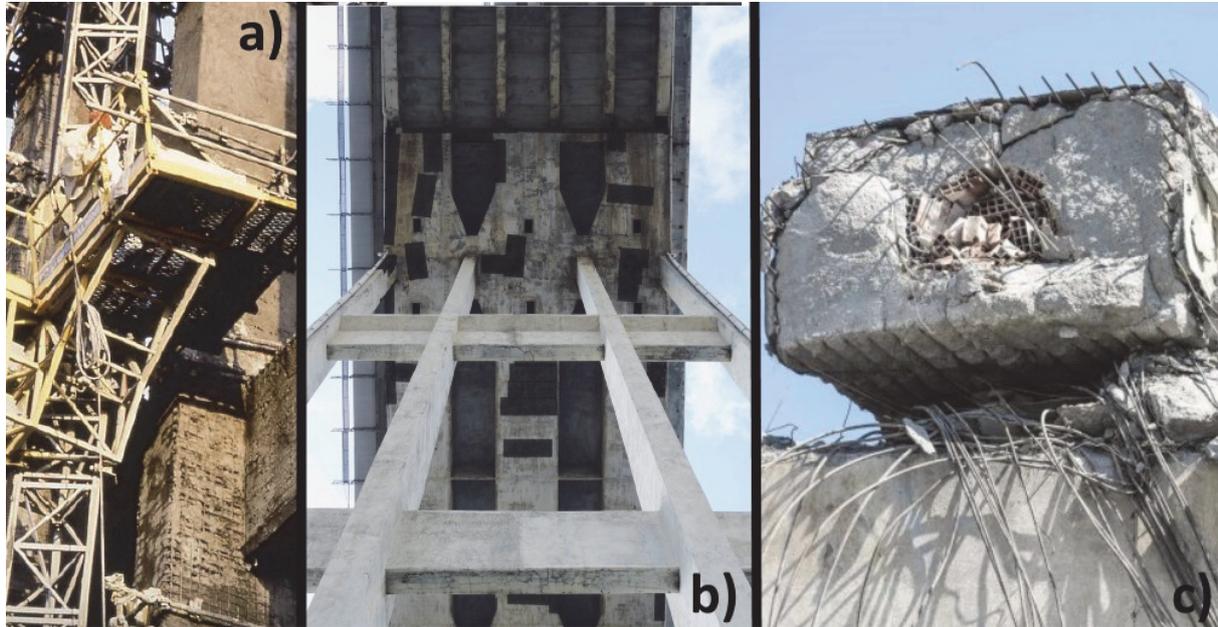
the epoxy covering was substituted with the Emaco S88 retained shrinkage grout and an Emaco Bianco white painting (Fig. 12(b)). Images of the collapsed Tower 9 prove the presence of this protective layer, but at the same time is possible to observe a neat discontinuity between the old and the new surfaces (Fig. 12(c)). Today, the state of the art for the same intervention prescribes that the removal must occur for all the thickness of the corrupted concrete, and complete bonding has to be assured between old and new surfaces to avoid stagnation and contaminant penetration [22].

Figure 12: Repairing of one of the tower of the Polcevera viaduct [17] (a); white covering of Tower 9 (b); ruins of Tower 9 (c).

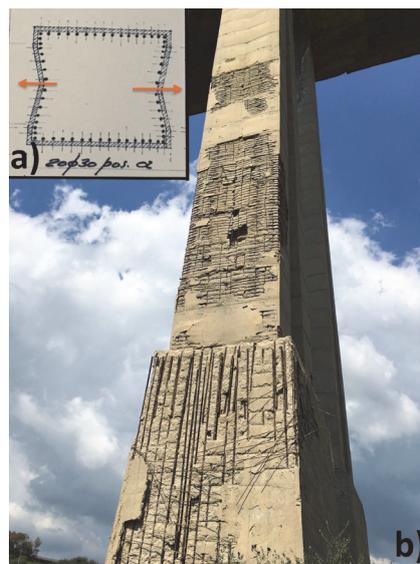
Throughout the same years, the Akragas Viaduct (S.S. 115-AG, Agrigento, 1970) was erected in Sicily. The design, by Morandi, considered a total length of 1400 m skewed viaduct with 31 spans, each 44 m long (Fig. 13(a)). The deck, 10 m wide, was realized by a grillage of 3 unbonded prestressed I-beams, 5 transverse beams, and a precasted pavement (Fig. 13(b)) [23]. Support for each beam consisted in a couple of reinforced concrete A columns, with a maximum height of 60 m. To date, these latter elements represent the key vulnerability of the structure. Each column was erected through a concrete concave precast box that works both as scaffolding (in the pouring phase) and as shear resisting element (Fig. 14(a)). It is reasonable to think that visible damage is due to the concave shape of the external box. When shear forces required confinement, the bars pushed against the box bulged the internal part as visible in Fig. 14(b). Together with the static problems, the retrofitting intervention has the aim of improving the seismic behavior by providing sufficient shear strength and ductility: a new element and the recovering of a confined state for the concrete of the core.

Figure 14: Column details (a); state of decay of the columns (b).

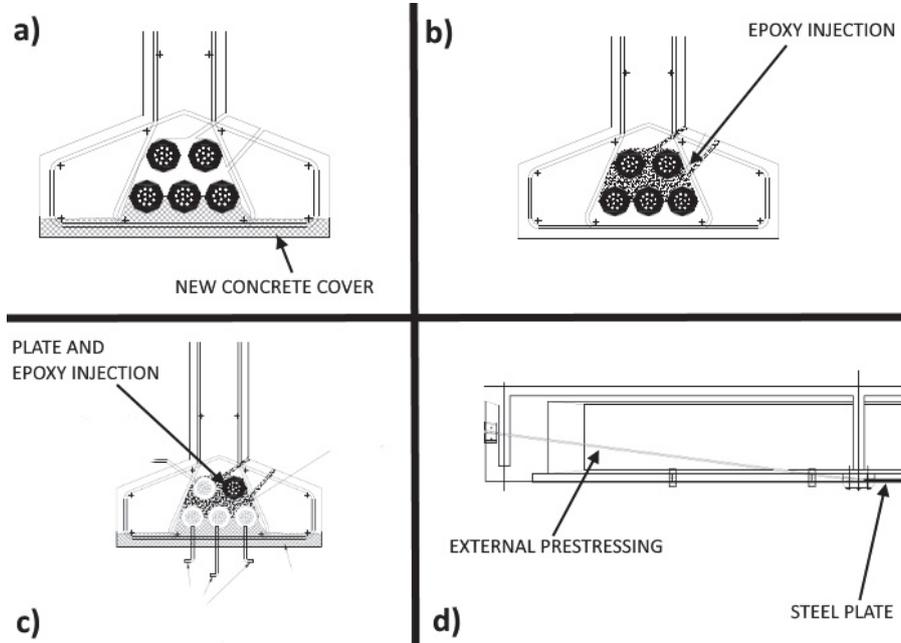
Figure 15: Suggested retrofitting. Level 1 damage (a); Level 2 damage (b); Level 3 damage (c); Level 4 damage (d).

The retrofitting intervention proposed for the Petrulla viaduct (Fig. 15) had also the purpose of increasing the robustness of the structure. Local plates and the external prestressing made recover structural continuity to the beams. Furthermore, the external cables are easy to inspect and check for integrity. This opportunity represents also a form of robustness because of the redundancy of controls. On the contrary, structural arrangement like the one of the Fossano Bridge requires to retriever firstly the structural coherence. The joints represent a discontinuity towards the fragile shear mechanism. This means that, if the cables are unbonded across the joint area, there is no possibility for the vertical loads to reach the supports once the cables are broken. This could be easily testified by looking at the intact joint that resisted the impact on the ground when bridge failed (Fig. 7(a)). Moreover, inspections in the web and epoxy void injections seems unfeasible due to the section shape. In the same way, external prestressing is rather impassable, since it is unknown the adequate force and steel to apply. A promising solution is represented by resurfacing the concrete beam with a steel carter that works both in shear and flexural regime (Fig. 19). The mandatory condition for this repair intervention is the absolute adherence between the steel sheathing and the concrete, in regard to congruent strains and humidity proofing [27].

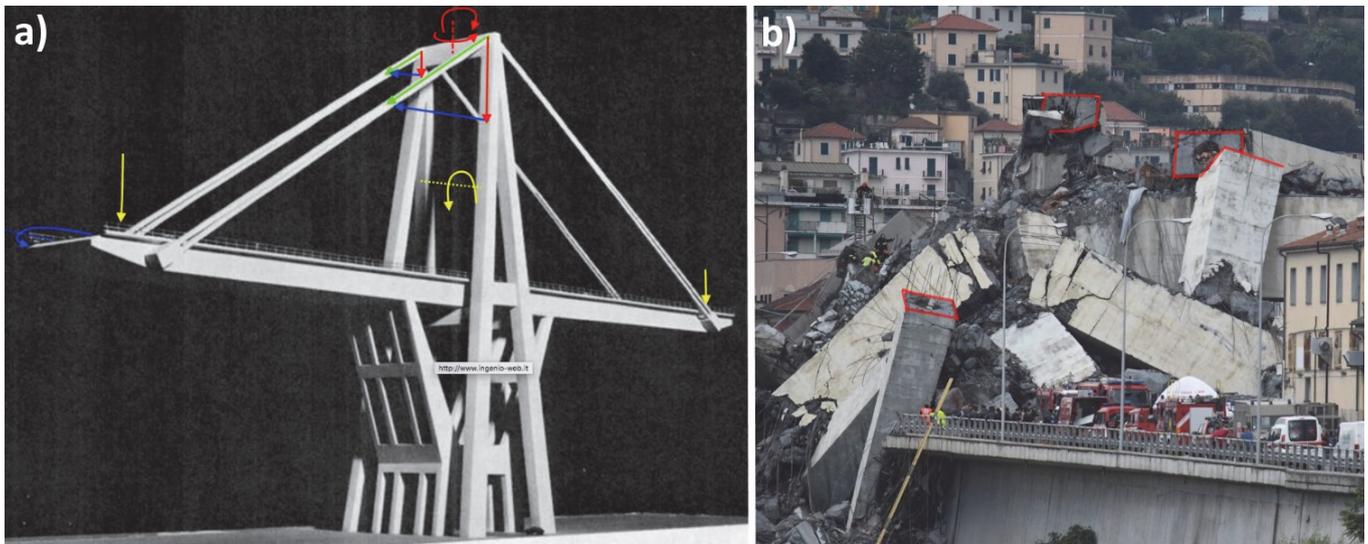
Figure 18: resisting mechanism of the Polcevera Tower: equilibrium in the three planes [www.ingenio-web.it]. (a); planar failure surfaces (b).

One of the shocking aspects of the Polcevera Viaduct collapse was its catastrophic nature. Even if the causes are currently under investigation, it is clear that the failure of one component has been followed by the entire structure, composed by the tower (green, Fig. 17) and two simply supported Gerber decks (red, Fig. 17). As anticipated, the equilibrium of the system rests upon the balance between the symmetry axes of the tower (Fig. 18a). A lack of balance in one of the two directions of the equatorial planes induces a flexural moment in the deck plane that can lose in-plane stability and could break due to unbalanced compressive forces (blue, Fig. 18(a)). Under these circumstances, the in-plane twisting could cause the slip of the Gerber decks, that without a vertical support become free to fall. At the same time, a disequilibrium in the plane of the bridge direction induces torsion and bending moment to the double framed A tower (red, Fig. 18a). This structure could not have the ductility capacity to resist at such asymmetric stress, because of the limited rotational capacity at the base (wider) and the lack of redundancy for force redistribution. Moreover, unbalanced forces in the plane of the stays causes deck uplifting on one side and subside to the other. This mechanism, could be again

responsible for the support loss of the Gerber deck and the rupture of the deck due to bending in its plane (yellow, Fig. 18a). An asymmetric fall of the deck causes and inevitable impact with the intermediate deck support that would find themselves dragged into the collapse. Finally, the observation of the Tower 9 ruins allows an additional comment: many of the parts of the tower broke with planar surfaces, evidencing low or nonexistent process zone and plastic hinge creation. These planar surfaces represent probably the casting phases of the vertical structure. This would imply that (i) no sufficient rebars content was present in that zones, or (i) the boxed section had not sufficient plasticity reserve (red, Fig. 18b). In the end, at this level of knowledge, the lack of structural robustness can be addressed to these factors:

- the low number of stays elements that causes zero redundancy in deck support;
- the low rotation capacity of the A framed lateral tower and its limited redistribution;
- the statically determined scheme for the entire viaduct, which causes higher displacements (and cracking as a consequence) and domino effect collapse;
- the low ductility at member scale;
- the intrinsic sudden loss of strength of prestressing technology.

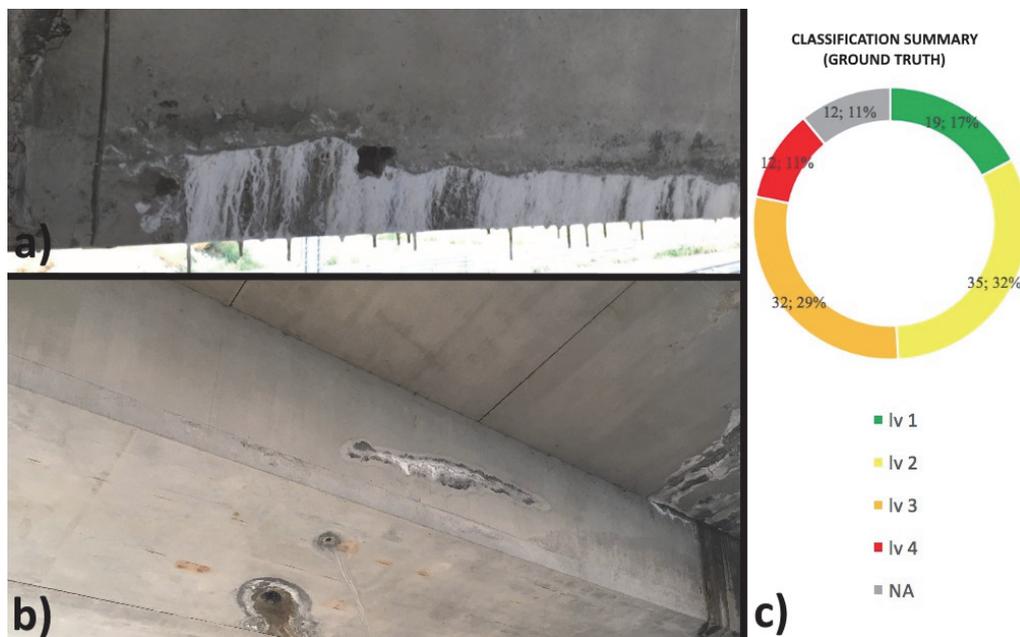
Figure 22: White stains due to grout drainage (a); red-brown stains due to corrosion (b); results from classification (c).

The spot in Fig. 22(a) exhibits a with a pale color and a layered aspect. This stain testifies a drainage of the grout by water seepage inside the cables. This obviously implicates inadequate water protection but also suggest that the cables lie in

bonded condition. At the contrary, red-brown stains (Fig. 22(a)) suggest unprotected cables and rust transport by continuous water gradient. This latter condition represents of course the worst scenario, with maximum damage and lower robustness. The presence of this particular damage has been catalogued as Lv.4 (red) for the entire bridge. Extended and joint-diffused white stains have been catalogued as Lv.3 (orange), while local or isolated as Lv.2 (yellow). Lastly, a clear external surface of the bridge deck has been assigned to a Lv.1 degree of damage (green). After the first photographic campaign, an image classification (labeling) has been carried out manually by experts. Results of this classification are shown in Fig. 22c. These results have been used as ground truth for the building of the image layer of a DCNN CV detector Fig. 23(a). The set has been splitted in 65%-35% for training and validation. Before training, each picture has been filtered for red-contrast enhancement. A random set of 200 images from Kaggle has been used as false test. Training lasted 21 hours on a 2014 MacBook Pro. DCNN has been implemented with Pytorch and Anaconda 3.5.2.0. Other two layers have been implemented in the net, one based on the results of the load test and one on the dynamic properties of the bridge, both computed by a FEM tuned model Fig. 23(b). To date, other two photographic campaigns (tablet-based) have been carried out by A.N.A.S. technicians, and Fig. 24(a) shows the results of the application of the DCNN on the bridge n. 48. The system correctly spotted a red stain and classified the bridge as a Lv.3. Analogously, for bridge n. 52 (Fig. 24(b)), a Lv.4 classification has been successfully matched. Regarding instead span n. 85, classified Lv.3 manually, the DCNN detected a Lv.2. damage degree Fig. 25(a).

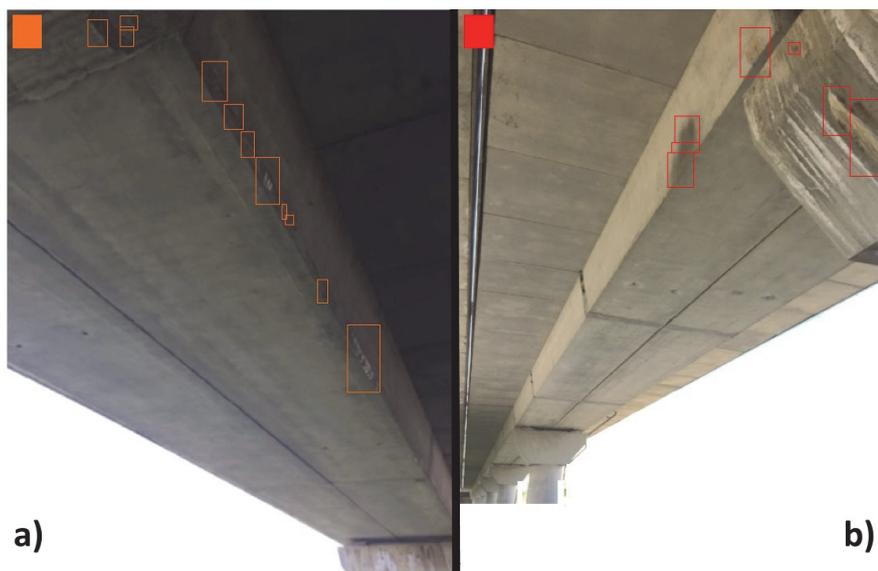
Figure 24: Detection of a Lv.3 damage (a); detection of a Lv.4 damage (b).

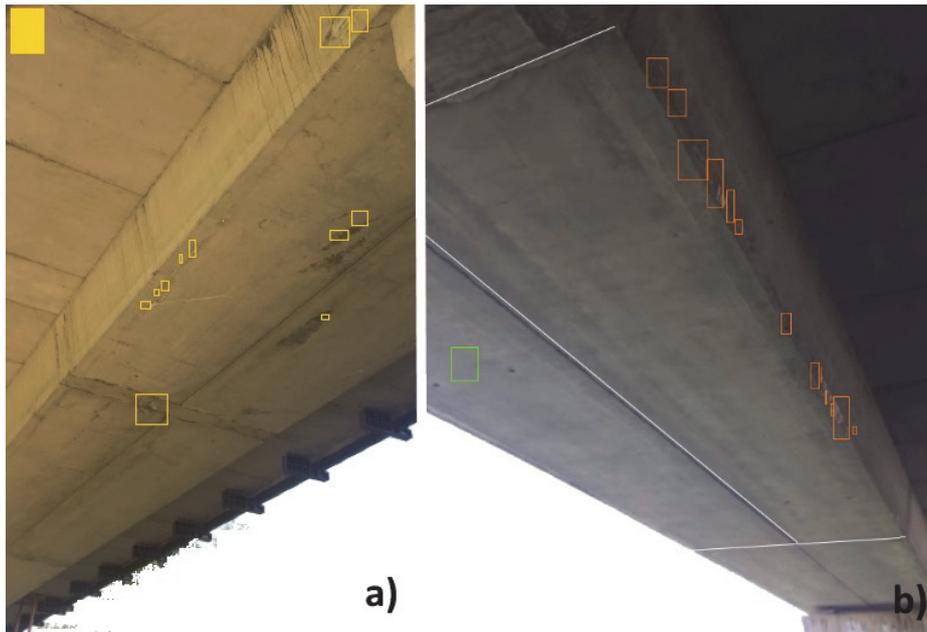
Figure 25: mismatch of damage degree (a); element-scale analysis (b).
