## Failure analysis and numerical simulation of slab carrying clamps

**ABSTRACT.** The goal of this study was to determine the reasons for failure of slab carrying clamps which had occurred in one of the clamp support levers. Detailed fractography analysis revealed that there was a welded joint at the location where failure occurred, which was not expected, since the second lever was not welded. Once the presence of the welded joint was confirmed by hardness measuring and the analysis of chemical composition, attempts were made to determine which materials were used for the welding, in order to obtain a more detailed insight into the nature of the failure. The first step of this extensive analysis involved the development of a simple, approximated numerical model, with the goal of determining the location of stress concentration in the support lever, so that it could be compared to the real failure location. Further investigations will involve more complex models, including the ones that will simulate crack growth, once its location is numerically verified.

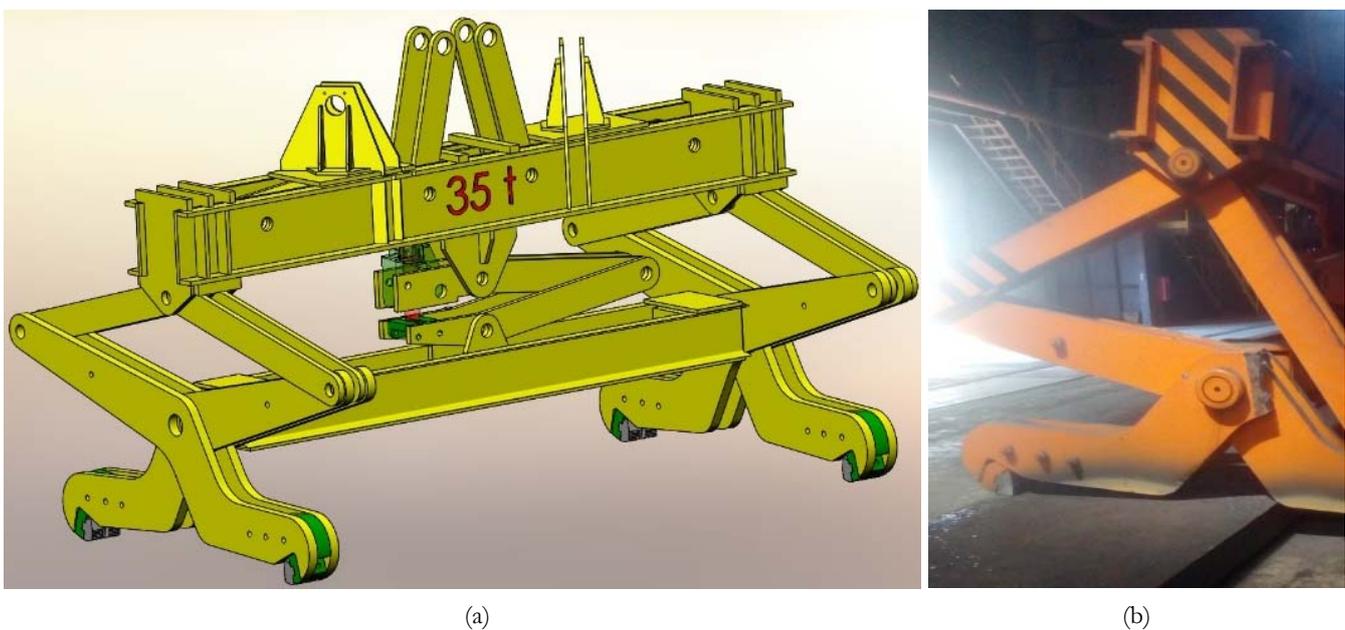
Figure 1: a) 3D model of the slab carrying clamps; b) One of the clamp levers where the failure occurred.

This paper presents the analysis of slab carrying clamps failure, in the part of the clamp used for transporting slabs through the steel mill, wherein these slabs are used for further manufacturing of sheets in the hot-rolling facility. Clamps are exposed to static loads during their work life. In order to determine the reasons behind this failure, analytical and numerical calculations (using FEM) were performed, wherein numerical simulations were performed using ABAQUS software. Additionally, visual inspection of the entire equipment was performed, along with the chemical analysis of the fractured surface, which will be presented here in detail. Fig. 1a shows the 3D model of the clamps, whereas Fig. 1b shows the appearance of the broken support lever, i.e. the location of the failure. An additional complication arose due to the fact that the visual testing revealed a welded joint in one of the support levers, which resulted in the need for additional analyses, including the determining of the chemical composition of the fracture surface and discovering the reason why fracture had occurred. Based on the aforementioned figure, i.e. figure of lever fracture, it can be observed that the influence of welding was noticeable, but despite of that the following questions arose: why did failure occur and why was it not located in the central hole of the support lever?

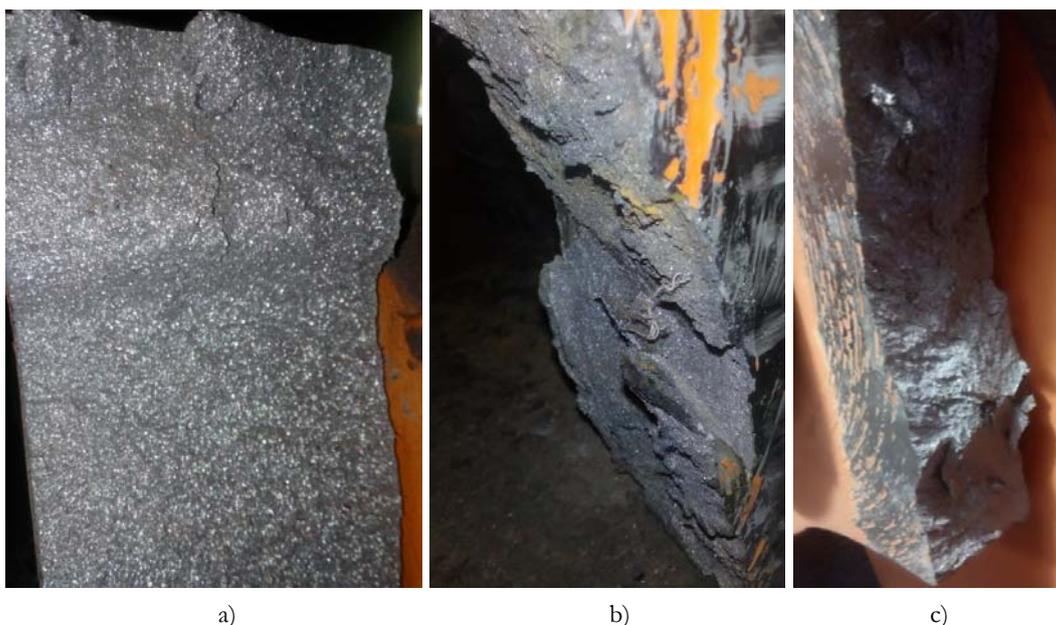
As can be seen in the above figure, one pair of clamps, with a carrying capacity of 35t consists of two levers. Fracture occurred in both of these levers, due to exploitation conditions, in service, which resulted in loads far exceeding the expected, i.e. calculated values. The second lever most likely failed after the first one broke, as it could not carry the full load on its own. On the Fig. 2 are presented fracture surfaces of the levers after performed visual inspection. This inspection also revealed that one of the lever was actually welded. This was initially assumed based on the fracture surface appearance, due to the presence of fusion lines. Figs. 2a and 2b show the fracture surface of the welded lever, whereas Fig. 2c shows the fracture surface of non-welded lever. Differences in these surfaces of the two levers can be easily observed. In order to verify the above assumption that one of the levers was welded, hardness testing was performed on both levers, in the fracture location. This measuring was performed using adequately calibrated equipment, and is given in HB units of hardness. Fig. 3a shows the measuring points on the lever which was welded. It can be seen that the region in the vicinity of the fracture surface has higher hardness (236 HB), compared to the region further away (191 HB), which indicates that this was the heat affected zone of the weld. Fig. 3b shows the measuring point in the lever which was not welded, also located in the vicinity of the fracture surface. No significant differences in hardness values were observed in this case, suggesting a much more homogeneous material, i.e. that there was no welded joint in this lever. Magnetic flux method of the NDT examination revealed no other cracks in the vicinity of fracture surfaces of both broken levers.

Figure 2: a) Appearance of fracture surfaces of the welded lever; c) fracture surface of the non-welded lever.

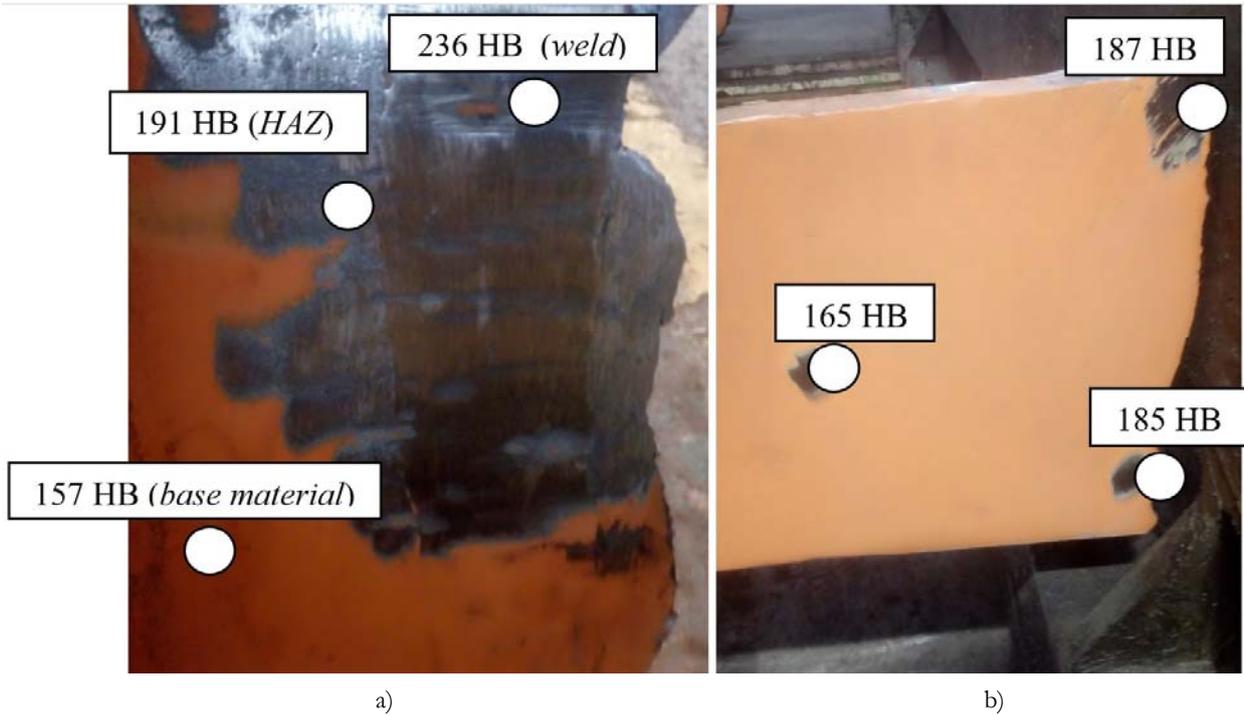
Figure 3: a) Hardness values and measuring locations on the welded lever; b) Hardness values and measuring location on the non-welded lever.

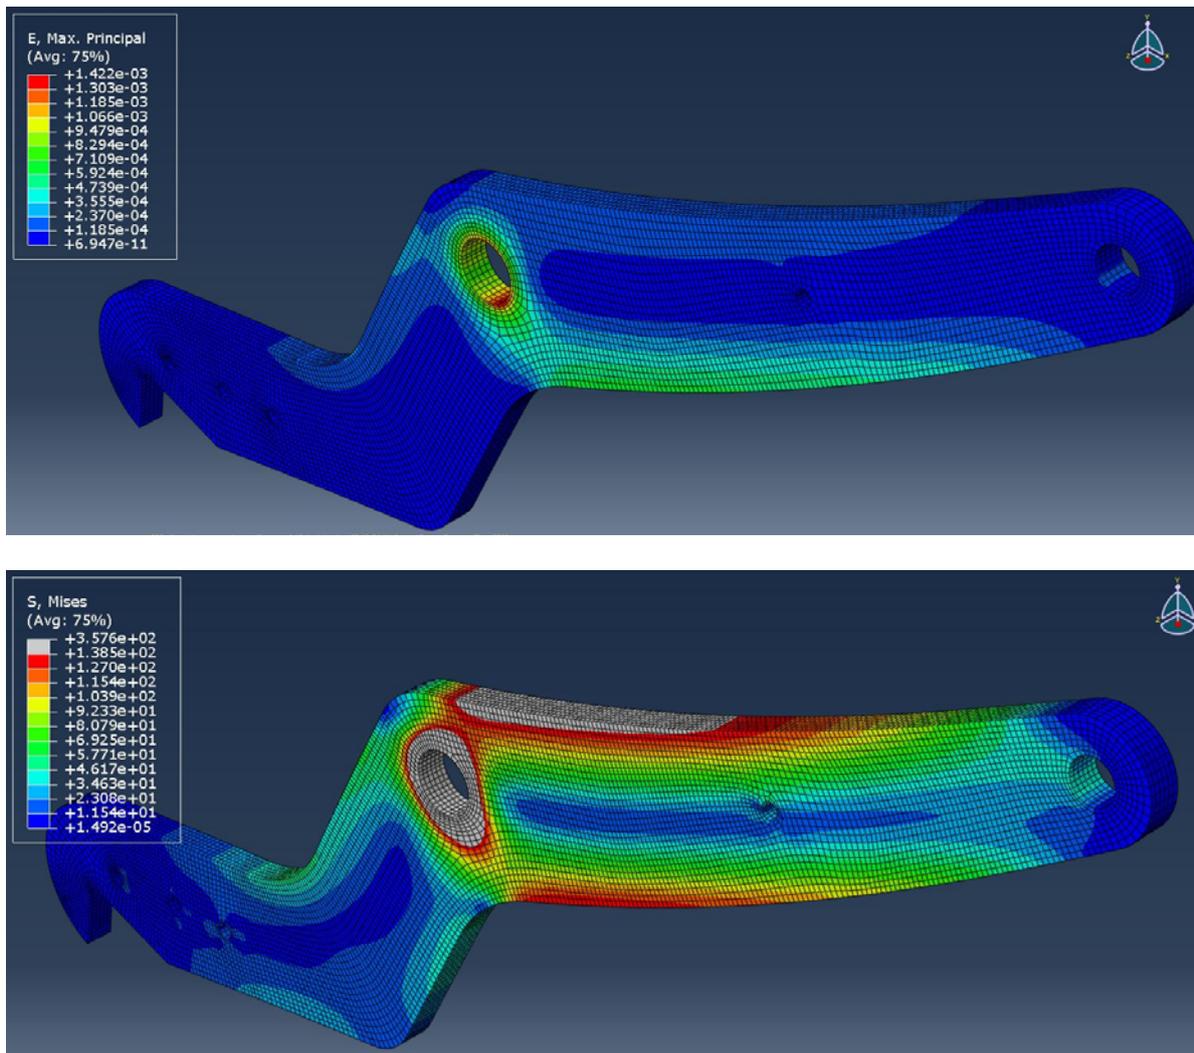
Figure 7: Strain (top) and stress (bottom) distribution in the numerical model.

The results, including stress and strain magnitudes and distribution, are shown in Fig. 7 below. As can be seen, there are some very high stress values obtained in certain locations, which suggests that a more detailed approach is necessary in order to make a fully functional model. However, the goal of this initial version was to determine the location of the maximum tensile stresses, which is denoted by the red colour in the aforementioned figure. The areas with much higher stresses (grey) can be neglected in this case since they are:

Strain distribution indicated that the most deformed part, outside of the support, was the region where highest tensile stresses, with a magnitude of 138.5 MPa, had occurred. If this is compared to the real situation, it can be seen that there is good agreement between the locations of highest tensile loads, i.e. the potential crack in the model would be initiated near the location where the actual support lever broke. The stress value in this case is still considerably below the allowed stress, although it is over 50% higher than the analytical, which also confirms that the model needs to be improved.
