Estimation of tensile mechanical parameters of existing masonry through the analysis of the collapse of Volterra's urban walls

Mario Lucio Puppio, Linda Giresini

University of PISA, Italy

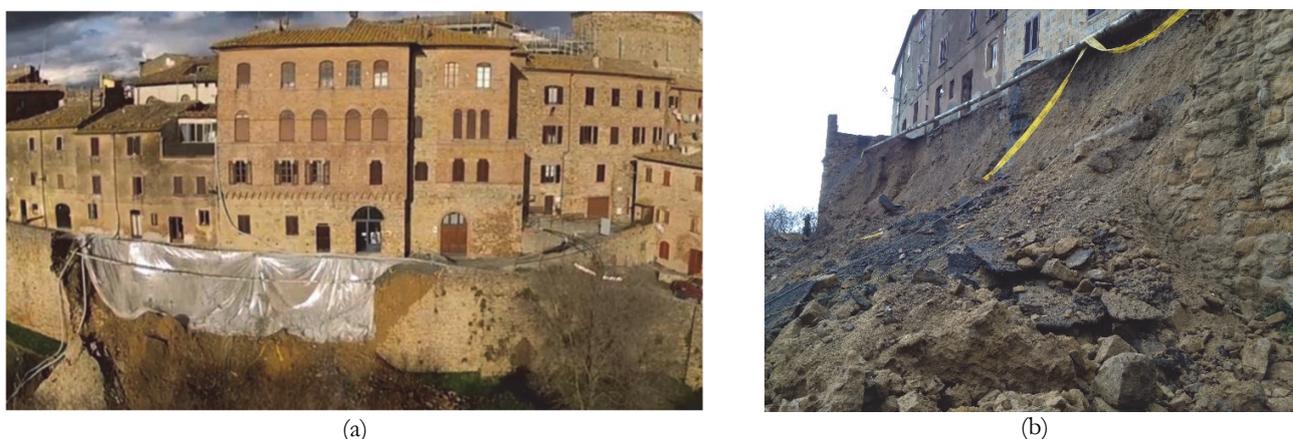
On January, 31st 2014, after that an extreme rainfall occurred, 30 meters of the urban walls collapsed (Fig. 1a) during the night. Luckily, there were no casualties, and the building close to the wall (at a distance of few meters) was not damaged at all. The part of collapsed walls is located between Porta all'Arco and Piazza dei Fornelli, one of the most panoramic points of the town. The collapsed wall is dated back to the second half of the XIII century and differs in technical features from the Etruscan walls, being mainly characterized by smaller blocks (Fig. 1b).

The collapsed portion of the wall can be defined as a retaining wall, the back part is completely filled with soil and behaves as a retainer for the rear two/four-storey buildings (Fig. 1a).

Figure 1: Historic urban walls of Volterra, the portion of wall right after the collapse (a) and the view from the base of the walls (b). In the background of figure (b) is also possible to see the typical section of the Urban walls of Volterra.

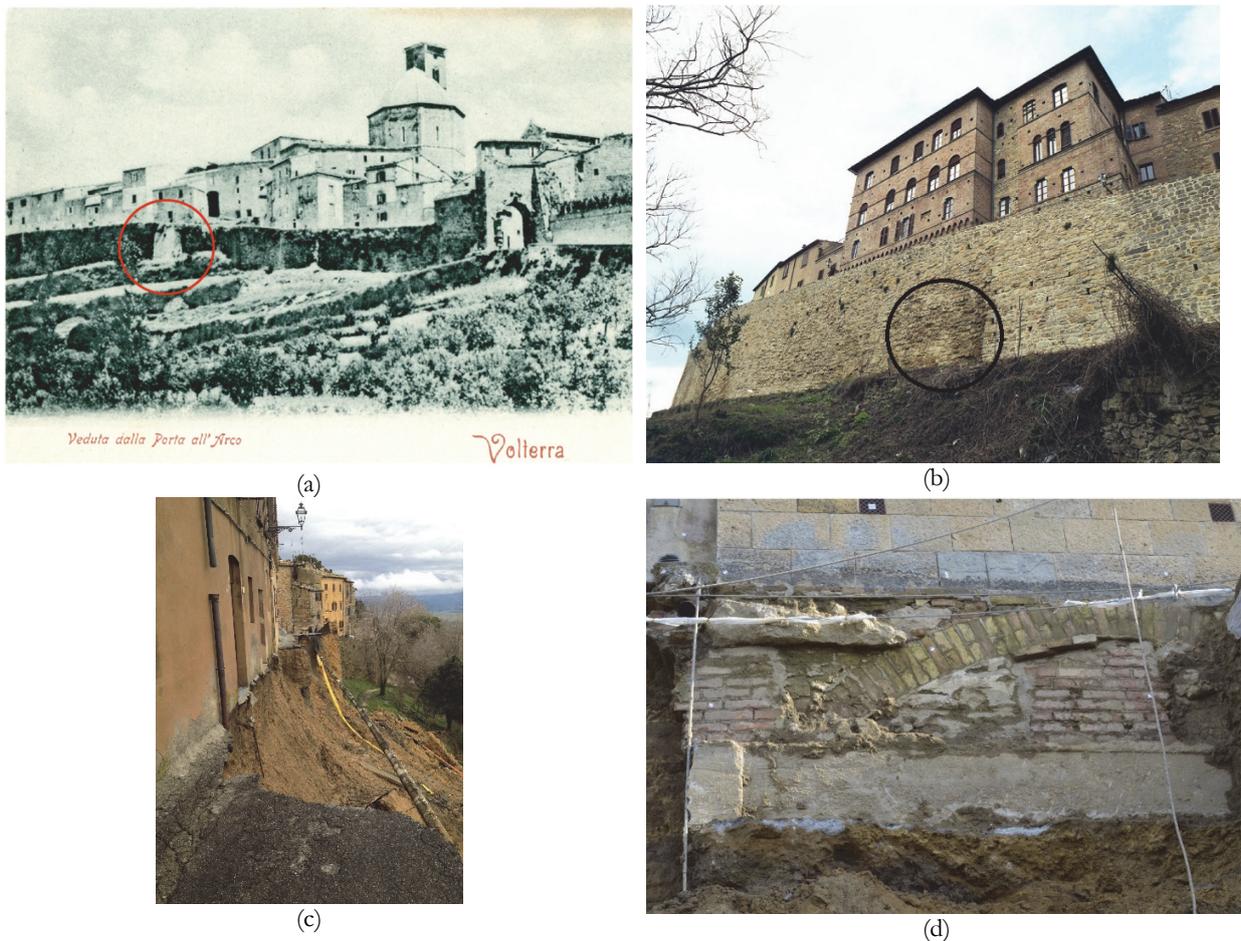
The causes of the collapse are multiple and of complex interpretation. It is necessary to observe that, as documents demonstrated (Fig. 2a), even in the early 20th century the stretch of wall under examination was highly vulnerable. The picture clearly shows a different masonry texture (Fig. 2), probably due to previous partial collapses and reconstruction. In addition, the moisture content, visible before collapse (Fig. 2) and proved by the presence of local vegetation, could have played a crucial role over time. This effect was likely exacerbated after the extreme event of rainfalls occurred during the days preceding the collapse. No proper drainage holes were visible in the collapsed part. The lack of a drainage system (or a non-adequate system) behind the wall probably caused filtration motions behind the retaining wall. This phenomenon plays a crucial role in the stability of a retaining wall, as it will be discussed in the third section (“Stability of masonry retaining wall”). The filtration phenomenon could have determined stresses not allowable for masonry, leading to its failure.

Also, the evidence of pipes (Fig. 2c) for water and gas services could have jeopardized the stability of the wall by reducing its resistance. However, the consequences could have been sensitively worse, due to the proximity of the buildings. It is worthy to observe that the landslide slope reached the foot of the rear structures (Fig. 2c), which surprisingly not only did not collapse, but also were not even damaged. The reason is perhaps due to the fact that part of the foundations is made of the ancient Etruscan walls, whose presence is proved by the pictures taken during the reconstruction (Fig. 2d) and by the results of standard penetration tests carried out for the soil identification.

Figure 2: Picture of the wall in the early 20th century (a), moisture evidence (b), top-down view of the collapsed zone that shows the presence of pipes (c), down-top view of the collapsed zone that highlights the texture of the existing foundation of the buildings (d).

Possible consolidation strategies to increase the safety level of this structure are related to an efficient drainage system, a global reinforcement of the stretch of wall through tie-rods avoiding out of plane mechanisms and surface coating of the wall front face to limit the detachment of stones.

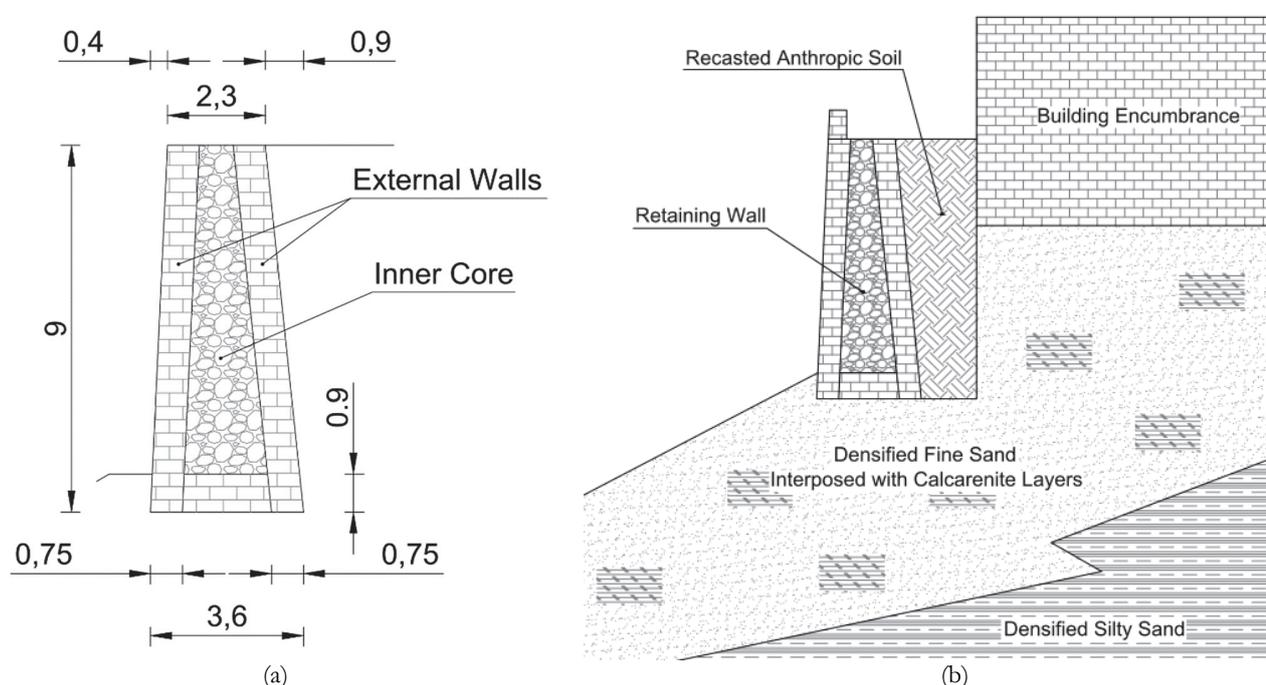
The Volterra's historic Walls tend to show a variety of different styles. However, the collapsed wall section can be considered sufficiently homogeneous; the cross-section, evaluated through visual inspections after the collapse and check of original drawings, is shown in Fig. 3. The structure is 9 m high, 3,6 m thick at the bottom and 2,3 m thick at the top, with an average slenderness of about 3. The inclination of the internal wall (10°) is greater than that of the external one ($4,5^\circ$). The external and the internal wall develop along all the height and turn out to be about 75 cm thick, keeping it constant from the base to the top. The base is constrained to the ground; indeed, it lays at a depth of about 90 cm with respect to the valley slope. This aspect certainly generates a minimum of soil passive thrust that helps to constrain the retaining wall at its base but there are many uncertainties due to this aspect in particular related to the downstream slope.

The wall is multi-leaf with two square stone external walls with fairly resistant lime mortar and a central filling core. This inner core has the only purpose of providing weight, and therefore stability, to the gravity wall, but it shows scarce traces of mortar, with a behaviour that is halfway between a poor masonry and a coarse-grained soil.

Figure 3: Wall structure with dimensions in m (a) and cross section view of the collapsed wall [12] (b).

A crucial aspect considered in the modelling is the soil-structure interaction. As shown in (Fig. 3 - b), the walls lay on densified fine sand with calcarenite layers, whereas the backfill derives from anthropic modifications and it is therefore highly non-homogeneous. Thus, for it, laboratory tests are carried out obtaining the soil volume density (γ), its friction angle (Φ), the transversal contraction coefficient (ν), the cohesion (c) and the edometric module (M_0), where the test has inhibited transversal dilatation. For modelling purposes, the normal elastic modulus (E), with free transversal dilatation, is necessary. This can be obtained directly from the edometric modulus from the expression [30]:

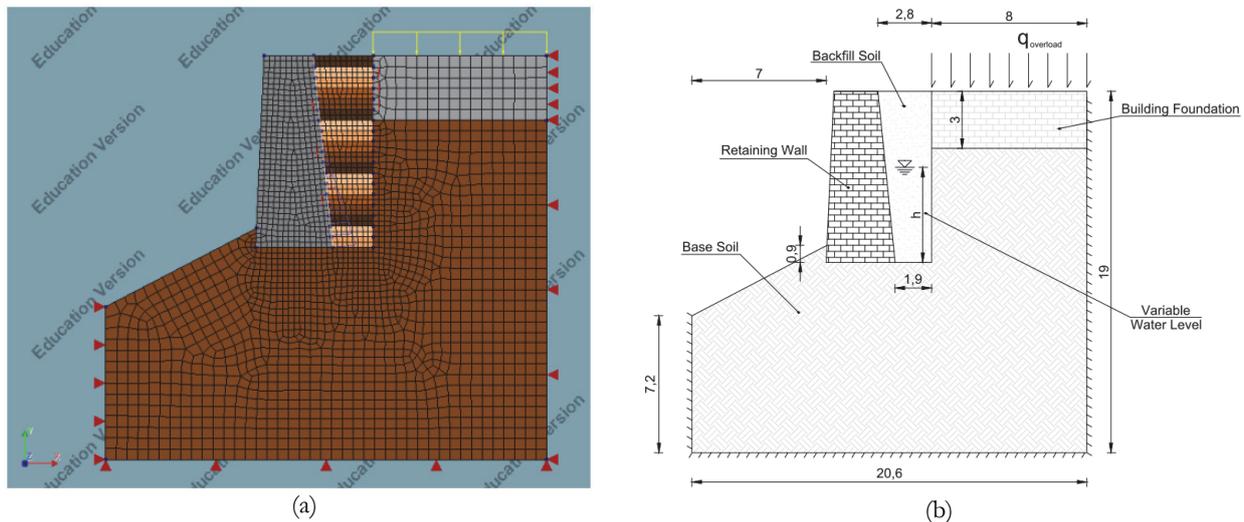
Two soil types are modelled, as shown in Fig. 4: the “backfill soil” and “base soil”, with characteristics reported in Table 1. The inclination of the downstream slope is of 50% and the lower and external extremes have been bounded with external constraints that prevent the displacement of the soil points in the direction perpendicular to the identified boundary.

The elements of the retaining wall and the backfill soil are meshed with element size of about 25 cm, so that each backfill layer could be divided into at least two parts (Fig. 4a); while for the foundations and the underlying soil a less accurate mesh is assumed, roughly doubled with respect to the former one. A significant portion of backfill soil is modelled. The backfill soil is divided into 18 layers of 50 cm each to faster define the change in water level, causing the variation of the constitutive laws of the backfill soil. The external nodes of the finite element are hinged.

Figure 4: Finite element model in DIANA (a) and loading conditions in the plain strain analysis (b).

The considered loading conditions are self-weight, overload due to the back buildings and water thrust. The overload is assumed to be 10 kN/m² per storey, therefore 40 kN/m². The water pressure is considered as an external hydrostatic pressure acting on the internal edge of the retaining wall with variable value depending on the water level behind the wall. This loading condition is assumed to reproduce that occurred in the night when the collapse occurred. Indeed, it is likely

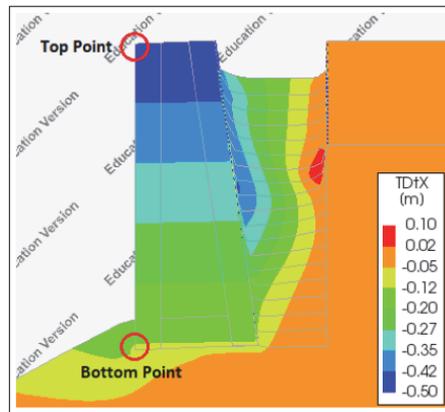
Figure 5: Control points for the capacity curves. [31]

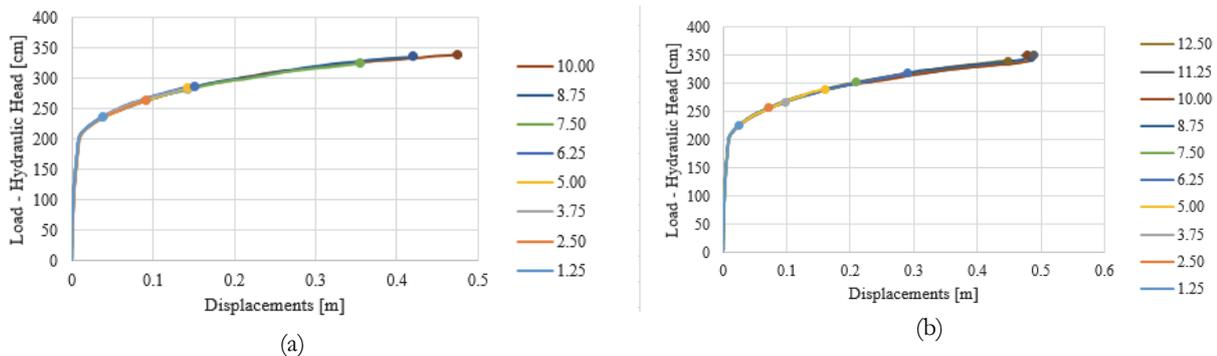
In this paragraph the results of the analysis are represented as capacity curves, showing the hydraulic head - corresponding to the wall failure - against displacements (Fig. 6) with variable tensile strength. The diagrams show the curves for values of tensile strength from 1.25 kN/m² to 12.50 kN/m² and for two fracture energies: $G_f = 0.00075$ kN/m (Fig. 6a) and $G_f = 0.03$ kN/m (Fig. 6 b). A monotonic trend is clearly visible, starting from a linear behavior up to values of hydraulic head of about 2 m. Beyond this value, the trend is non-linear and the hydraulic head leading to collapse is asymptotically approaches 3.5 m. This means that, even adopting higher (unrealistic) values of tensile strength for masonry, the critical water level cannot conceivably overcome such a value.

Figure 6: Capacity curves of the parametric analysis: variation of the tensile strength (in the legend, values in kN/m²): $G_f = 0.00075$ kN/m (a) and $G_f = 0.03$ kN/m (b)

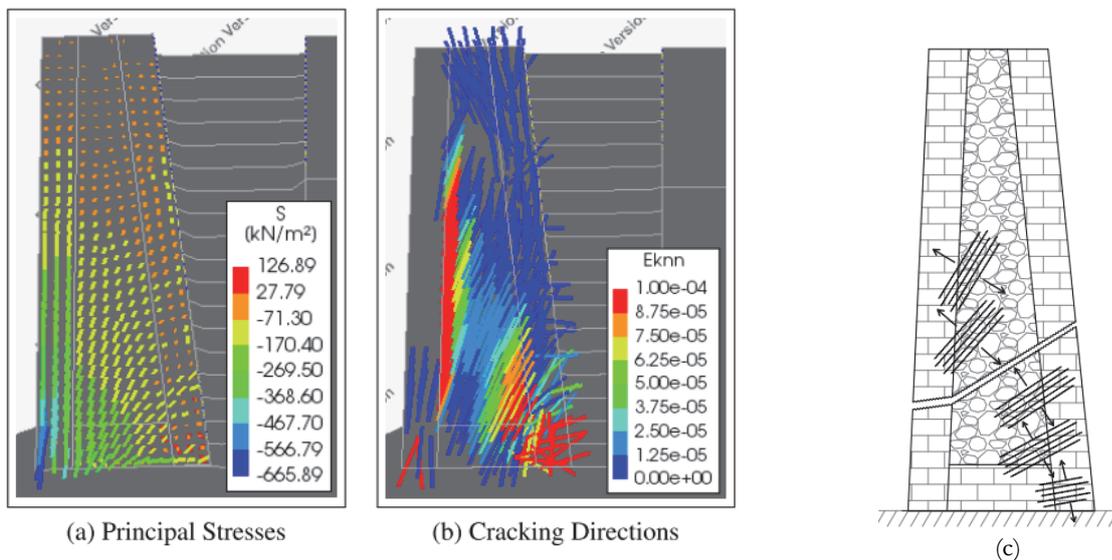
Observing what really happened during the actual retaining wall failure, it is possible to guess that case 1 ($f_t < f_{t,lim}$) is the one that took place. Indeed, after the collapse the lower part of the wall remained in place. The collapse mechanism probably was due to a slit that takes place in the lower part of the external wall face and that probably propagates inward following the material friction angle, according to a scheme very close to what is represented in Fig. 7. In practice the increasing of the horizontal action produces a partialisation of the resisting section with the progressive reduction of the compressed section. The only compressed section offer shear resistance and the collapse is obtained for the overcome of the shear resistance of this section section. It can be concluded that the maximum masonry tensile strength is around a value of $f_t = 15$ [kN/m²].

Figure 7: Stress distribution (a), corresponding cracking (b) and schematic view of the most likely collapse (c)

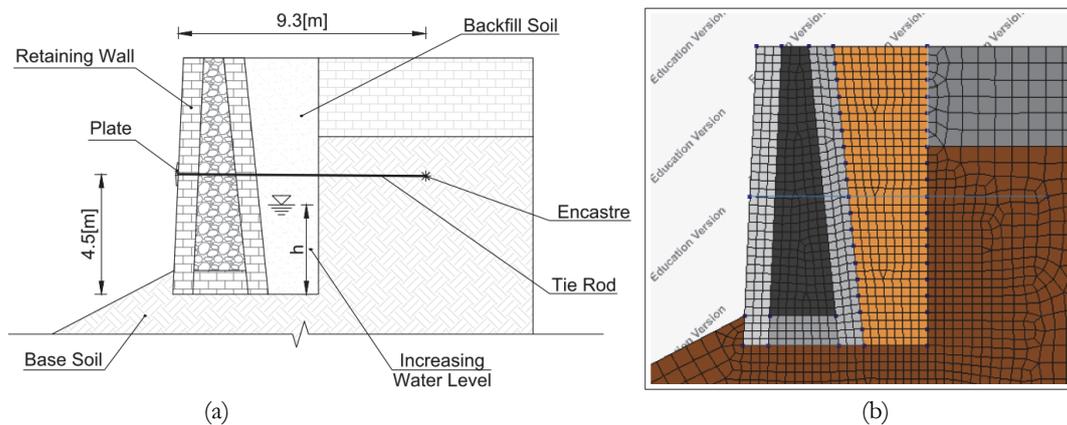
Figure 8: Retrofitting of the historic wall by means of a steel tie rod at mid-height (a) and analyzed finite element model (b).

It is worthy to evaluate the role of a retrofitting solution that could have impeded the wall collapse [34,35]. A traditional but effective technique is adopted: a steel tie-rod installed at a certain depth in the sandy soil beyond the artificially added soil (Fig. 8 - a). The designed length is 9.3 m and the tie is modelled as a non-linear truss beam element (Fig. 8 - b). The tensile force of the tie-rod is about 254 kN if the design actions displayed in Fig. 9 are considered. The tie is so designed considered the limit equilibrium of the wall also in case of drain obstruction. The tie is placed in the half of the wall and the uplift pressure of the water is also take into account in the design of the tie. Assuming the high resistance steel ASTM A416, a minimum diameter of 15 mm results. In the numerical modelling, fracture energy, elastic modulus and compressive strength of the wall are kept constant, not being so significant for the capacity curves, whereas the diameter is the only variable parameter assumed.

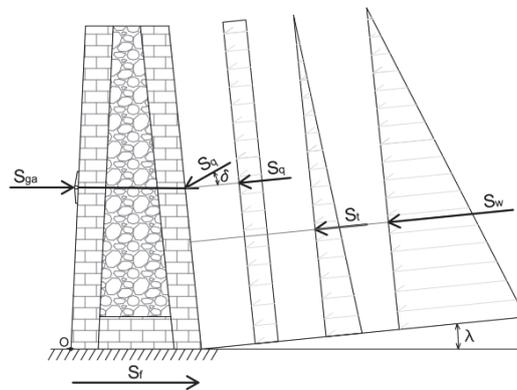
Figure 9: Actions acting on the retaining wall restrained by a tie-rod. [31]

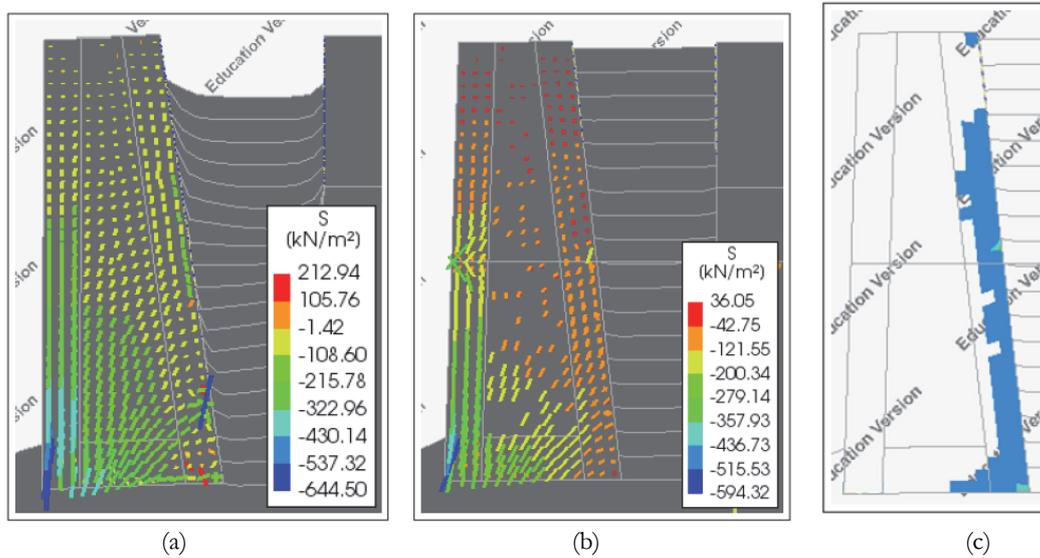
The obtained results show a decisive increase in the water level necessary to cause the structural collapse. This improvement is due to the addition of a stabilizing force determining a beneficial effect for the internal stress distributions (Fig. 10 a - b). As for a quantitative assessment, the tensile stress of the wall is one order of magnitude lower than that without tie-rod (Fig. 10 - a) whereas the compressive stress at the foot corner does not significantly change. The crack pattern is consequently improved as well with a reduced cracking in the inner part of the wall but a wider spread in the inner wall (Fig. 10 - c). Another economic and effective solution is the restoration of the drain. This can be made by coring and it is recommended to produce alternate drainage both in height and in horizontal direction. This device is useful and recommendable even in the occurrence of a consolidation by means of tie elements.

Figure 10: Principal stress distribution without (a) and with tie-rod (b); crack pattern with tie-rod (c).

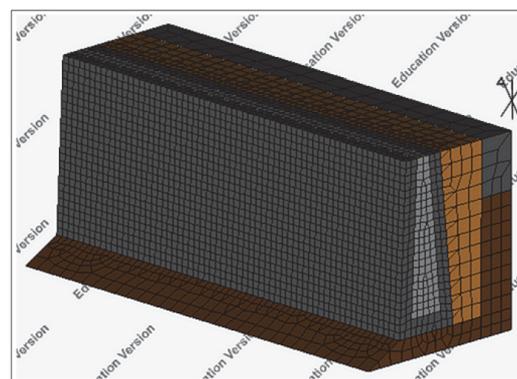
Finally, the three-dimensional model was assessed, in order to verify the occurred “spoon shaped” section breakage. A stretch of wall with length 46 meters was considered since the collapsed portion of the wall is about 30 m. By exploiting the symmetry of the problem, only half of it is modelled (Fig. 11). A careful modelling of the interface in contact with the adjacent portion of wall is necessary. It is chosen to model the constitutive law of the interface with a shear type non-linear behaviour by assuming a shear strength of 1.5 times the tensile strength (assumed equal to 10 kN/m²) and a tangential modulus 0.4 times the elastic modulus. The other parameters and boundary conditions are analogous to those assumed for the 2-dim model. The displacements and the cracking pattern matched with the actual one. Anyway the macro-element approach as simplified way to detect of the correctness of the results is commonly adopted in masonry constructions [36].

Figure 11: 3D model of the collapsed wall.

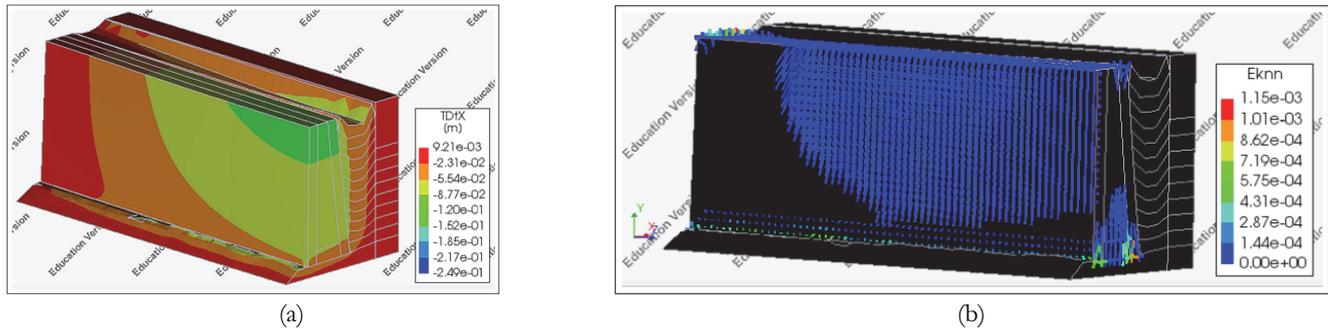
By increasing the water level and pushing the 3d wall to collapse, it is possible to estimate the amount of out-of-plane displacement (Fig. 12 - a) and the cracking configuration (Fig. 12 - b), that is pretty similar to that actually occurred. The cracking pattern of the collapsed section of the 3 dim model is very similar to the one obtained by the 2-dim model of the

Figure 12: Out-of-plane displacements (a) and crack pattern (b) at collapse.
