## Monitoring and analysis of reinforced concrete plate-column structures under room temperature and fire based on acoustic emission

**ABSTRACT.** This paper attempts to disclose the damage mechanism of reinforced concrete plate-column structures under room temperature and fire. Several tests were carried out to record the law of crack development on the plate surface under room temperature. The infrared detection technology was adopted to observe how cracks develop under fire. The acoustic emission (AE) signals at different positions of the specimen were monitored by the AE techniques. Coupled with the macroscopic test phenomena, several characteristic parameters collected by the AE system, namely, cumulative number of events, event rate, energy rate and b-value, were analyzed in details. The results show that: the cumulative number of events was active in the loading, heating and cooling stages; the crack density and the change of internal forces could be derived from the trend of event rate; the local energy changes of the specimen could be deciphered from the curves of energy rate and b-value, making it possible to judge if a component has reached the failure state; the specim

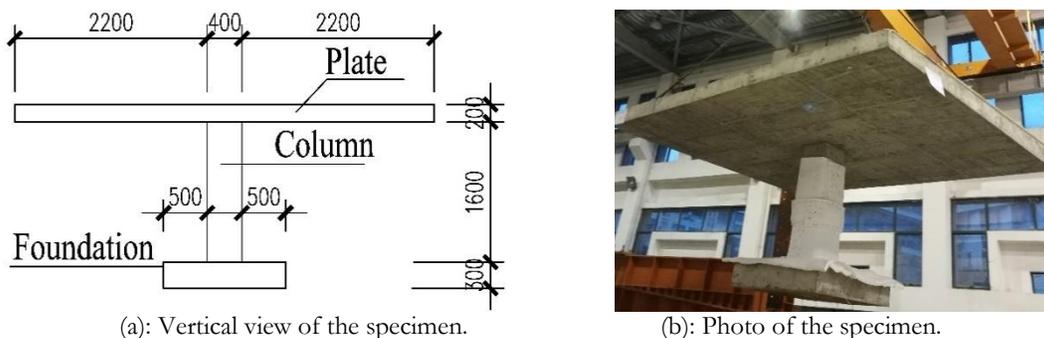
Figure 1: Vertical view and photo of the specimen.

Three specimens, denoted as S1-3, with the same size were designed according to the provisions of the relevant code [32]. The plate is 4.8 m in length ( $l$ ), 4 m in width ( $b$ ) and 0.2 m in thickness ( $h$ ). The square column is 0.4 m in side length ( $a$ ) and 1.6 m in height. Beneath the column, there is a foundation with the side length of 1.4 m and thickness of 0.3 m. The vertical view and photo of a specimen are given in Fig. 1(a) and Fig. 1(b), respectively.

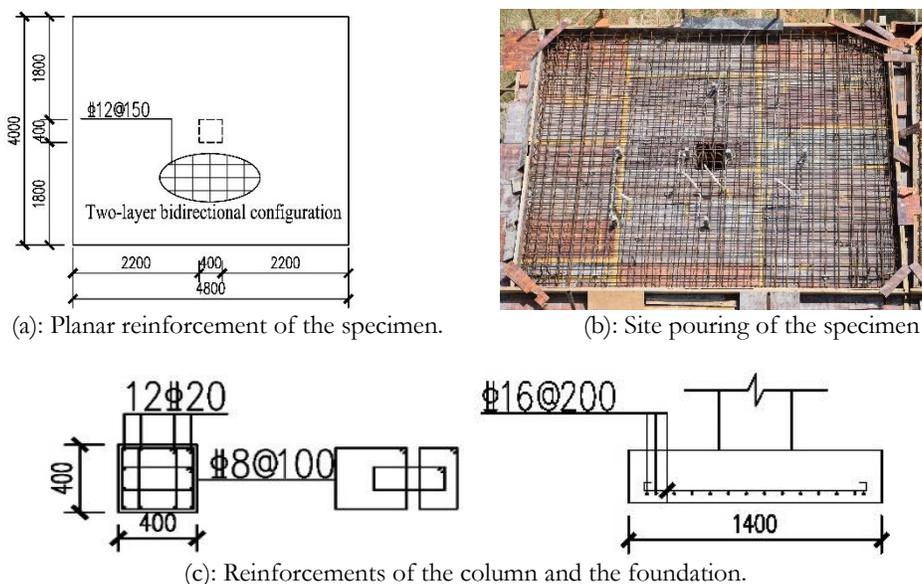
Figure 2: Reinforcement information and photos of specimen

HRB400 steel bars were selected and subjected to pull-out tests [34]. The standard values of the yield strength  $f_{yk}$  and the ultimate strength  $f_{stk}$  of the steel bars were measured through the tests. Then, the mean design strength  $f_y$  of the steel bars was derived as 412 MPa [32]. The plate was reinforced by two layers of bidirectional steel bars, with a diameter of 12 mm, a spacing of 150 mm and a 20 mm-thick protective layer. The column was reinforced by eight 20 mm-diameter longitudinal steel bars, and 8 mm-diameter stirrups, with a spacing of 100 mm. The foundation was reinforced at the bottom by bidirectional steel bars, with a diameter of 16 mm and a spacing of 200 mm. The reinforcement of each specimen is illustrated in Figs. 2.

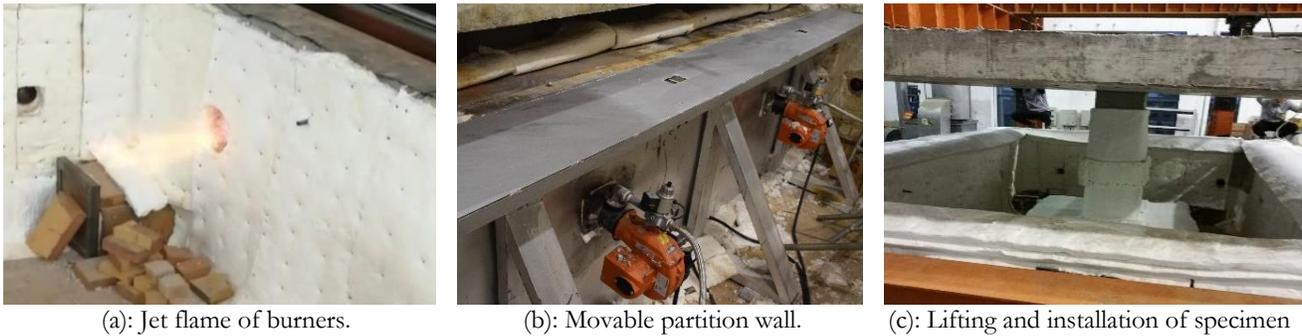
Figure 3: Fire furnace reconstruction and lifting and installation of specimen

The tests were performed in a combined horizontal fire furnace in the structural laboratory of Huaqiao University. The net size of the furnace is 5.95m in length, 4.31 m in width and 1.5 m in height. Three burners were installed on the long side of the furnace, and two on the short side. To correctly install and position specimens, a movable partition wall was added in the fire furnace. Two burners were arranged in the middle of the wall, with a spacing of 2.8 m. Fig. 3(a) shows the jet flame of the burners. On the unexposed surface of the wall, a 0.3 m-wide steel platform was set up for applying the fireproof cotton (Fig. 3(b)). After the wall is fixed, the net distance from the edge of the exposed surface to the inner edge of the short side of the furnace is 3.7m.

Before the test, the column and its foundation were covered by aluminum silicate fireproof cotton. As shown in Fig. 3(c), each specimen was lifted into the horizontal fire furnace by the lifting equipment in the lab. Once the specimen was in place, the plate surface is about 0.3 m taller than the movable partition wall.

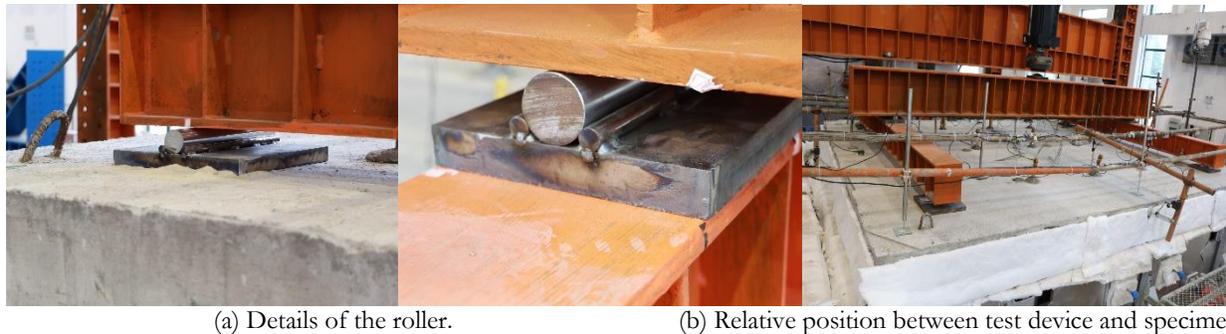
Figure 4: Details of the roller and relative position between test device and specimen.

The primary distribution beam, connected to the jack via a ball hinge, was placed right between the two secondary distribution beams. A steel roller (diameter: 45 mm) was added between the two stages of beams and cushioned with a 200 mm×350 mm baseplate. Each secondary distribution beam was deployed close to the edge of the short side of plate surface. A steel roller (diameter: 45 mm) was added between the beam and the edge and cushioned with a 300 mm×300 mm baseplate. Before the beam was in place, the outer edge of the baseplate was fixed at 0.4 m from the edge of the short side of plate surface. To prevent rollers from falling off under load, two 15 mm-diameter steel rods were welded to each baseplate. Fig. 4(a) provides the details on the steel rollers and baseplates. Fig. 4(b) shows both the specimen and the testing arrangement.

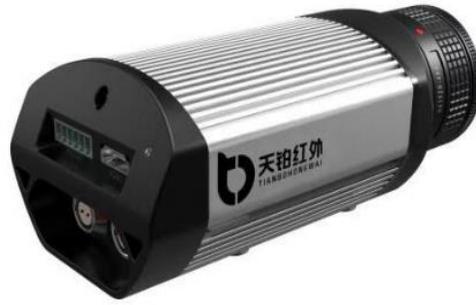
Figure 6: Infrared monitoring device.

In the event of a fire, the crack development on plate surfaces can be recorded in real-time by infrared detection technology [35]. In our tests, the temperature field and crack development on the plate surface were observed by a fully digital dynamic infrared thermal monitoring device (Fig. 6).

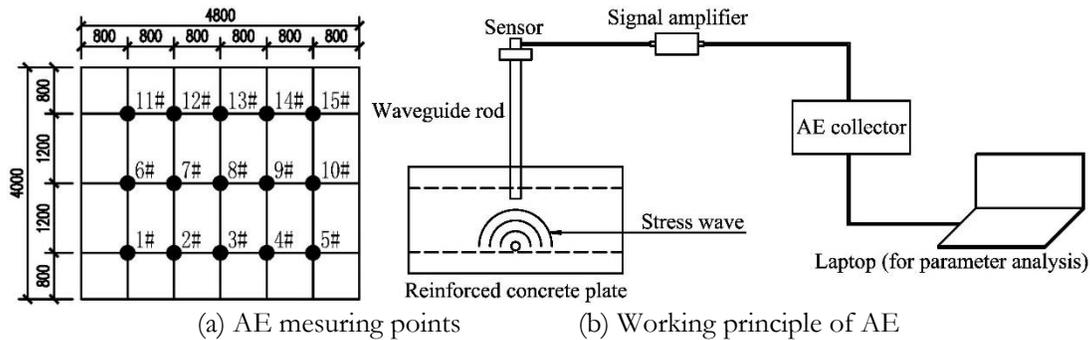
Figure 7: Layout of AE measuring points and working principle of AE.

This paper adopts the Micro-II multi-channel digital AE system with a PCI-E acquisition card. As shown in Fig. 7a, fifteen AE sensors were deployed on the plate surface to record the AE signals at different positions, considering how plate cracking affects the generation and propagation of AE signals under fire. The working principle of AE is illustrated in Fig. 7b. Tab. 1 describes the setting of AE system and sensors.

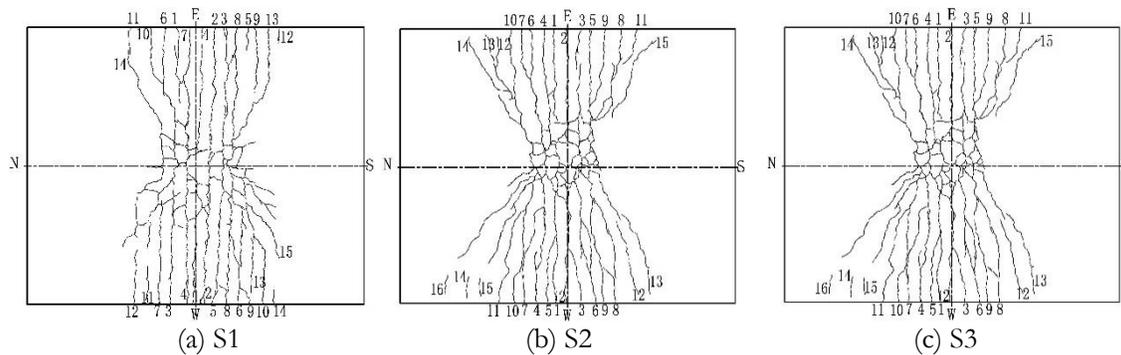
Figure 8: The crack development at room temperature.

From 49 to 50 min, the load continued to rise from 175 to 200 kN. During this process, two new cracks emerged on the east long side, and one on the west long side. In the areas of plate-column nodes, cracks developed quickly and became rather wide (10 mm). The original cracks widened quickly. The crack width on the edge of the plate fell between 0.38 and 2.8 mm. Fig. 8 presents the crack development at room temperature.

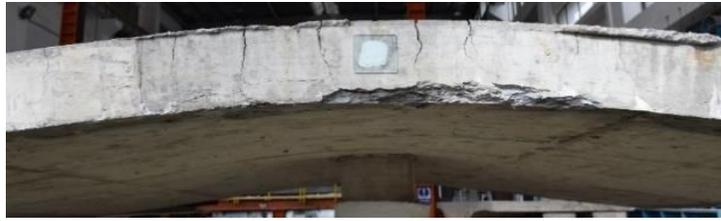
Figure 10: Crack distribution in the thickness direction on the long sides of the plate.

Fig. 10 displays the distribution of cracks in the thickness direction on the long sides of the plate. It can be seen that, in the thickness direction, longitudinal cracks developed and extended to 3/4 of plate thickness, without penetrating the plate. The spacing of the cracks was basically the same as the steel bars on the plate. After flameout, the cracks on the top of the plate radiated from the center to the edges (Fig. 11).

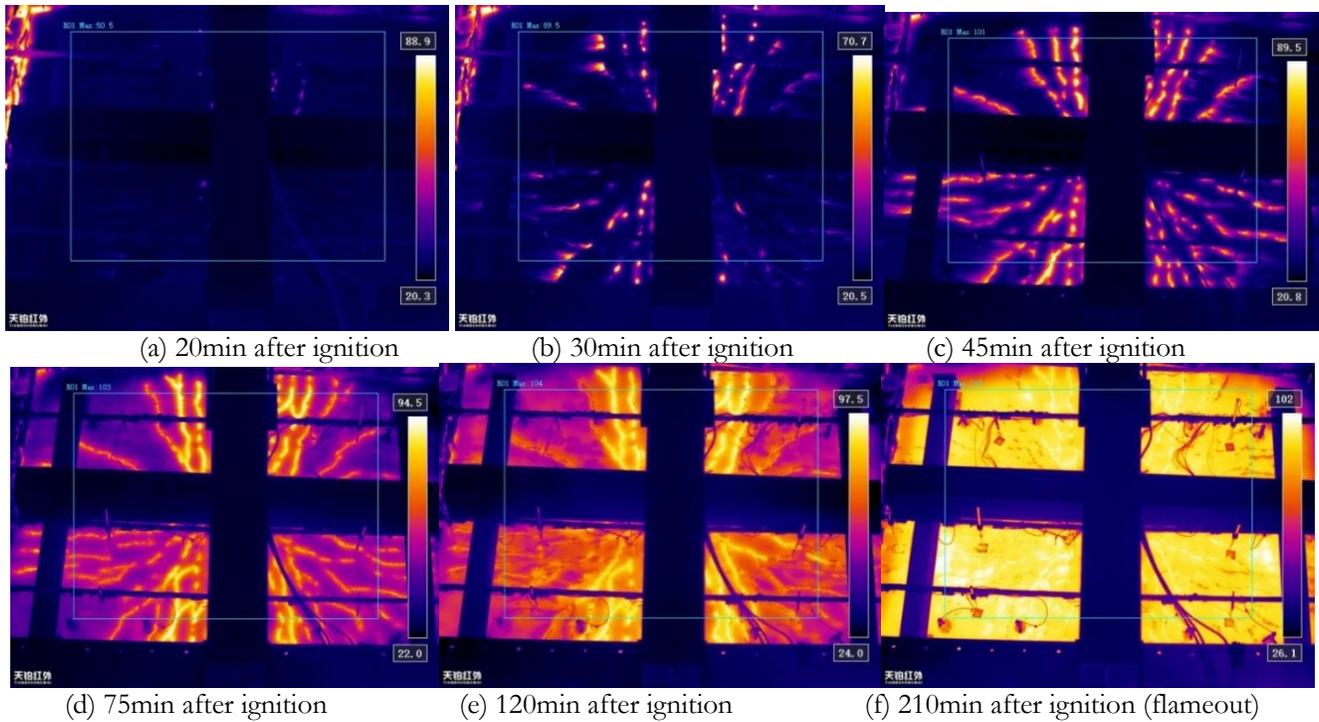
Figure 12: Crack development on the top of the plate of S3 under fire.

As shown in Fig. 12, at 125 min (20 min after ignition), several hot spots formed in the longitudinal cracks near the center of the plate surface, indicating that the longitudinal cracks near the center were wider than those in other places.

At 135 min (30 min after ignition), hot spots were clearly visible on several large longitudinal cracks and individual diagonal cracks. The radiating contour of cracks on the plate was faintly visible, and the cracks on the north and south sides developed in a uniform manner.

At 150 min (45 min after ignition), there were lots of water stains on the plate surface. Through our infrared thermal monitoring device, the hot spots were clearly visible on each crack, and the cracks were radiating from the center on the plate surface. Moreover, the hot spots were plump and hot in the longitudinal cracks along the long sides. This means the longitudinal cracks are wide, and much heat is transmitted to the plate surface. By contrast, there were few low-temperature hot spots in diagonal cracks and transverse cracks, indicating that these cracks are relatively narrow.

At 180 min (75 min after ignition), the hot spots in diagonal cracks were as plump as those in longitudinal cracks, and new short diagonal cracks formed at the corner of the plate.

At 225 min (120 min after ignition), the temperature at other positions of the plate gradually approached the temperature in the cracks.

At 315 min (flameout), the shape of the cracks of the plate surface was illegible.

In the fire test, the plate surface was covered by lots of water stains and water vapor, making it difficult to observe crack distribution and development with the naked eye. To overcome the difficulty, infrared detection technology was introduced to monitor the plate crack development. For the lack of space, this paper only provides the crack development of S3 in six stages after ignition, which was captured by our infrared thermal monitoring device (Fig. 12). The crack development in plate-column was not captured, for the device was installed directly above the specimen (i.e. the central nodes were blocked by the loading beams and distribution beams).

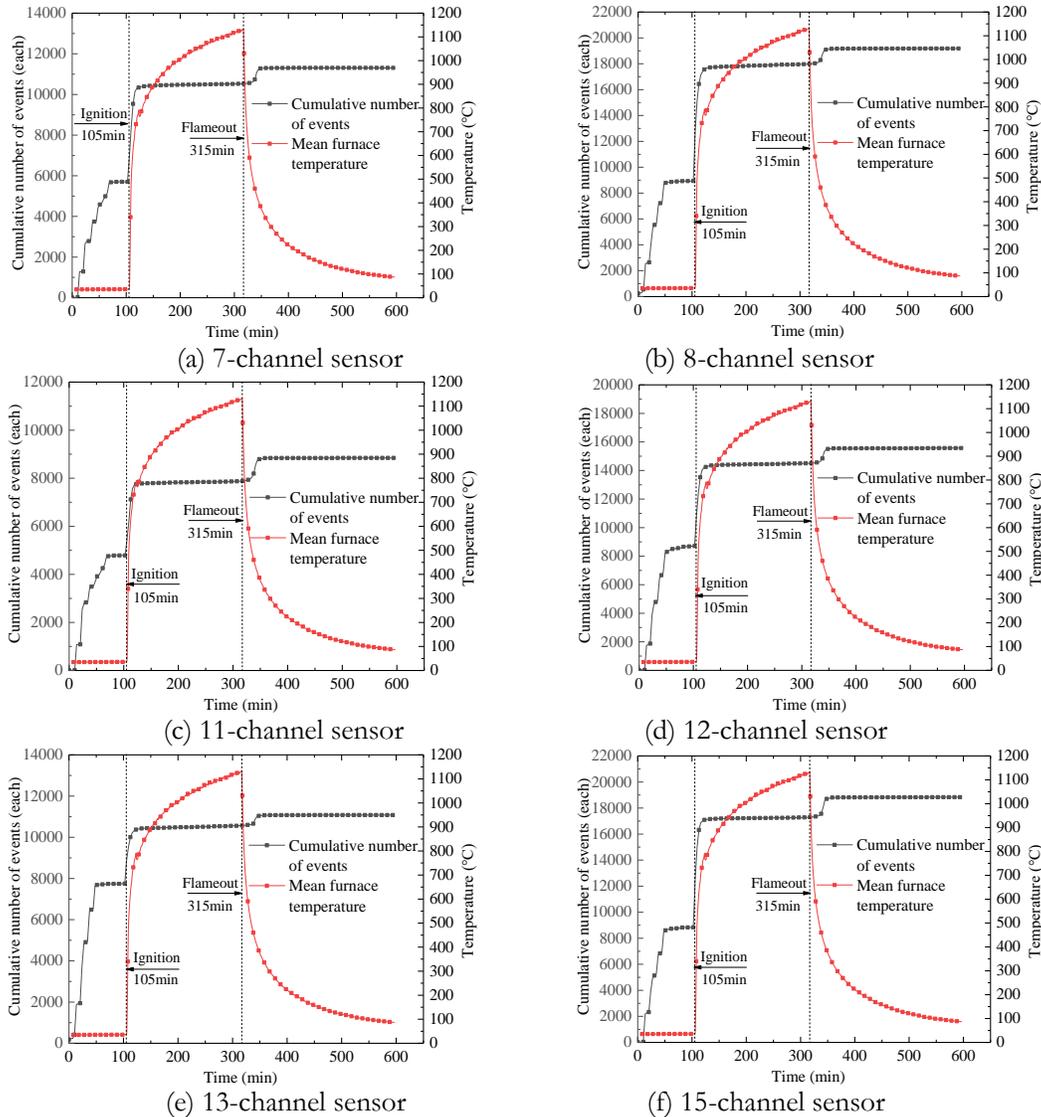
Figure 13: Variation in the cumulative number of events of S3 with time and furnace temperature.

The AE event is defined as a local change in the material that emits acoustic waves. The total count of all events in a process is called the cumulative number of events. This parameter reveals the time of crack emergence and the degree of crack development. The maximum cumulative number of events demonstrates the development and density of cracks at the measuring point, providing a yardstick of source activity. Fig. 13 shows the variation in the cumulative number of events at each measuring point of S3 with time and furnace temperature. Obviously, the entire process can be divided into the following three phases.

The first phase is the staged loading at room temperature. In the first 72 min, the cumulative number of events surged up at each measuring point. The fastest growth rate (124 events/min) appeared at 8# at the center of the plate, with a cumulative number of events of 8,899. The cumulative number of events was relatively large (8,000) at 12#, 13# and 15#, which were arranged along the long side. The above results show that the central nodes of the plate were relatively active in the staged loading at room temperature, resulting in a high density of cracks. This agrees well with the macroscopic phenomenon that ring cracks continuously emerge in the area of these nodes. In addition, the nodes along the long side were more active than those along the short side, which is in line with the macroscopic phenomenon that longitudinal cracks mainly develop along the long sides.

In the second phase, the fire was ignited and the furnace temperature started to rise. In this case, the cumulative number of events increased sharply and then stabilized. The sharp increase occurred between 106 and 143 min when the furnace temperature jumped from to 868 °C. In this phase, numerous diagonal cracks emerged, and the longitudinal cracks formed under room temperature continued to expand, causing the concrete at the bottom of the plate to spall. Echoing with

macroscopic phenomena, the cumulative number of events at all measuring points rocketed up, with growth rates of 82.8, 98.2, 62.5, 65.0, 34.7, and 94.1 %, respectively. The growth rates at 8# and 15# both surpassed 90 %. Hence, in the heating phase, the area of plate-column nodes was still more active and more severely damaged than the other places. The relatively large cumulative number of events at 7# signifies the generation of many diagonal cracks.

In the third phase, the fire was turned off, and the furnace cooled down. In this case, the cumulative number of events rose rapidly for a while by less than 10 % and then stabilized.

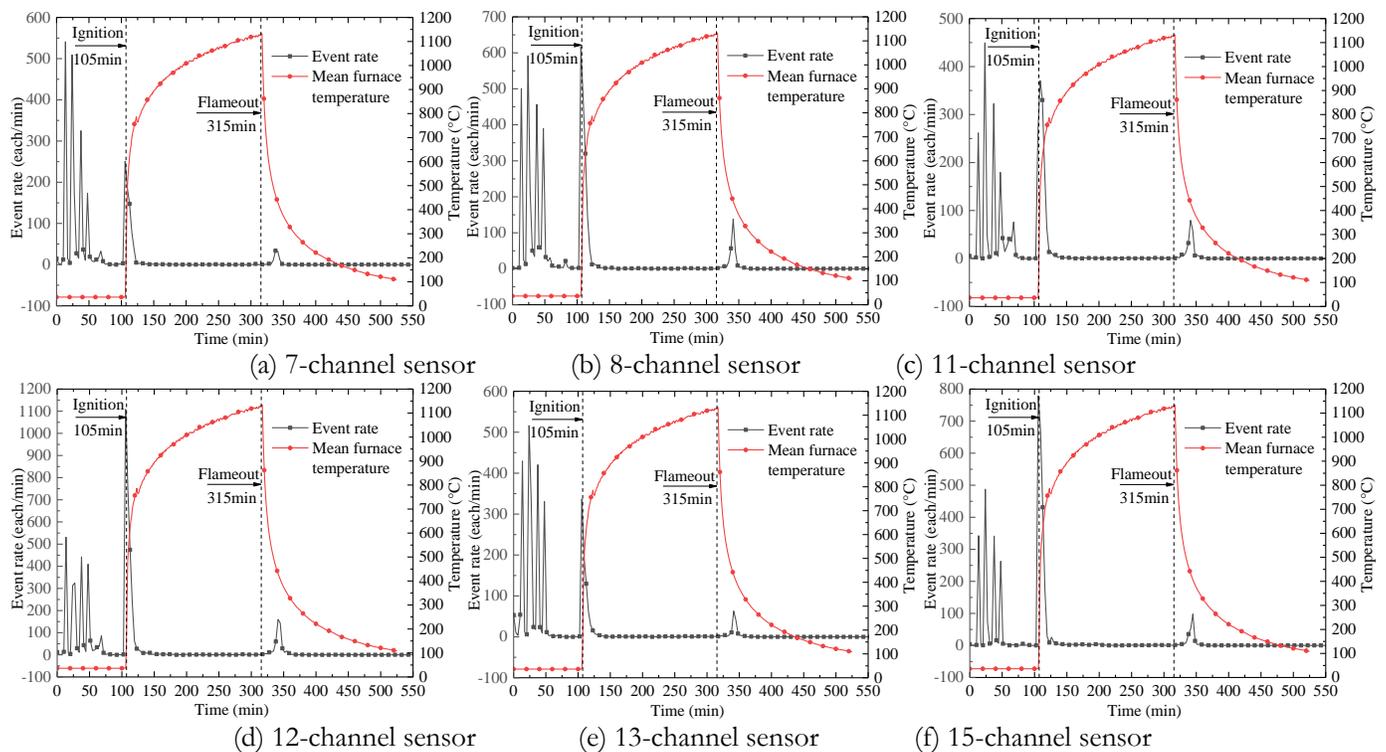
Figure 14: Variation in the event rate of S3 with time and furnace temperature.

Figs. 14-16 show the variations in event rate, energy rate and b-value with time and furnace temperature, respectively. Coupled with macroscopic phenomena, the change laws of the three characteristic parameters in each stage were analyzed based on the three figures:

As shown in Fig. 14, the event rates of measuring points were around zero events/min, and the peak event rate, 53 events/min only, was captured by 13#, reflecting the rarity of cracks inside or on the plate.

As shown in Fig. 14, with the emergence of new cracks on the edges, the penetration of cracks and the appearance of ring crack on the top of the column, the event rates of the measuring points surged up to the peak values, and then plunged in the holding period, exhibiting as serrated curves. The event rates were uniformly distributed across the different loading stages. In the second loading stage, the peak event rate (541 events/min) was recorded at 7#; in the third loading stage, the peak event rate (591 events/min) was recorded at 8#. In the fourth loading stage, the peak event rate (456 events/min) was recorded at 8#; in the fifth loading stage, the peak event rate (409 events/min) was recorded at 12#.

As shown in Fig. 14, the event rates at all measuring points declined sharply to the valleys at around zero events/min. This shows that no new cracks or concrete spalling occurred in this “quiet” stage.

As shown in Figs. 14 and 15, the event rates and energy rates at all measuring points surged up to the peak values between 326 and 329 min. The 3 min difference is due to multiple factors, such as the attenuation of acoustic waves in the propagation path. The peak event rate (137 events/min) was measured by 8#, while the peak energy rate (50,098  $\text{mv}\cdot\mu\text{s}/\text{min}$ ) was captured by 12#. These results indicate that, after flameout, the furnace temperature dropped sharply, and the heat was transferred from the bottom to the top of the specimen. The moisture in the plate continued to evaporate, creating temperature stress and internal stress, releasing some energy, and thus AE sources. After that, no new crack emerged, and no original crack widened. As a result, the event rates and energy rates at all measuring points dropped deeply to a low level, kicking off another “quiet” period.

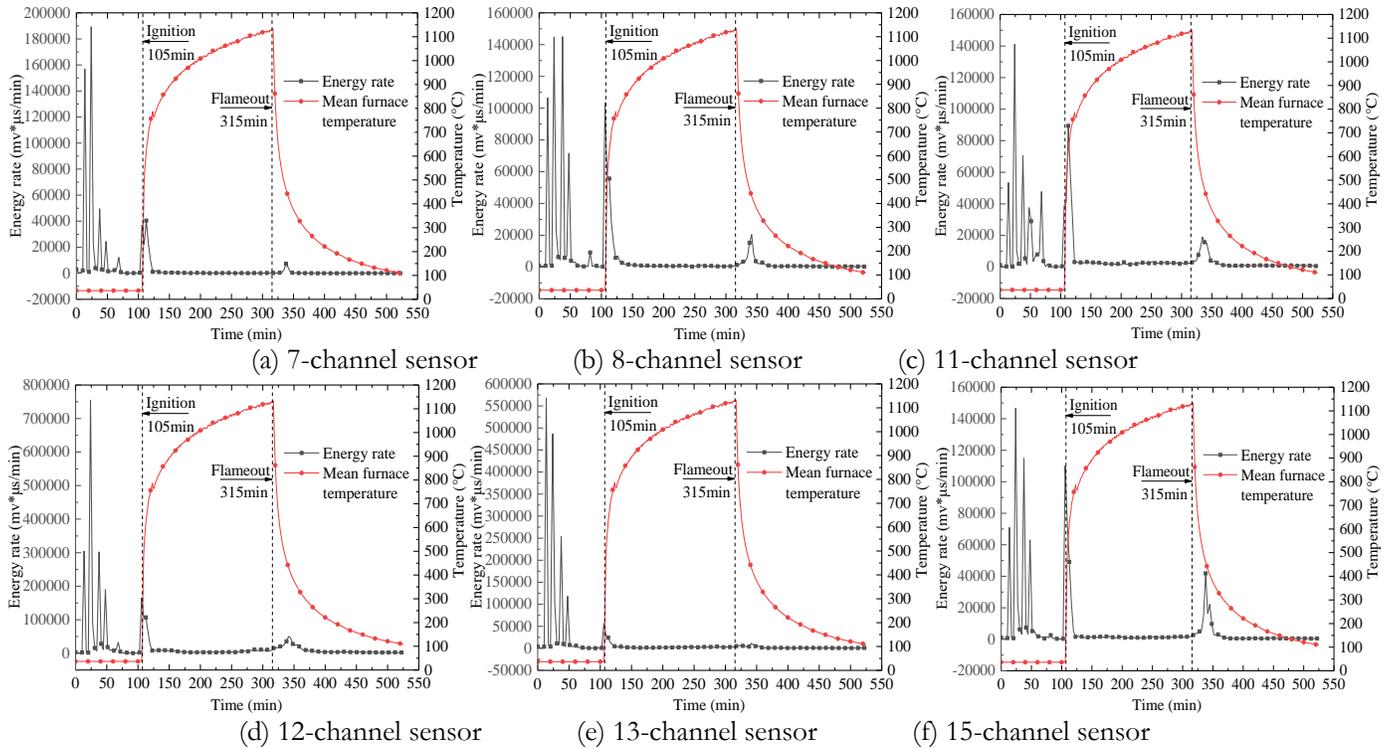
Figure 15: Variation in the energy rate of S3 with time and furnace temperature.

As shown in Fig. 15, the energy rates of measuring points were rather low at about zero  $\text{mv}\cdot\mu\text{s}/\text{min}$ . Thus, the cracks released a very small amount of energy.

As shown in Fig. 15, the energy rates at measuring points rose sharply to the peak values, and nosedived in the holding period, exhibiting as serrated curves. The peak energy rates differed greatly from measuring point to measuring point. Relatively high peak values were observed at 12# and 13# through the five loading stages. In the second loading stage, the peak energy rate (568,205  $\text{mv}\cdot\mu\text{s}/\text{min}$ ) was recorded at 13#; in the third loading stage, the peak energy rate (754,844  $\text{mv}\cdot\mu\text{s}/\text{min}$ ) was recorded at 12#; In the fourth loading stage, the peak energy rate (302,332  $\text{mv}\cdot\mu\text{s}/\text{min}$ ) was recorded at 12#; in the fifth loading stage, the peak energy rate (189,839  $\text{mv}\cdot\mu\text{s}/\text{min}$ ) was recorded at 12#.

As shown in Fig. 15, the energy rates at all measuring points returned to the peaks after ignition. The highest peak energy rate (165,293  $\text{mv}\cdot\mu\text{s}/\text{min}$ ) appeared at 12#. The results indicate that new energy was released by new cracks and concrete spalling.

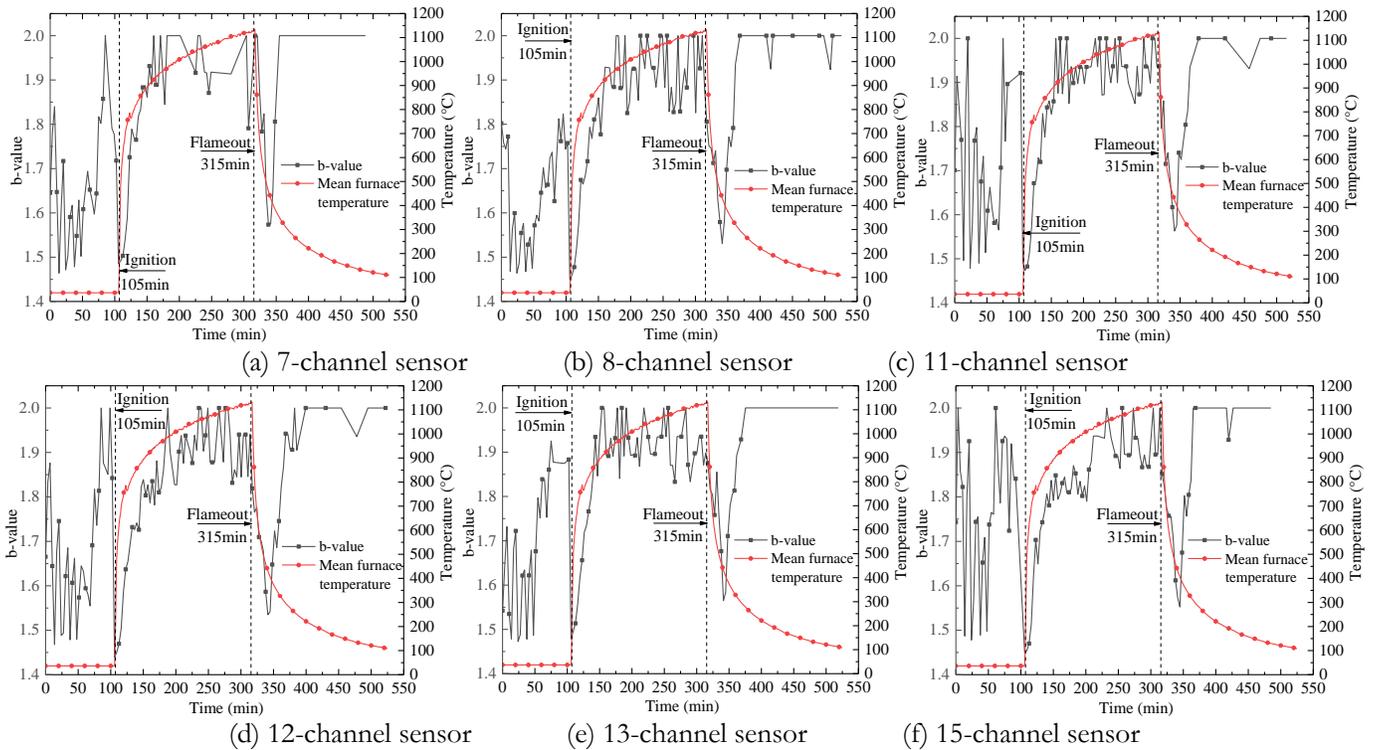
Figure 16: Variation in the b-value of S3 with time and furnace temperature.

There are many different definitions on the  $b$ -value of concrete. Here, the physical meaning of  $b$ -value [36] is defined as the degree of cracking on the plate surface under fire. The  $b$ -value is negatively correlated with the crack width and the proportion of large-amplitude signals in AE signals [citation suggested]. The  $b$ -value can be adopted to evaluate the degree of internal damage of concrete.

As shown in Fig. 16, the first valley was observed for the b-values in all channels. The b-values at most measuring points were around 1.7-1.8, except that (1.55) at 13#. The values were much higher than those in the subsequent loading stages at room temperature. This means the crack width in this stage was much narrower than that in other stages. That is why the cracks were not observable in this stage.

As shown in Fig. 16, the b-value at each measuring point hit the valley in each loading stage, and the valley values were close to each other, ranging from 1.45 to 1.50. Therefore, the cracks developed rapidly in all loading stages.

As shown in Fig. 16, the b-values at all measuring points hit the valleys quickly after ignition. The valley values were between 1.40-1.45, lower than those under room temperature. Next, the b-values gradually rebounded. It can be seen that cracks widened quickly and diagonal cracks emerged rapidly at the beginning of the fire; with the growing furnace temperature, it is increasingly difficult for new cracks to emerge and for old cracks to widen.

As shown in Fig. 16, the b-values at all measuring points remained at a high value (2), exhibiting as serrated curves. This means, when the plate was under the same load, the crack width changed in a certain degree in the later period of heating, but the crack development was rather limited.

As shown in Fig. 16, after flameout, the b-values of all measuring points started to decrease and reached the valleys (1.55-1.60) at around 326-329 min. It shows that in this stage, with the redistribution of internal forces, the internal cracks of concrete develop further. Then, the b-values gradually picked up, and the number of AE sources decreased slowly in the specimen.
