Thermal Degradation and Fracture in E1698-VD Nickel Alloy

Impact of elevated temperatures on the strength, plasticity, and fracture mechanisms of a heat-resistant nickel-based alloy used in gas turbine engines.

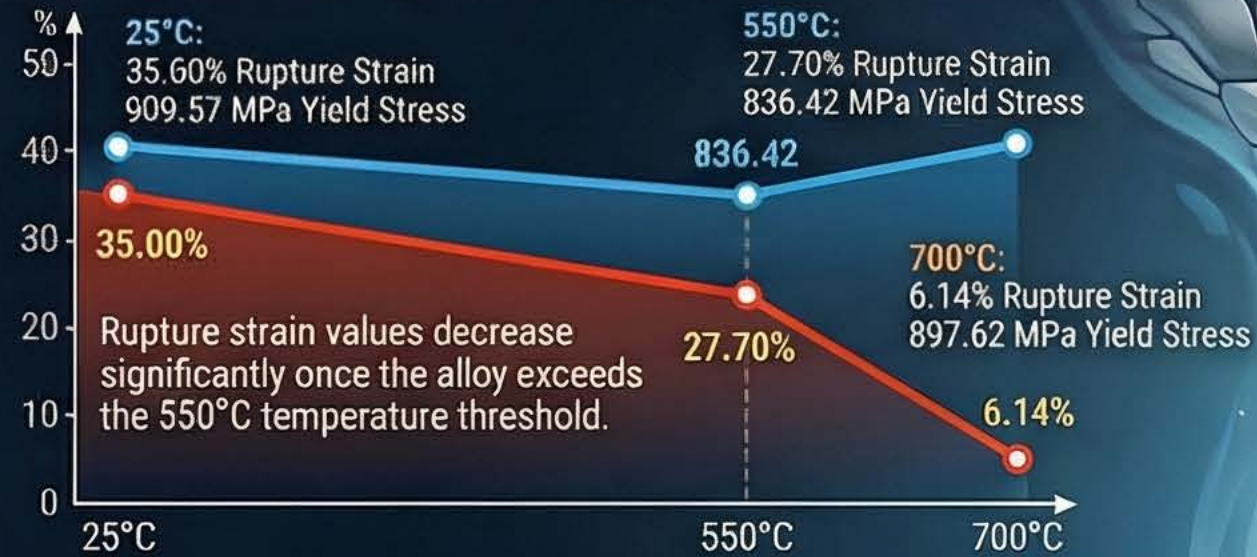
Sharp Plasticity Loss Above 550°C

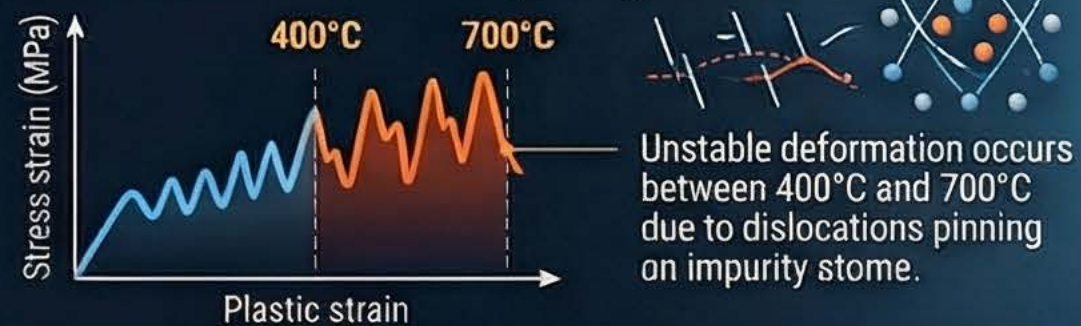
The Serrated Flow (PLC) Effect

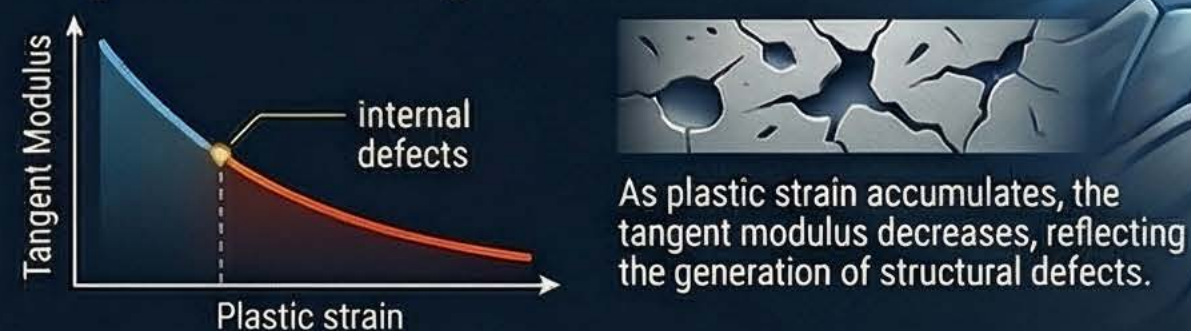
Logarithmic Tangent Modulus Decline

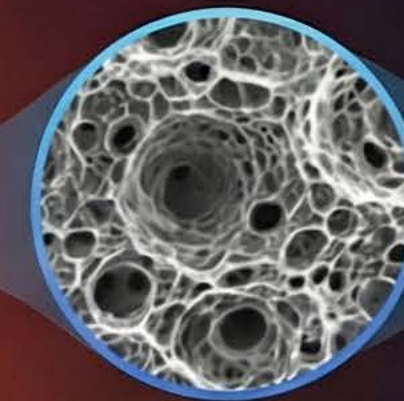
Lower Temps (<550°C)
Ductile Pore Coalescence

Failure transitions from ductile pore coalescence to brittle intergranular cracking at higher temperatures.

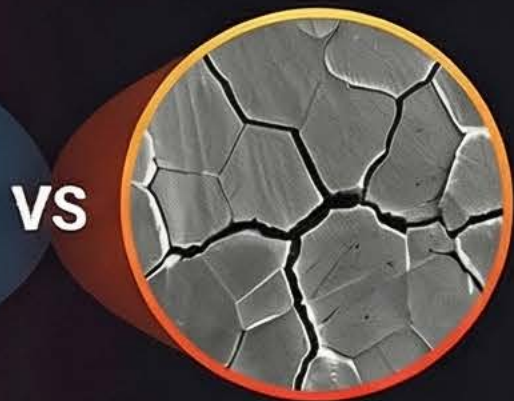
Higher Temps (>550°C)
Brittle Intergranular Cracking

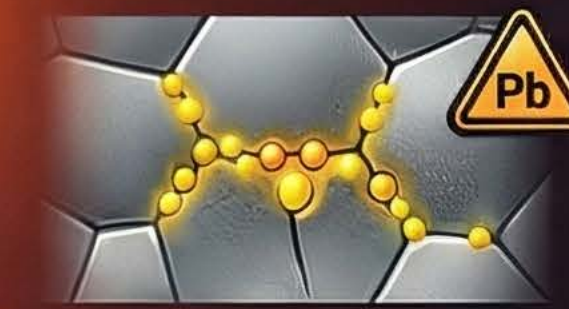
Critical Lead (Pb) Contamination

Lead levels 90 times the acceptable limit promote premature cracking and reduce strength.

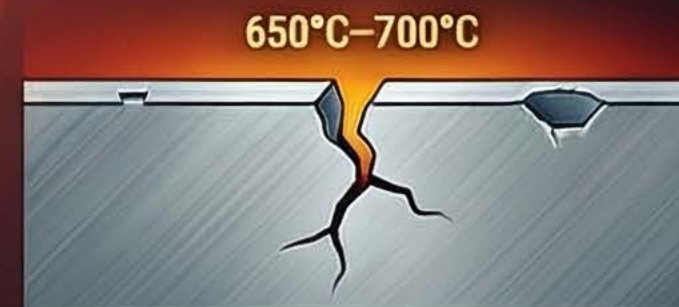
Surface-Initiated Crack Growth

At 650°C-700°C, fracture initiates from surface defects rather than internal voids.
