Effect of corrosion damage on the fatigue behavior of S460NL High-Strength Steel under cyclic loading

Citation: Al Khazali, M.S., Seitl, S., Malíková, L., Křivý, V., Vacek, M., Effect of Corrosion Damage on the Fatigue Behavior of S460NL High-Strength Steel under Cyclic Loading, *Fracture and Structural Integrity*, 77 (2026) 56-77.

ABSTRACT. The present study investigates the influence of corrosion exposure on the fatigue behavior of S460NL high-strength structural steel, a material that is frequently utilized in offshore and civil engineering structures. Accelerated corrosion was simulated under controlled laboratory conditions for exposure periods of 3 days, 6 days, and 6 + 3 days, in addition to specimens subjected to natural atmospheric corrosion. To this end, fatigue tests were performed to obtain $S-N$ curves, and the results were evaluated using Basquin's law and the probabilistic Castillo–Canteli model.

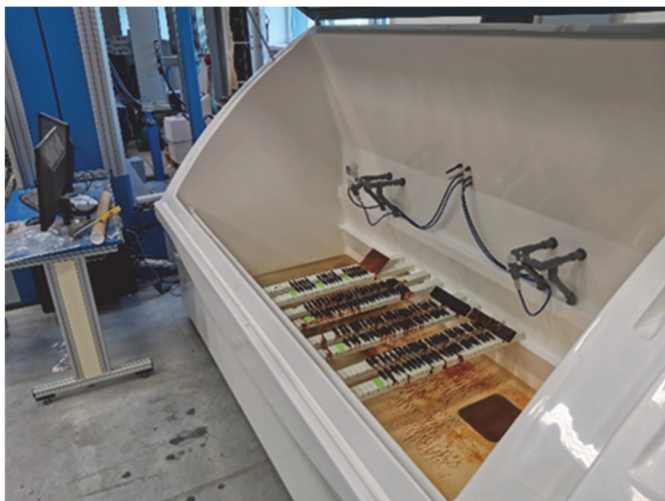
Figure 3. S460NL fatigue specimens placed inside the Ascott S2000is corrosion chamber during the accelerated salt spray corrosion test according to ISO 9227. The specimens correspond to the corrosion exposure groups of 3 days (35°C), 6 days (35°C), and 6 days (35°C) + 3 days (50°C). Plastic covers were used to protect the threaded ends of the specimens from corrosion.

Accelerated corrosion tests were performed using the Ascott S2000is corrosion chamber following the procedures outlined in the ISO 9227 salt spray test standard [23]. The specimens were subjected to two distinct chamber modes to simulate different corrosive environments.

- Mode 1: The chamber temperature was maintained at +35°C, while the humidifier temperature was set to +48°C.
- Mode 2: The chamber temperature increased to +50°C, with the humidifier temperature remaining at +48°C.

In both modes, a 5% NaCl solution was used to generate salt mist, which provided a consistent corrosive environment. The specimens were exposed to salt mist in the following conditions:

Fig. 3 shows the specimens placed inside the corrosion chamber, while Fig. 4 presents the specimens exposed to natural atmospheric conditions.

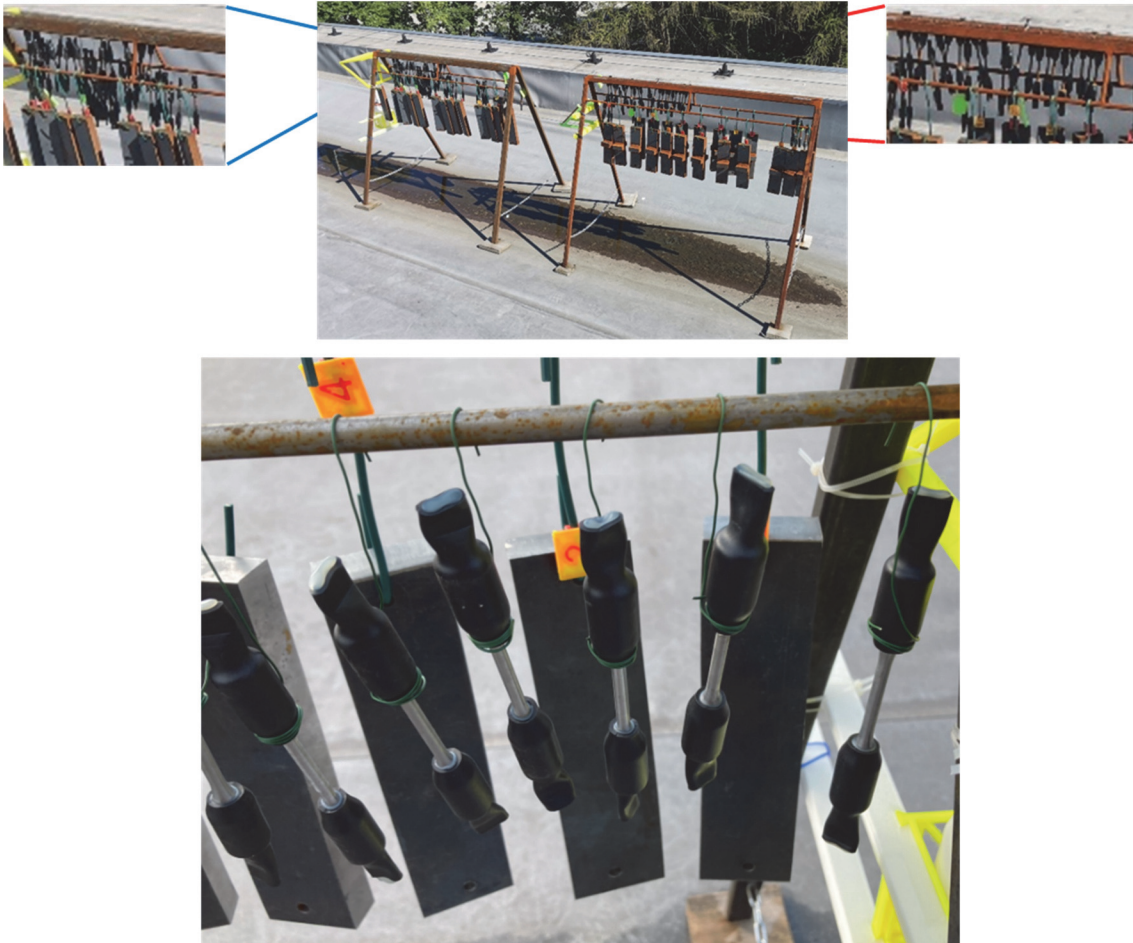
Figure 4. S460NL fatigue specimens exposed to natural atmospheric conditions on the roof of the Experimental and Diagnostic Building Center at VŠB–TU Ostrava. The specimens were mounted on an outdoor exposure frame to simulate real environmental conditions. Plastic covers were used to protect the threaded ends of the specimens from corrosion.

- Additional specimens were exposed to natural atmospheric conditions on the roof of the Experimental and Diagnostic Building Center at VŠB–Technical University of Ostrava from April 2022 to October 2023. The site is characterized by an urban environment with relatively low industrial pollution and moderate traffic intensity. During the exposure period, environmental parameters such as temperature, precipitation, and relative humidity were monitored to characterize the corrosion environment. The recorded temperature ranged approximately from –5 °C in winter to 30 °C in summer, with an average relative humidity of about 70% and total precipitation of approximately 600 mm during the exposure period. The weather data can be accessed through; Meteocentrum Weather Archive.

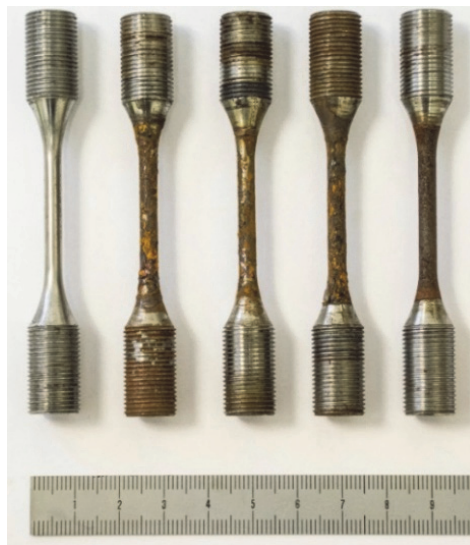
Figure 5. Examples of steel specimens for fatigue experiments without and with four various levels of corrosion. Reference; 3 (35°C) days; 6 (35°C) days; 6 (35°C) +3 (50°C) days specimens and specimen from natural exposure (from left to right).

Typical specimens of steel S460NL for fatigue experiments without and with four various levels of corrosion are shown in Fig. 5.

The uncorroded specimens exhibited a bright metallic surface (Fig. 5). With increasing corrosion exposure, the metallic luster gradually disappeared, and corrosion products formed on the specimen surface. Localized corrosion pits became more pronounced with increasing exposure time (3 days, 6 days, and 6 + 3 days), which act as stress concentrators and promote fatigue crack initiation.

After completing the rust removal process, a visual inspection reveals a hierarchical distribution of corrosion pits, with varying degrees of damage in each area. This observation indicates that as the corrosion duration increases (3 (35°C), 6 (35°C) and 6 (35°C) + 3 (50°C) days), the size of corrosion pits gradually grows.

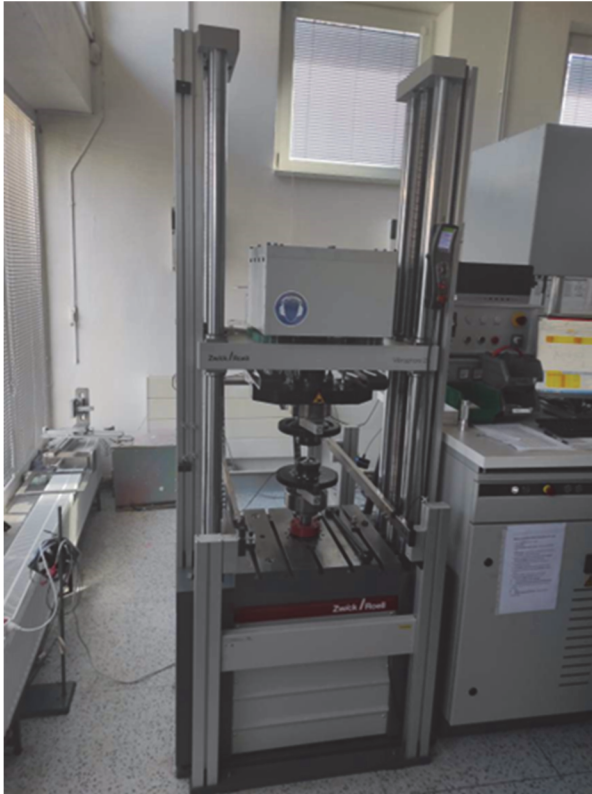
Figure 6. Experimental set up for fatigue: ZwickRoell Vibrophore resonance pulsator with specimens.

Fatigue tests were performed using a ZwickRoell Vibrophore resonance pulsator (Fig. 6). The specimens were subjected to constant-amplitude axial loading with a stress ratio of $R = 0.1$. The contractual fatigue limit was defined at $N = 10^7$ cycles, and the loading frequency varied between 70 and 110 Hz depending on the stress level. The tests were performed in laboratory air at temperature $21 \pm 2^\circ\text{C}$ and a humidity of approximately 40 %. The specimens were loaded by constant force amplitude P_a .

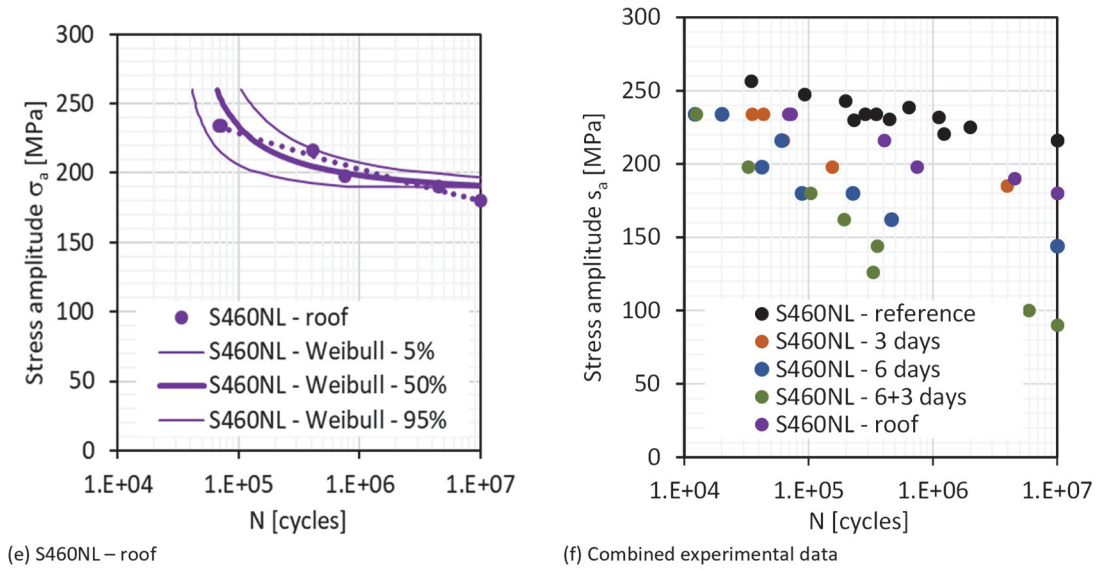
Figure 7: S–N curves of S460NL steel under different corrosion conditions: (a–e) Experimental fatigue data with Weibull statistical fits (5%, 50%, and 95%) obtained using the Castillo–Canteli model. (f) Combined diagram showing all experimental fatigue failure data points for direct comparison between corrosion exposure conditions.

The relationship between the stress amplitude (σ_a) and the number of cycles to failure (N) for S460NL steel under different corrosion conditions is represented by the $S-N$ curves. Fig. 7 illustrates how fatigue resistance clearly declines as exposure to corrosive environments increases.

The specimens exposed to combined 6 (35°C) + 3 (50°C) days of corrosion show the greatest reduction in fatigue life, whereas the reference specimens, which were not subjected to any corrosion, show the highest fatigue resistance. The Basquin’s model parameters (a , b) with the coefficients of determination (R^2) and endurance limit $\sigma_c (1 \times 10^7)$ for studied different conditions are summarized in Tab. 4.

If we compare the fatigue behavior, shown graphically in Fig. 7. We can see a clear pattern of a downward trend in fatigue resistance depending on the length of time the specimens are exposed to the corrosive environment. Some specimens did not fail within the maximum test duration of 10^7 cycles and were therefore classified as run-outs. These tests were stopped at the predefined cycle limit and treated as right-censored data in the statistical fatigue analysis performed using the Castillo–Canteli Weibull model.

The experimentally obtained $S-N$ curves demonstrate a clear reduction in fatigue life with increasing corrosion severity. Specimens exposed to corrosion for 3 days, 6 days, and 6+3 days, as well as those exposed to natural atmospheric corrosion on the roof, all exhibit shorter fatigue lives compared with the reference specimens. The reduction becomes more pronounced in the high-cycle fatigue region, where fatigue performance is highly sensitive to surface conditions.

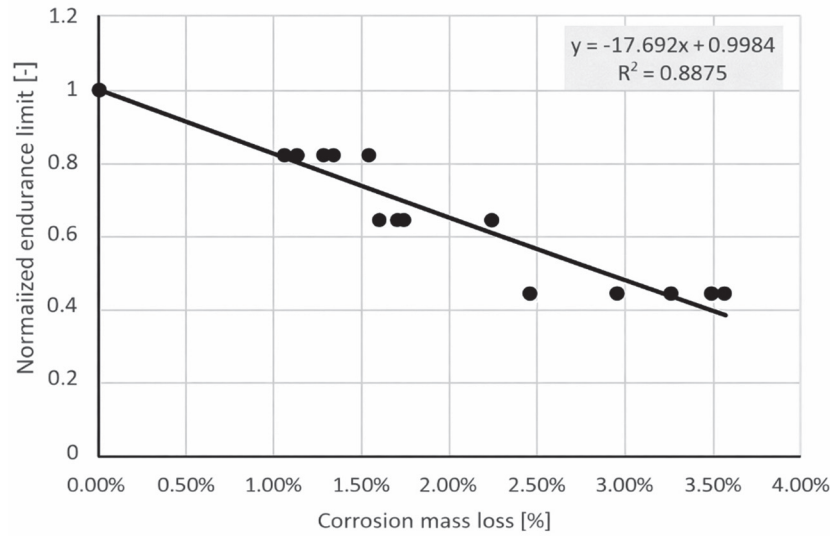
Figure 12. Relationship between corrosion mass loss and normalized endurance limit of S460NL steel derived from Basquin’s law.

The relationship between corrosion damage and fatigue resistance is further illustrated in Fig. 12, which shows the correlation between corrosion mass loss and normalized endurance limit derived from the Basquin model. The endurance limit of corroded specimens is normalized by the corresponding endurance limit of the uncorroded reference specimens.

As shown in Fig. 12, the normalized endurance limit decreases approximately linearly with increasing corrosion mass loss. This trend demonstrates that corrosion-induced surface damage plays a dominant role in reducing the fatigue resistance of S460NL steel.
