# Recycled Carbon Fiber Composites: Bridging the Performance Gap

## Root Causes & Process Obstacles

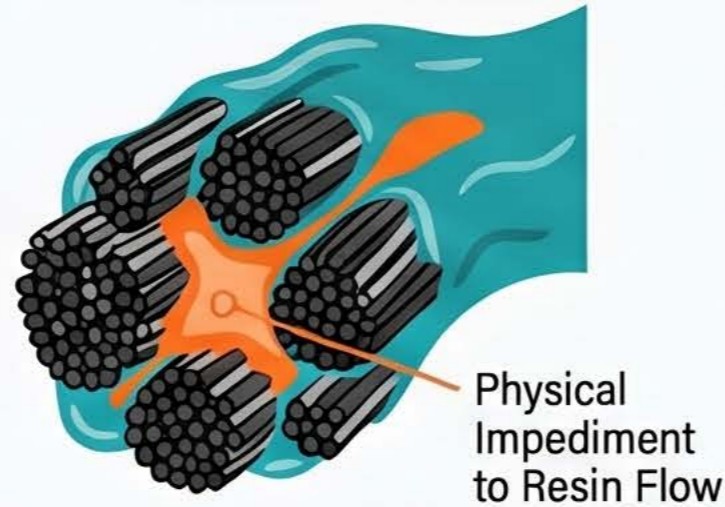
### Dense Bundles Block Resin

Non-uniform fiber distribution creates dense clusters; poor impregnation leads to irregular "shrinkage cavities" and spherical bubbles trapped during injection.

Use High-Vacuum Injection

Increase Mat Homogeneity

Increasing mat homogeneity and using high-vacuum injection are essential to eliminate internal defects and bridge the performance gap.

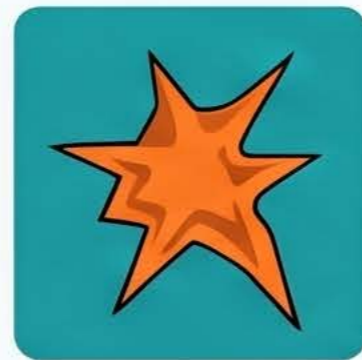
Shrinkage Cavities (Poor Impregnation)

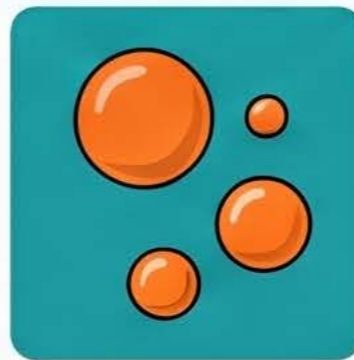
Air Bubbles (Injection Traps)

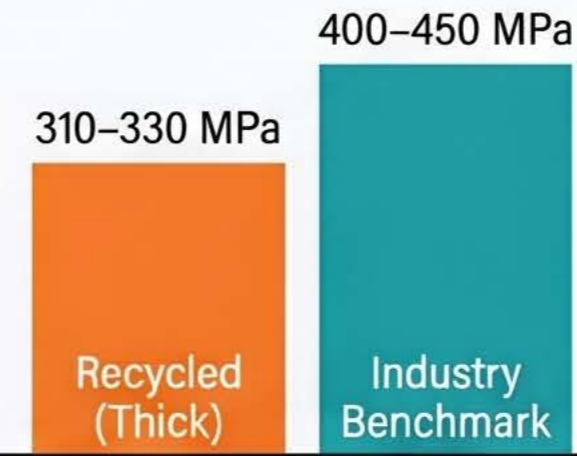
### 30% Lower Tensile Strength (vs. Benchmark)

Tensile Strength (UTS)

Despite clean fibers, recycled panels achieved significantly lower UTS and Young's Modulus compared to industry benchmarks.

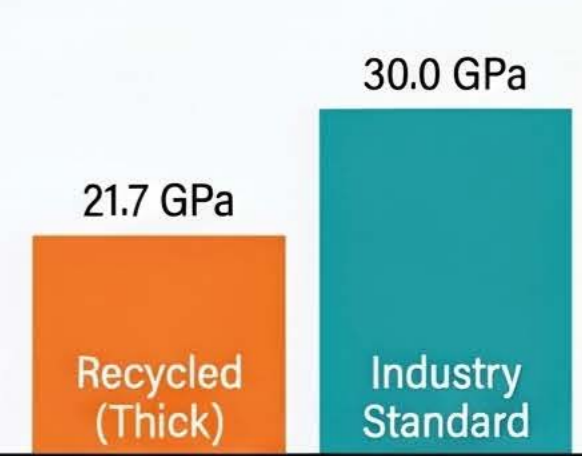
### Reduced Structural Stiffness (vs. Standard)

Structural Stiffness (Young's Modulus, E)
