Considerations over the Italian road bridge infrastructure safety after the Polcevera viaduct collapse: past errors and future perspectives

Fabio Bazzucchi, Luciana Restuccia, Giuseppe Andrea Ferro

Politecnico di Torino, Turin, Italy

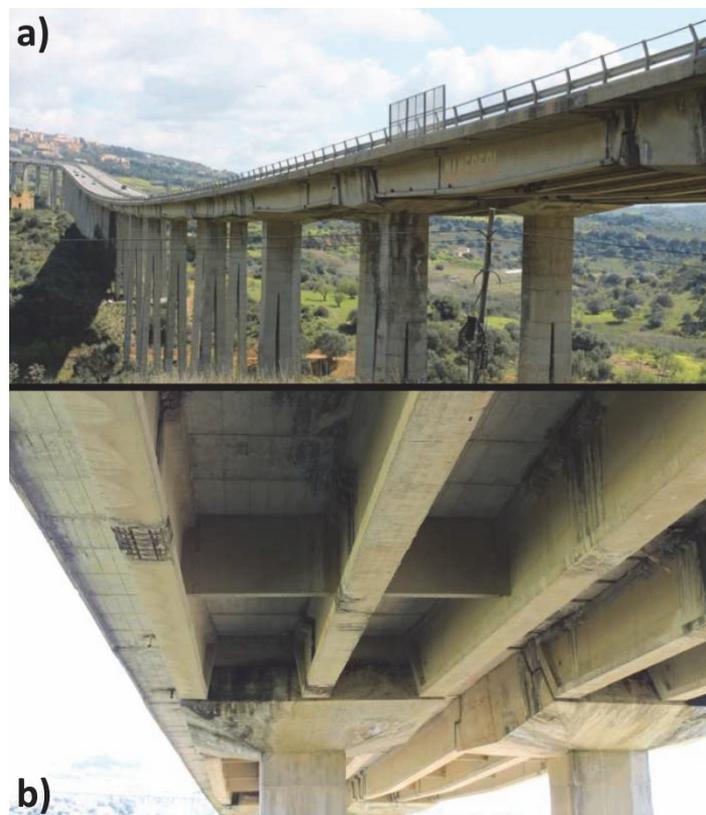
Figure 13: Overall view of the Akragas viaduct (a); deck detail (b) [23].

Throughout the same years, the Akragas Viaduct (S.S. 115-AG, Agrigento, 1970) was erected in Sicily. The design, by Morandi, considered a total length of 1400 m skewed viaduct with 31 spans, each 44 m long (Fig. 13(a)). The deck, 10 m wide, was realized by a grillage of 3 unbonded prestressed I-beams, 5 transverse beams, and a precasted pavement (Fig. 13(b)) [23]. Support for each beam consisted in a couple of reinforced concrete A columns, with a maximum height of 60 m. To date, these latter elements represent the key vulnerability of the structure. Each column was erected through a concrete concave precast box that works both as scaffolding (in the pouring phase) and as shear resisting element (Fig. 14(a)). It is reasonable to think that visible damage is due to the concave shape of the external box. When shear forces required confinement, the bars pushed against the box bulged the internal part as visible in Fig. 14(b). Together with the static problems, the retrofitting intervention has the aim of improving the seismic behavior by providing sufficient shear strength and ductility: a new element and the recovering of a confined state for the concrete of the core.

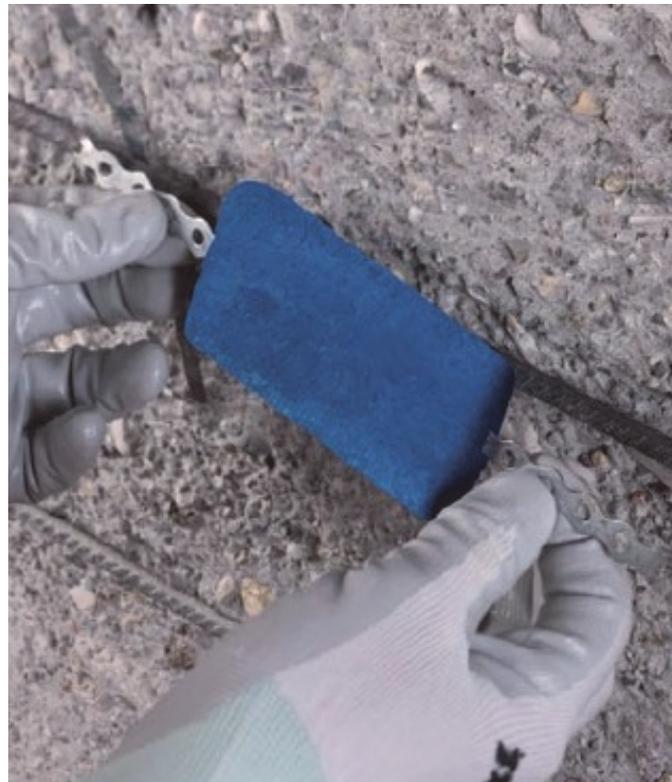
Figure 16: galvanic protection: sacrificial anode [Copyright: Mapei].

Considering now the case of La Reale Viaduct (Fig. 7(a)). Durability problems are overcome by the peculiar shape of the deck and its modular assemblage. To avoid a fragile collapse, the structure must improve its robustness. Since the analyses of the safety of the infrastructure are still under exploitation, different levels of intervention are suggested towards the observed damage pattern. For the spans that will evidence lack of cable protective grout, epoxy injection would be necessary to stop di advancement of corrosion. This operation could result particularly difficult to do because of the inaccessible boxed section. A frequent problem in bridge concrete walls is concrete spalling and exposure of reinforcement. This situation is particularly dangerous when the exposed reinforcement realizes the primary load carrying system, i.e. dapped-end corbels (Fig. 5(a), Fig. 5(b)). Under this circumstances, health of the steel is essential to exclude a sudden collapse due to shear failures. Considering the numbers of the existing artifacts, sometimes just blocking the advance of corrosion represents a good strategy to keep reasonable safety factors while retrofitting is pending. This strategy can be implemented by the use of sacrificial anodes (galvanic protection) directly connected to exposed reinforcements (Fig. 16) [24]. These anodes, usually realized in zinc-based compounds, guarantee local protection to the

steel by the higher electronegative power of the sacrificial anode. The monitoring of these devices can be executed by simple electronic tester that measures electricity rates in the anodes. When the exposed reinforcement is large and interconnected (i.e. a wire mesh), an alternative solution is the cathode protection. In this case, an electric current is supplied to the steel by an external generator, shielding the reinforcement from corrosion.

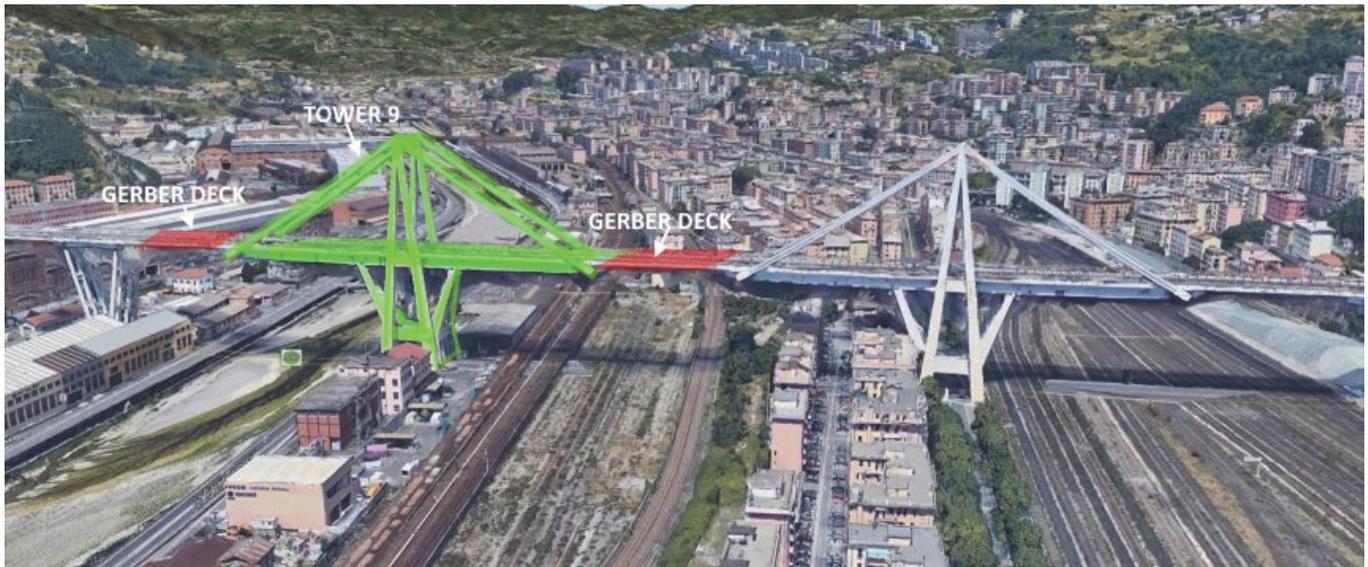
Figure 17: Involved structure in the collapse: tower and Gerber decks.

One of the shocking aspects of the Polcevera Viaduct collapse was its catastrophic nature. Even if the causes are currently under investigation, it is clear that the failure of one component has been followed by the entire structure, composed by the tower (green, Fig. 17) and two simply supported Gerber decks (red, Fig. 17). As anticipated, the equilibrium of the system rests upon the balance between the symmetry axes of the tower (Fig. 18a). A lack of balance in one of the two directions of the equatorial planes induces a flexural moment in the deck plane that can lose in-plane stability and could break due to unbalanced compressive forces (blue, Fig. 18(a)). Under these circumstances, the in-plane twisting could cause the slip of the Gerber decks, that without a vertical support become free to fall. At the same time, a disequilibrium in the plane of the bridge direction induces torsion and bending moment to the double framed A tower (red, Fig. 18a). This structure could not have the ductility capacity to resist at such asymmetric stress, because of the limited rotational capacity at the base (wider) and the lack of redundancy for force redistribution. Moreover, unbalanced forces in the plane of the stays causes deck uplifting on one side and subside to the other. This mechanism, could be again

responsible for the support loss of the Gerber deck and the rupture of the deck due to bending in its plane (yellow, Fig. 18a). An asymmetric fall of the deck causes and inevitable impact with the intermediate deck support that would find themselves dragged into the collapse. Finally, the observation of the Tower 9 ruins allows an additional comment: many of the parts of the tower broke with planar surfaces, evidencing low or nonexistent process zone and plastic hinge creation. These planar surfaces represent probably the casting phases of the vertical structure. This would imply that (i) no sufficient rebars content was present in that zones, or (i) the boxed section had not sufficient plasticity reserve (red, Fig. 18b). In the end, at this level of knowledge, the lack of structural robustness can be addressed to these factors:

- the low number of stays elements that causes zero redundancy in deck support;
- the low rotation capacity of the A framed lateral tower and its limited redistribution;
- the statically determined scheme for the entire viaduct, which causes higher displacements (and cracking as a consequence) and domino effect collapse;
- the low ductility at member scale;
- the intrinsic sudden loss of strength of prestressing technology.

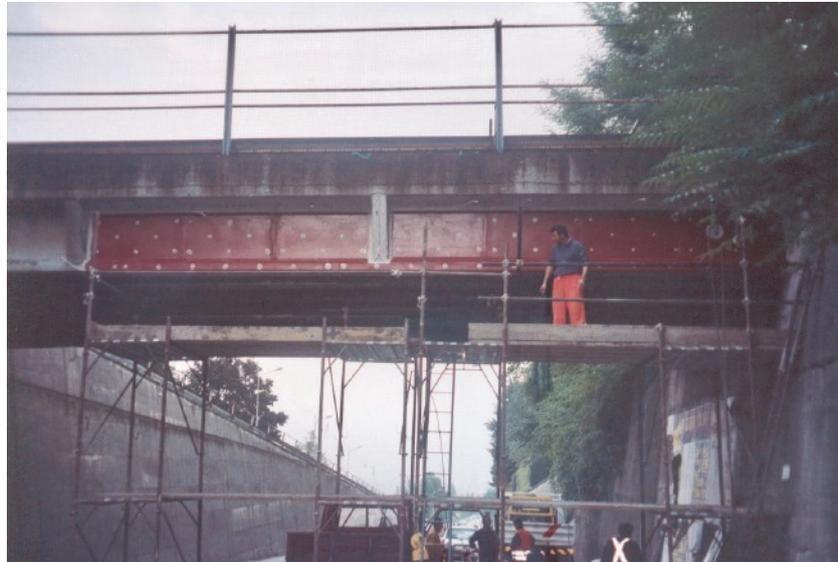
Figure 19: Steel resurfacing for I-beams of an overpass [Copyright: RELUIS].

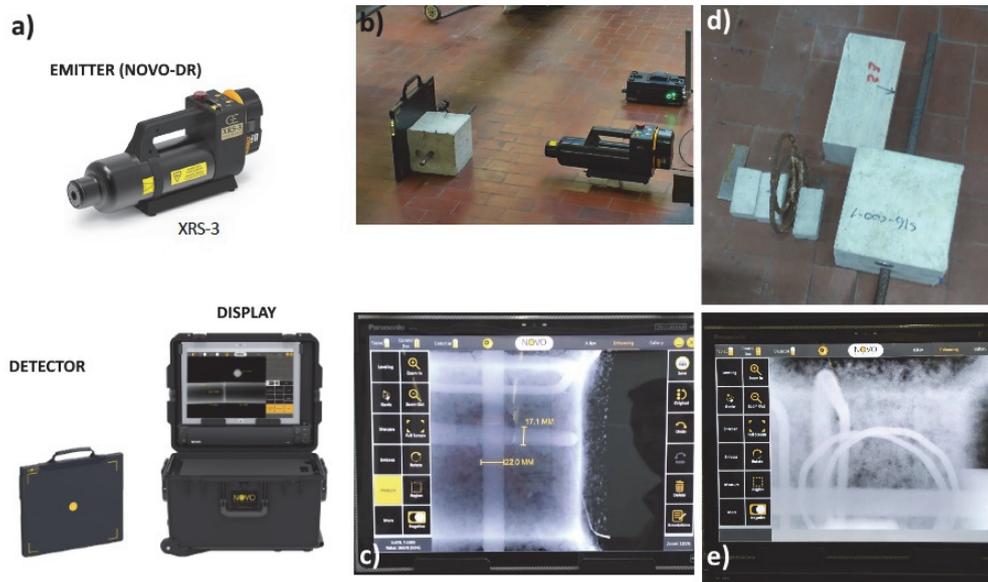
Figure 20: X-Ray device (a) [Copyright: <https://www.novo-dr.com/>]; scanned image (b) of specimen (c); scanned image (d) of specimen (e).

The system is usually composed by an emitter, a real time display and a shield detached detector (Fig. 20(a)). This technology enables to generate immediate and high-quality X-ray images while keeping radiation levels to the minimum. Fig. 20(b) shows the results of an X-Ray test conducted in Politecnico di Torino laboratory Fig. 20(c). The system exhibited a significant power of penetration, completely scanning the 150x150x150 mm concrete cube. Furthermore, the system was able to detect additional reinforcement positioned beyond the cube, then has a great potential also for the inaccessible portion of a structure (Fig. 20(d), Fig. 20(e)). The all system weight less than 200 kg (the heavier component is the detector, 150 kg in its largest dimension) and can be easily carried by a robotic-arm installed on a vehicle (Fig. 21). Inspection of I-beams could be carried by a scraped scanning. Of course, this method represents a screening procedure but could be extremely reliable and effective for a preliminary census or fast track assessment.
