## Failure analysis and numerical simulation of slab carrying clamps

**ABSTRACT.** The goal of this study was to determine the reasons for failure of slab carrying clamps which had occurred in one of the clamp support levers. Detailed fractography analysis revealed that there was a welded joint at the location where failure occurred, which was not expected, since the second lever was not welded. Once the presence of the welded joint was confirmed by hardness measuring and the analysis of chemical composition, attempts were made to determine which materials were used for the welding, in order to obtain a more detailed insight into the nature of the failure. The first step of this extensive analysis involved the development of a simple, approximated numerical model, with the goal of determining the location of stress concentration in the support lever, so that it could be compared to the real failure location. Further investigations will involve more complex models, including the ones that will simulate crack growth, once its location is numerically verified.

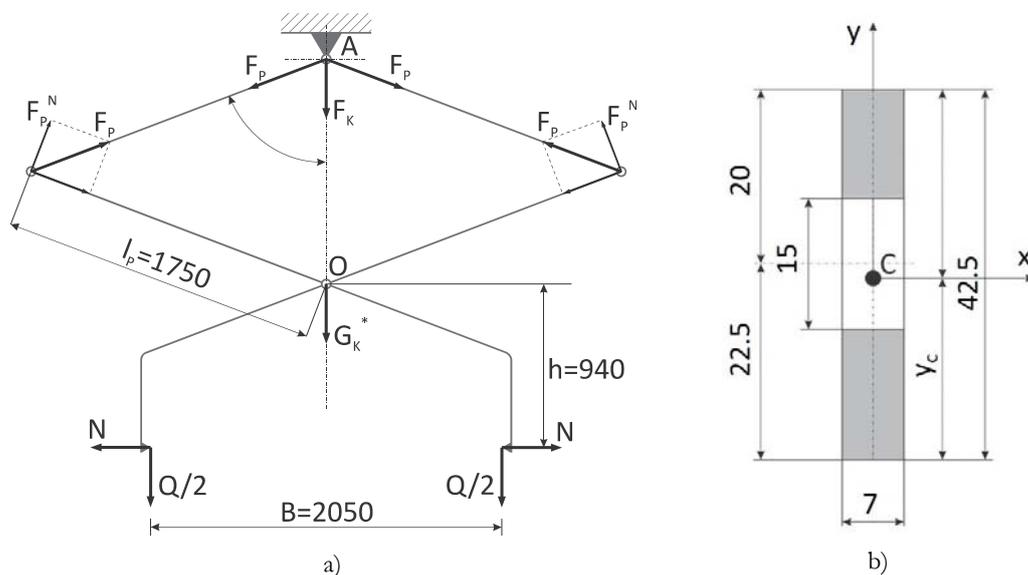
Figure 4: a) Loading scheme of the levers, with their dimensions; b) lever cross section at the support O location and its dimensions.

By decomposing the forces along the directions of the levers and their normal components, and by using the well-known statics relation given by (1), the moment for point O is obtained, i.e. for the circular opening approximated with it. This moment equals 72688 kNcm. Since this moment is transferred onto four levers, the moment for each levers is equal to 18172 kNcm according to (2).

Fig. 4b shows the cross-section of one of the levers at the support, along with the dimensions. Basic concepts of strength of materials were used to determine the cross-section centre mass, moment of inertia and the elastic section modulus in the “upper” and the “lower” zone (denoted as U and L), and the stresses in both these zones were obtained for a lever which was subjected to compression in the “upper” and tension in the “lower” zone, as shown by relations (3) and (4). Values of stresses obtained by these calculations were as follows: -93 MPa for the upper zone (negative due to the fact these were compressive stresses), and 88.4 MPa in the lower zone of the cross section. These values were below the allowed stress for the lever, which was 230 MPa. This value was determined based on the yield stress of the base material and the safety factors which are adopted in these cases (and are usually around 1.5).

In the case of extremely non-uniform load, to be accurate, when only one pair of clamps is subjected to the full load, maximum values for the “upper“ and “lower“ zones are obtained -186 MPa and 176.8 MPa, respectively. Even though these values are, as expected, two times higher than the stresses obtained in the case of uniform load on both pair of clamps, and they are still below the allowed stress levels. These remarks and afore obtained load level leave the space for numerical simulation and FEM analysis, because analytical calculation did not give the answer of reason for fracture occurrence.

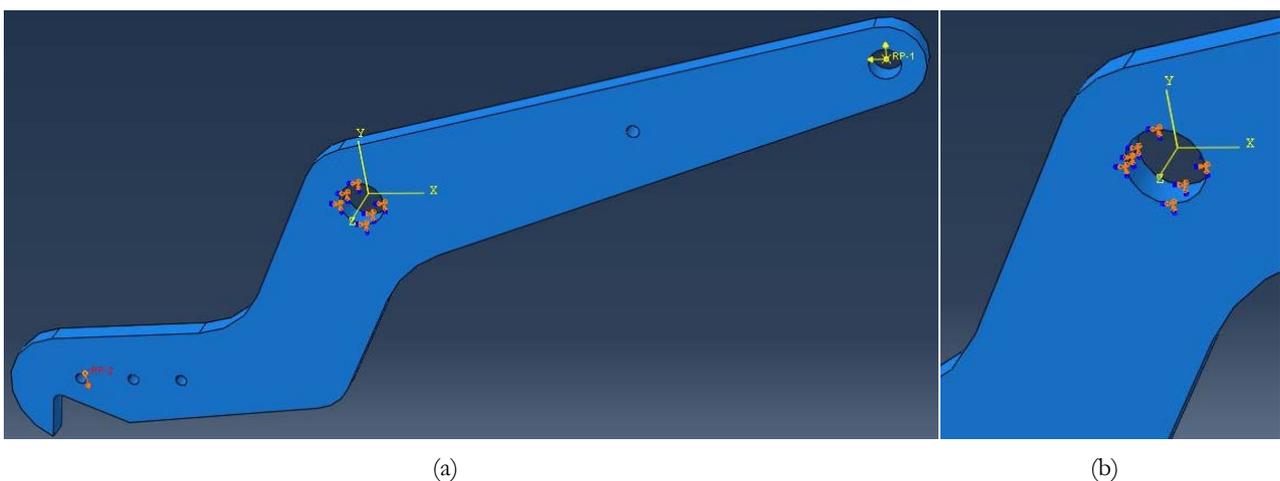
Numerical simulation in this research was focused on one of the levers, for the purpose of determining the stresses that would occur in it, and whether the critical location (where highest tensile stresses were observed) would correspond to the actual fracture location, without taking into account the material heterogeneity. This was done in order to see if the initial assumptions about the model were correct, and to determine the location of crack initiation in the future, improved models. For the reason of initial model simplicity, certain approximations were made to the model – only the fractured lever itself was modelled, and its connection with the upper lever which is supported in point A from the Fig. 4 was replaced with the corresponding force  $F_p$ . It should be noted that this force was decomposed into x and y axes components, instead along the lever axis, due to ABAQUS requirements. Hence, the values of this load were -269034 (x axis) and 143048 N (y axis). To avoid confusion with the results, all forces were defined in Newtons and dimensions were assumed to be in millimeters, so that the stress results would be obtained in N/mm<sup>2</sup>, i.e. in MPa. Another load was defined at the bottom part of the lever, and it was equal to one quarter of the work load (since only one lever was modelled). Hence it was equal to -85837.5 N. Model geometry and loads can be seen in Fig. 5a. Boundary conditions were defined in the central opening, by constraining its inner surface. All displacements and rotations were prevented, with the exception of rotation about the z axis, in order to replicate the real boundary conditions as close as possible. There is also a possibility to further improve this boundary condition, but this will be done in the future, once new and more complex models are developed. The boundary condition can be seen in Fig. 5b.

Figure 5: a) Numerical model geometry and loads (defined in RP-1 and RP-2 points) b) The boundary condition (only the rotation about the z-axis is allowed).

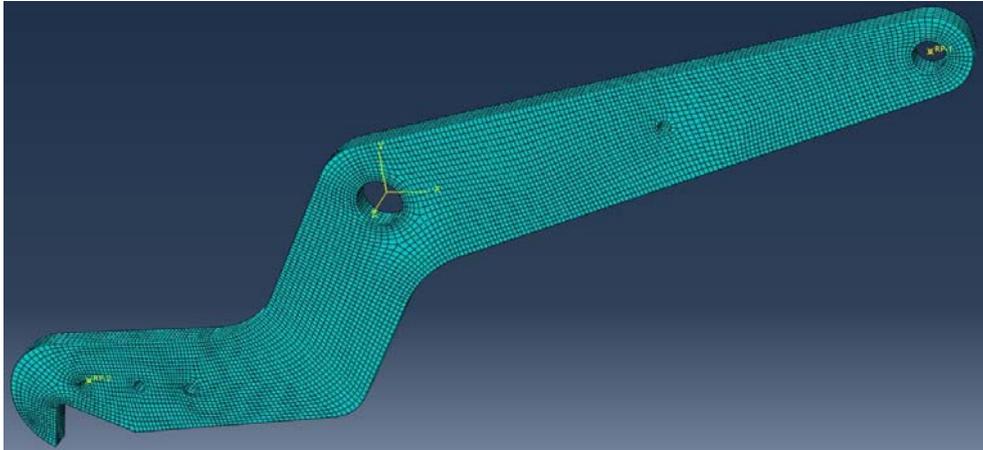
Finally, the finite element mesh is given in Fig. 6. Element size was approximately 13.5 mm, since it was determined that this size provides sufficient convergence of results, after a number of iterations. Element type used for this analysis was C3D8R, and the total number of elements and nodes was 30285 and 38330, respectively.

Figure 6: Finite element mesh of the model.
