# Composite Fracture in Al Li Cu Alloy

M. CAVALLINI - Dipartimento Ingegneria Industriale - Università di Cassino, F. FELLI - Dipartimento ICMMPM - Università di Roma "La Sapienza", P. DELOGU - ENEA Casaccia - TIB MAT

## Abstract

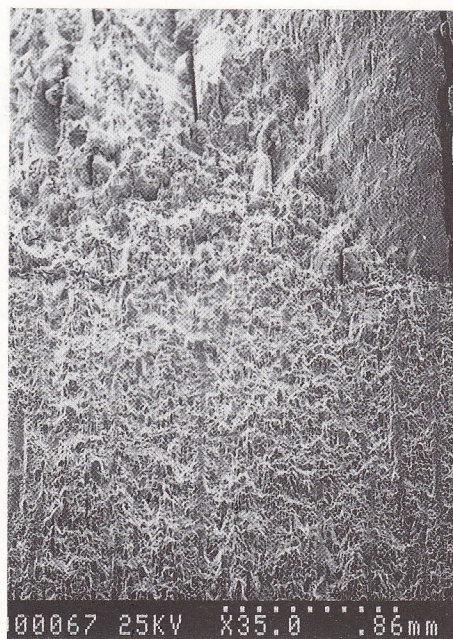
Fig. 3:  
Transition in fracture between fatigue (lower part) and overload (upper) in a CT specimen in LT orientation.

The transition between fatigue and final fracture clearly appears in fig. 3 for an LT specimen. Delamination doesn't occur during fatigue crack growth where the stress, and the  $K_I$  level, are not high enough. During plane strain fracture test the fatigue cracked CT specimen is slowly loaded up to the final failure; the specimen, up to this time monolithic, suggests a fracture surface self-similar to the already formed one. Nevertheless, the triaxial stress state in the process zone ahead of the crack tip promotes the failure in the weakest orientation, i.e. along grain boundaries, via delamination. The new internal surfaces change the stress state from plane strain to plane stress, allow the onset of shear lips inside the ligament, thus requiring more energy for crack propagation. Moreover, as it happens in the external surfaces, traces of crack bifurcation appear as secondary cracks parallel to the main crack front, connected to these internal surfaces.

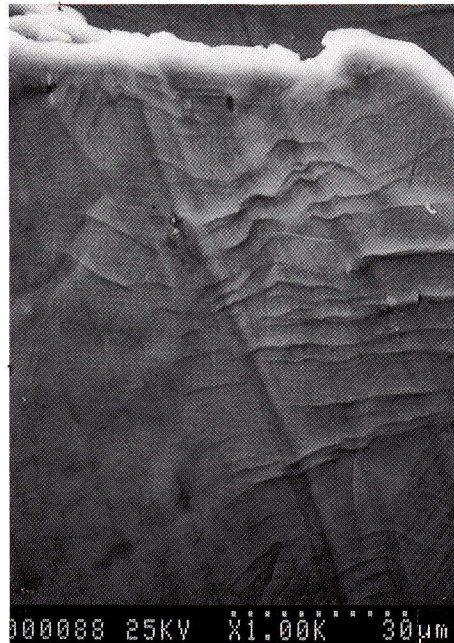
Fig. 5:  
Shear bands emerging on lateral surface near the crack after overloading.
