Investigation of corrosion resistance of pre-painted Zn-11%Al-3%Mg-0.2%Si alloy coated steel sheet through outdoor exposure test in Okinawa

K. Ueda, A. Takahashi, Y. Kubo

Steel Research Laboratories, NIPPON STEEL CORPORATION
20-1 Futtsu, Chiba Japan 293-8511

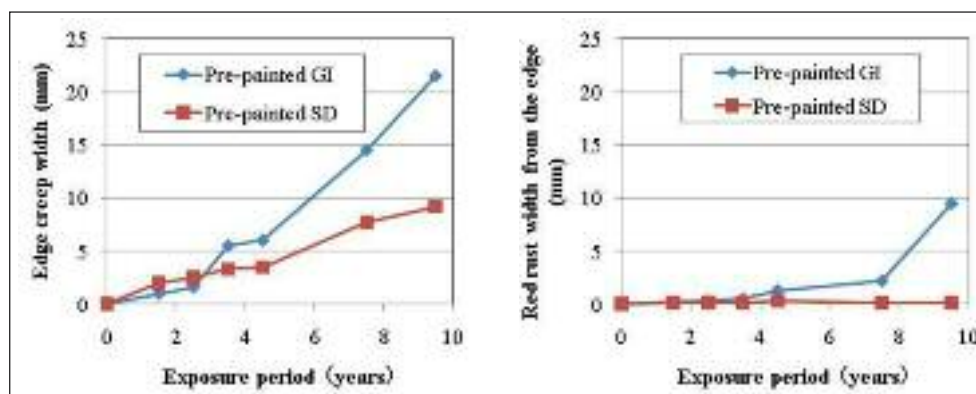
FIG.2

hand, the corrosion at the cut edge of pre-painted SD was only edge creep without red rust. Fig.2 shows the change of corrosion width of pre-painted GI and SD with time. There were not so much difference of the corrosion width between pre-painted GI and SD in a short period of exposure.

However, the edge creep of pre-painted GI was more developed than that of SD with time passes and there was very little red rust on the pre-painted SD. The cut edge corrosion resistance of pre-painted SD was better than that of GI in a long period of exposure.

The change of corrosion width / edge creep (a) and red rust (b) of pre-painted GI and SD in OKINAWA with time.

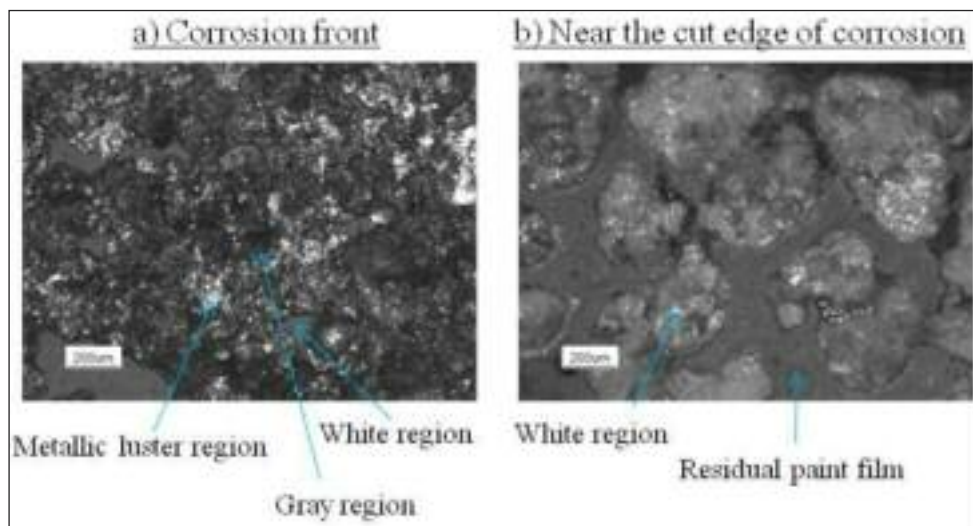
FIG. 7

Optical microscope image on the corroded metallic coating surface after removing the paint from the pre-painted SD exposed in OKINAWA (9.5 years).

The paint film at the red sphere portion on the pre-painted SD sample photograph in Fig.1 was removed and the naked metallic corrosion site was observed and analyzed. The microscope images were shown in Fig.7. The white region that is corrosion product, the grey region that is corroded metallic coating and metallic luster region that was the uncorroded metallic coating were observed at the corrosion front (Fig.7-a).

The metallic coating was covered by the island like white corrosion products near the cut edge site (Fig.7-b).

In the result of XRD on the cut edge (Fig.8-b), the zinc aluminium carbonate hydroxide, $\text{Zn}_6\text{Al}_2(\text{OH})_{16}\text{CO}_3 \cdot 4\text{H}_2\text{O}$, was found. This indicated the island like corrosion product shown in Fig.7-b agrees with the corrosion product in Fig.4-b. The zinc aluminium carbonate hydroxide was also identified from the XRD and IR spectra of

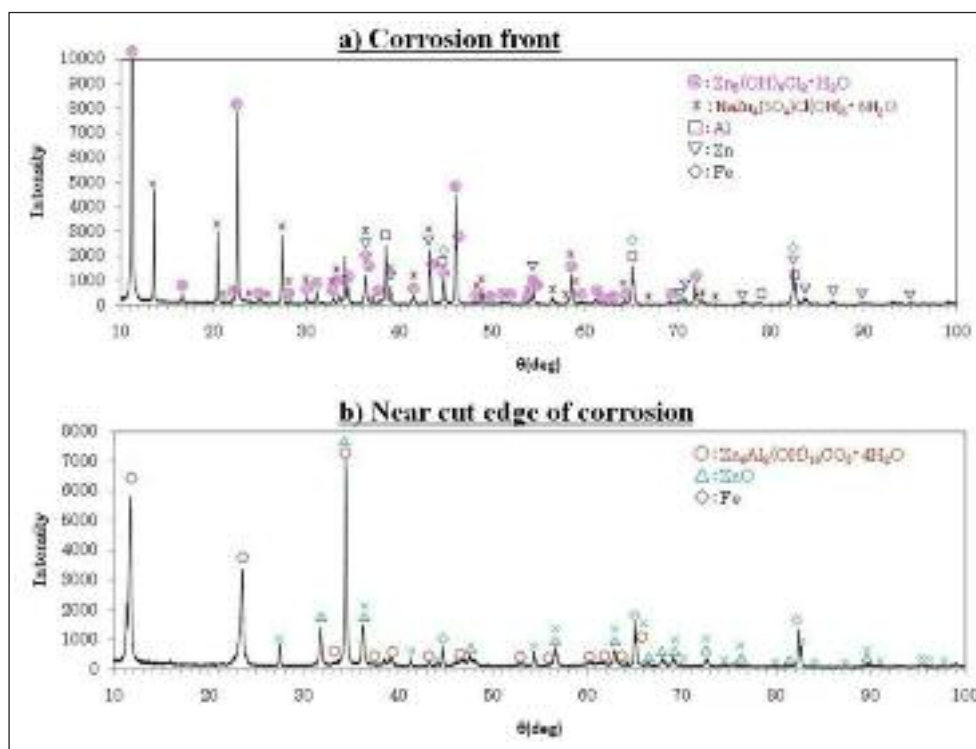
FIG. 8

X-ray diffraction diagrams of corroded metallic coating surface after removing the paint from the pre-painted SD exposed in OKINAWA (9.5 years).

The XRD spectra of the corrosion products were shown in Fig.8. The XRD showed the presence of metallic zinc, metallic aluminium, simonkolleite, $\text{Zn}_5(\text{OH})_8\text{Cl}_2 \cdot \text{H}_2\text{O}$, and gordaite,

$\text{NaZn}_4(\text{SO}_4)\text{Cl}(\text{OH})_6 \cdot 6\text{H}_2\text{O}$ on the corrosion front (Fig.8-a). The metal zinc and aluminium seemed to originate from uncorroded metallic coating observed as metallic lustre region. The simonkolleite, $\text{Zn}_5(\text{OH})_8\text{Cl}_2 \cdot \text{H}_2\text{O}$ should be the corroded eutectic phase from the result by EPMA, while the gordaite, $\text{NaZn}_4(\text{SO}_4)\text{Cl}(\text{OH})_6 \cdot 6\text{H}_2\text{O}$ should be metallic coating layer. The simonkolleite is well known as a stable corrosion product which is also detected in the corrosion site of Zn-Al-Mg alloy coated in the studies [17,18]. The gordaite, $\text{NaZn}_4(\text{SO}_4)\text{Cl}(\text{OH})_6 \cdot 6\text{H}_2\text{O}$ transformed from simonkolleite under the influence of sulphate ion [19]. That is also found as a corrosion product of Zn-Al-Mg alloy coated steel after natural exposure [18]. In the case of this study, the sulphur detected by both EPMA and XRD seemed to come from marine salt because the influence of industry was small in Okinawa atmosphere.
