An assessment of composite repair system in offshore platform for corroded circumferential welds in super duplex steel pipe

Citation: de Barros, S., Budhe, S., Banea, M.D., Rohem, N.R.F., Sampaio, E.M., Perrut, V.A., Lana, L.D.M., An assessment of composite repair system in offshore platform for corroded circumferential welds in super duplex steel pipe, *Frattura ed Integrità Strutturale*, 44 (2018) 151-160.

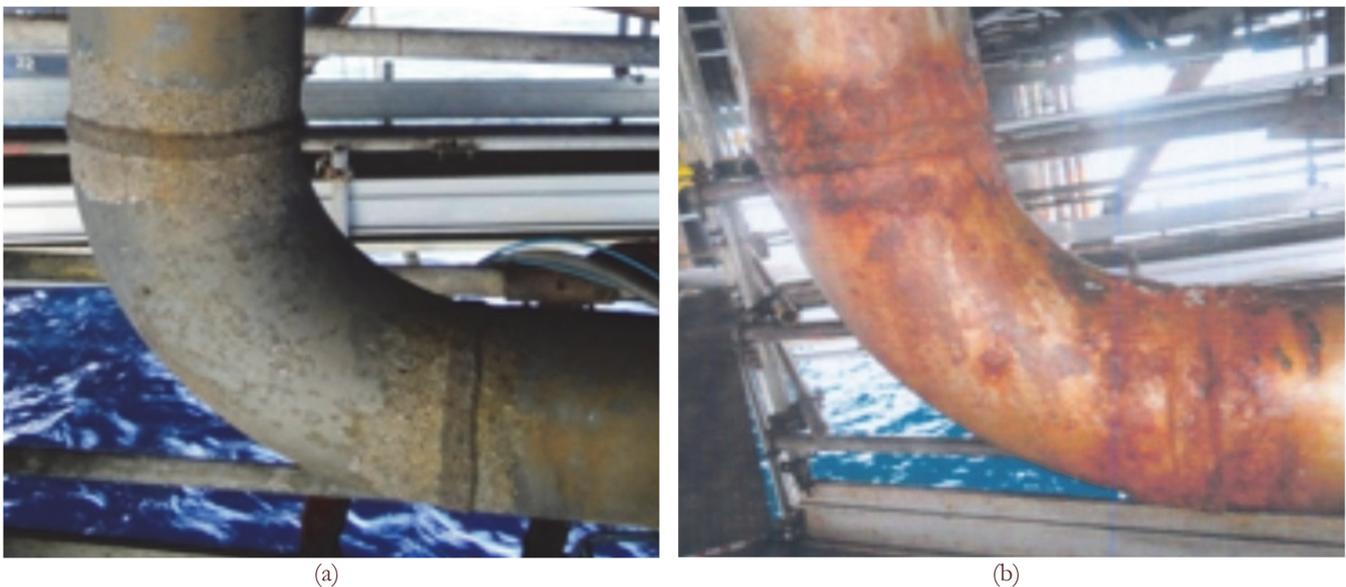
Figure 1: Super duplex steel piping assembly: (a) uncorroded welds (b) corroded welds.

Nowadays, the super duplex stainless steel pipes are increasingly used due to an excellent resistance to corrosion in harsh environments combined with good mechanical properties. However, despite the high resistance to corrosion, the welding process of this material is not simple and is susceptible to corrosion, if the welding parameters are not properly controlled [7-9]. Thus, it is possible to have duplex or super duplex steel piping assemblies with significant corrosion damage at the welds (Fig.1).

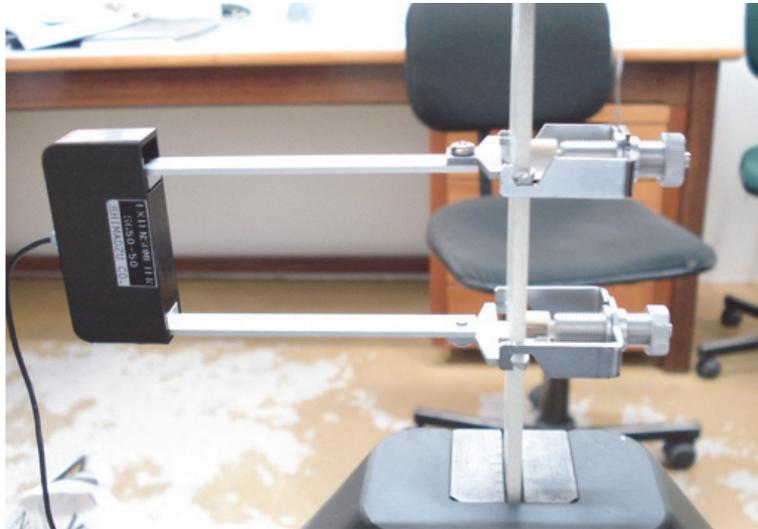
Figure 2: Tensile test set up with an extensometer

In order to obtain the material properties of the composite laminate, tensile test specimens were prepared as per the standard ASTM D3039 [30]. The specimens were tested in a universal testing machine (Shimadzu AGI 100 kN) at room temperature and relative humidity of $50\% \pm 10\%$. Five specimens were tested at a crosshead speed of 2 mm/min. Fig.2 shows the tensile test setup with an extensometer (model SG50-50 Shimadzu) attached to the specimen. The load-displacement curve of

specimens obtained from was recorded. The Young's modulus and tensile strength values in both directions (circumferential and axial) were calculated and the results can be seen in Tabs. 2 and 3, respectively. The average circumferential elasticity modulus of the laminate is $E_0 = 16.60$ GPa, the axial elasticity modulus is $E_z = 9.52$ GPa and the Poisson's ratio is $\nu = 0.1326$.

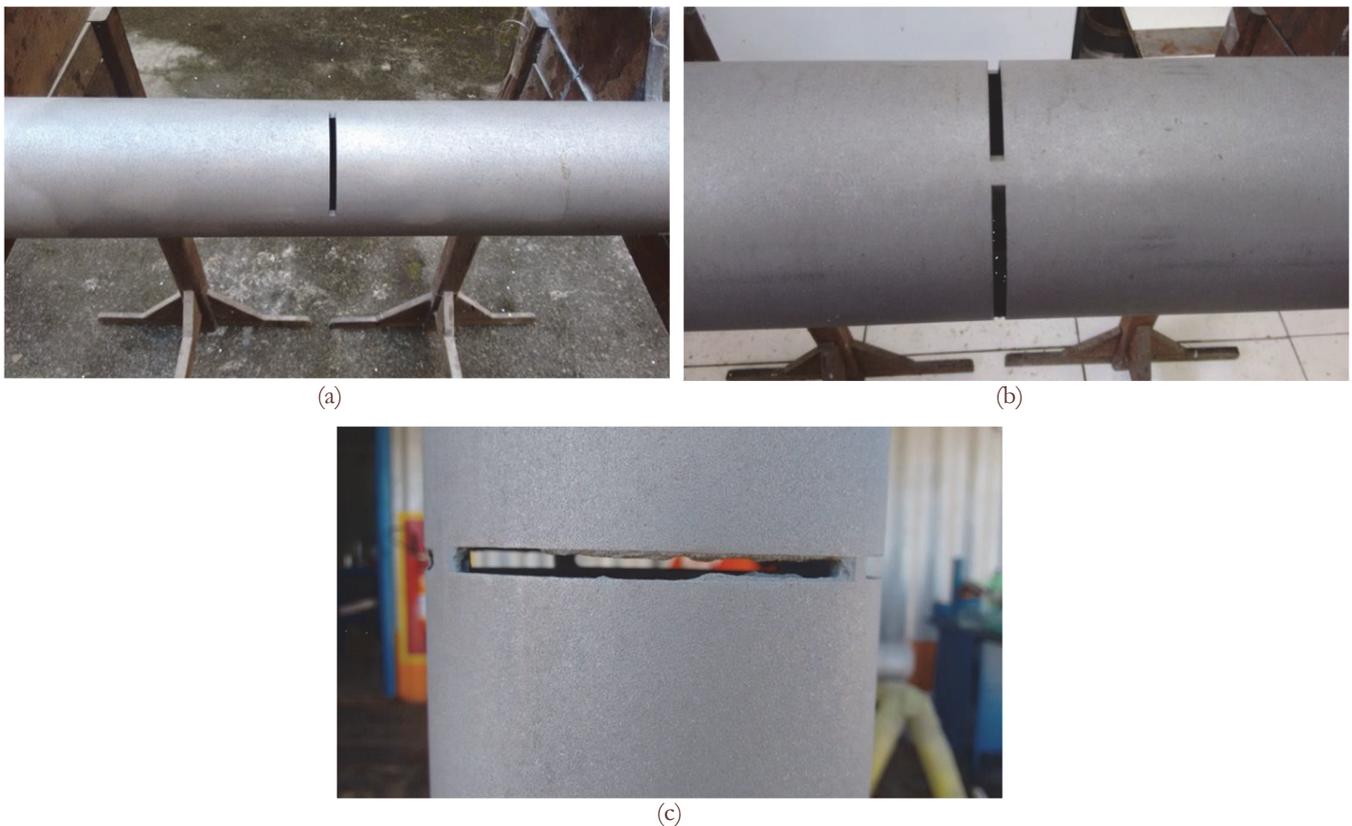
Figure 3: Through thickness defect: (a) in 25% of the perimeter (b) in 50% of the perimeter (c) in 96% of the perimeter.

- 1) 25% of the perimeter through-thickness defects were fabricated and the size of defects is 90 mm x 5mm. (Fig.3a).
- 2) 50% of the perimeter through-thickness defects were fabricated. Two defects of approximately 90 mm x 5 mm were machined. Among the defects, a 5 mm section was left in order to guarantee the spacing and to keep the tube attached (Fig.3b).
- 3) 96% of the perimeter through-thickness defects were fabricated. Two damages of approximately 90 mm x 5mm and a single damage of approximately 180 mm x 5mm were machined (stretches of 5 mm were left between the defects in order to guarantee the spacing and keep the tube attached (Fig.3c)).

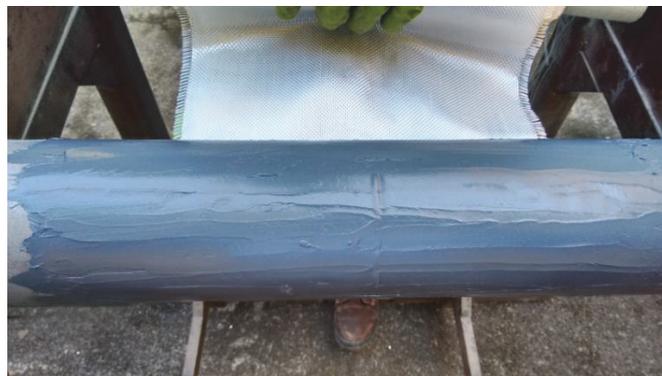
Figure 4: Primer Layer.

of super duplex stainless steel tube was cleaned with acetone to remove dust and foreign particles and then a layer of primer NVT was applied, as shown in Fig.4. The defect pipe is wrapped with concentric layers of a fiberglass tape with laminating resin (32 layers with approximately 0.298 mm thickness each). The calculation of composite repair thickness was based on the ISO 24817 standard. The calculated composite repair thickness was 9.5 mm. The repair system used PIPEFIX, adhesive and 32 turns of the laminate being applied with an axial length of 300 mm. Each laminate turn was followed by a layer of resins and pressed with a metallic roller for compact, as shown in Fig. 5.

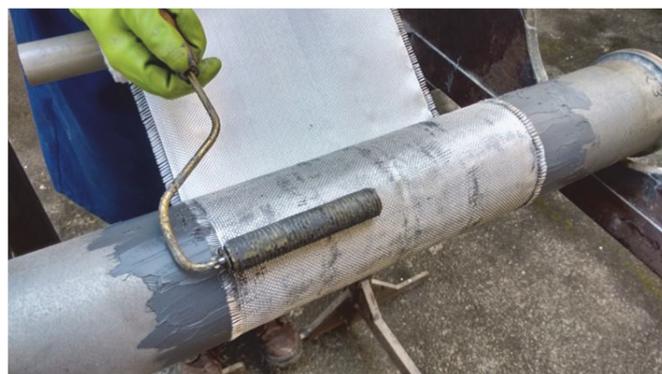
Figure 5: Pre-impregnated, bi-directional composite.

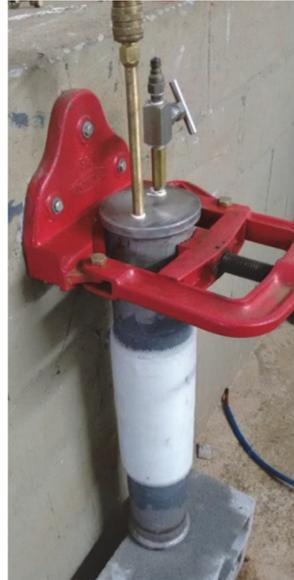
Figure 6: Hydrostatic testing.

The hydrostatic tests were performed in the bunker at room temperature condition. The specimen used in the hydrostatic test is presented in Fig.6. For the hydrostatic test, the Flutrol's Test Pac equipment was used. The pressure was increased by approximately 1 bar/second and after reaching a certain level, the pressure was maintained for 30 minutes. Then again raised by 1 bar/second up to next level, until the repair system fails. Load the tube specimen for 30 min at a particular operating pressure and then increased for next pressure level. Each test shall be monitored by a PID system to record the test results.
