# CORROSION BEHAVIOUR OF ALUMINIUM ALLOY METAL MATRIX COMPOSITE JOINTS OBTAINED BY FSW

F. Zucchi, V. Grassi, C. Monticelli, A. Frignani

"A. Daccò" Corrosion Study Centre, Department of Chemistry, University of Ferrara, Ferrara, Italy.

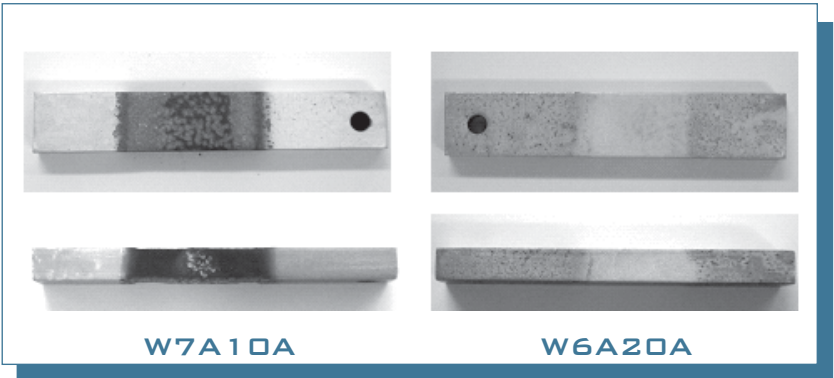
Fig. 1: Appearance of the FSW joints after soaking 48 hours in EXCO solution and pickling

The difference appears even more evident if, as documented in Figure 1, it is considered that the corrosive attack is located on the nugget and in the thermally affected zone only. Corrosion rates higher than 2000 mdd were measured on specimens taken from the nugget or thermally affected zones (Table 3).

The behaviour of W6A20A joint is completely different.

In this case the corrosive attack develops on the base material and on the adjacent heat affected zones.

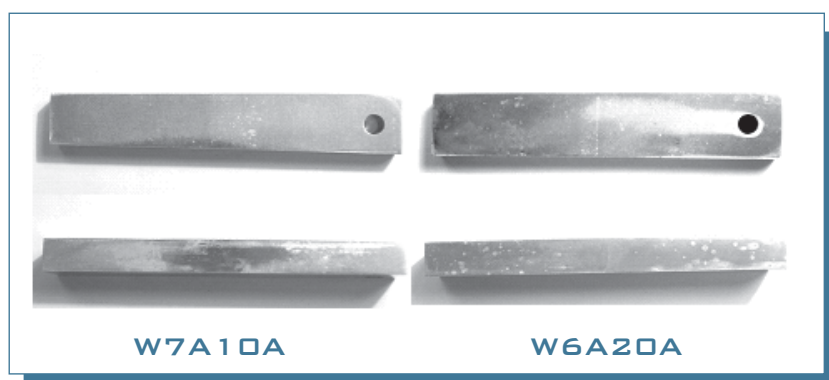
**Fig. 2: Appearance of FSW joints after soaking 21 days in 3.5% NaCl solution and pickling**

After 21 days of exposure, the welded W7A10A specimen showed that the corrosive attack was concentrated on the nugget and in the immediately surrounding zones (Figure 2).

After pickling, a deep attack of the nugget was observed, while the adjacent zone was unaffected. The base material specimen shows only a strip of corrosion products arising from the hole drilled to hang up the specimen.

After the same exposure time in the same solution, pitting was clearly evident on the surface of W6A20A specimen.

In this case, pits were distributed both on the

horizontal side and on the transversal sections of the specimen.

In 3.5% NaCl corrosive environment, considerably less aggressive than the EXCO solution, only in the case of W7A10A joints, corrosion was localised in the nugget zone. The pitting of the W6A20A joint did not appear; indeed, particularly stimulated by the structural modifications occurring during welding; the corrosion points, not particularly deep, developed on the base material, while the nugget remained unaltered.

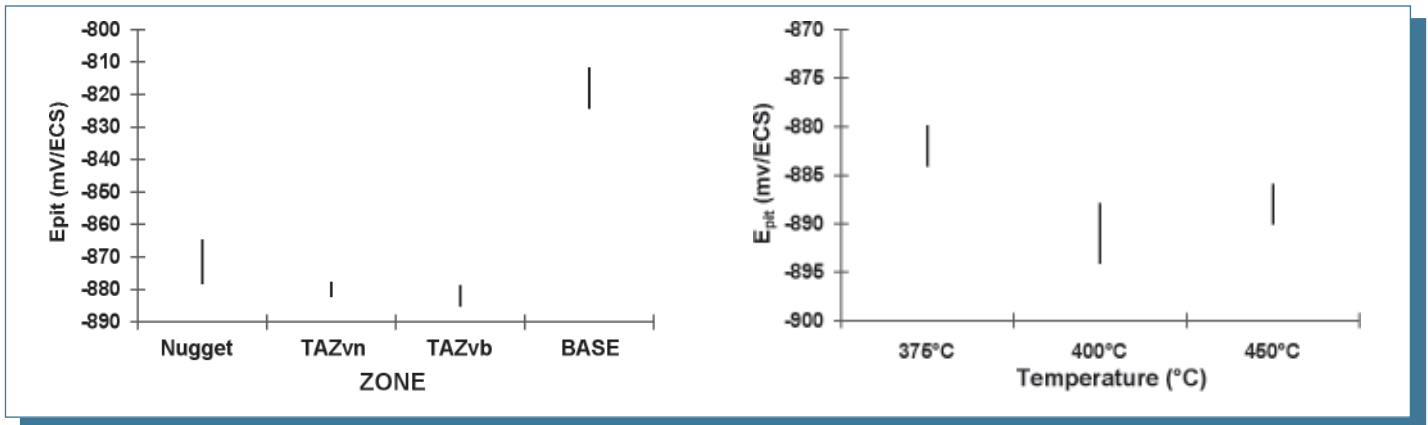
Fig. 3: Pitting potentials of the characteristic zones of the W7A10A joint and the base material after thermal treatment at different temperatures.

In the case of W7A10A base material,  $E_{pit}$  was -820 mV/ECS, while the thermally affected zone and the nugget presented an  $E_{pit}$  from -872 mV/ECS (nugget) to -880 mV/ECS (TAZ) (Figure 3).

Similar or slightly more negative pitting potential values were found on the electrodes made of the base material thermally treated from 375°C to 450°C.

These measurements confirm the observations in 3.5% NaCl corrosion tests performed on the welded material in which corrosion was concentrated in the central zone of the joint, the one subjected to a highest heating temperature.

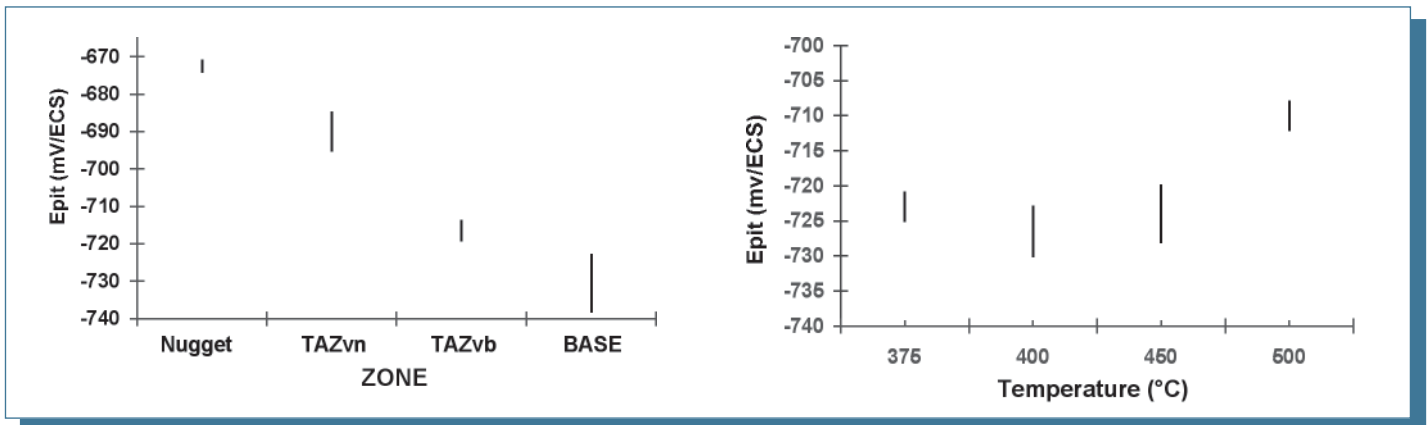
Fig. 4: Pitting potentials of the characteristic zones of the W6A20A joint and the base material after thermal treatment at different temperatures

The  $E_{pit}$  values of electrodes taken from the characteristics zones of W6A20A joint and of the thermally treated material are considerably more positive than the corresponding values measured on the first composite (Figure 4).

This aspect confirms a higher resistance to pitting corrosion of this alloy in this environment.

The pitting potentials decrease gradually from the nugget (-672 mV/ECS)

to the thermally affected zone (-688 mV/ECS), to the base material (-730 mV/ECS).

The thermally treated specimens present an  $E_{pit}$  value which tends to increase as the treatment temperature increases. The specimen treated at 500°C for two minutes shows a value of  $E_{pit}$  close to that of the thermally affected zone.

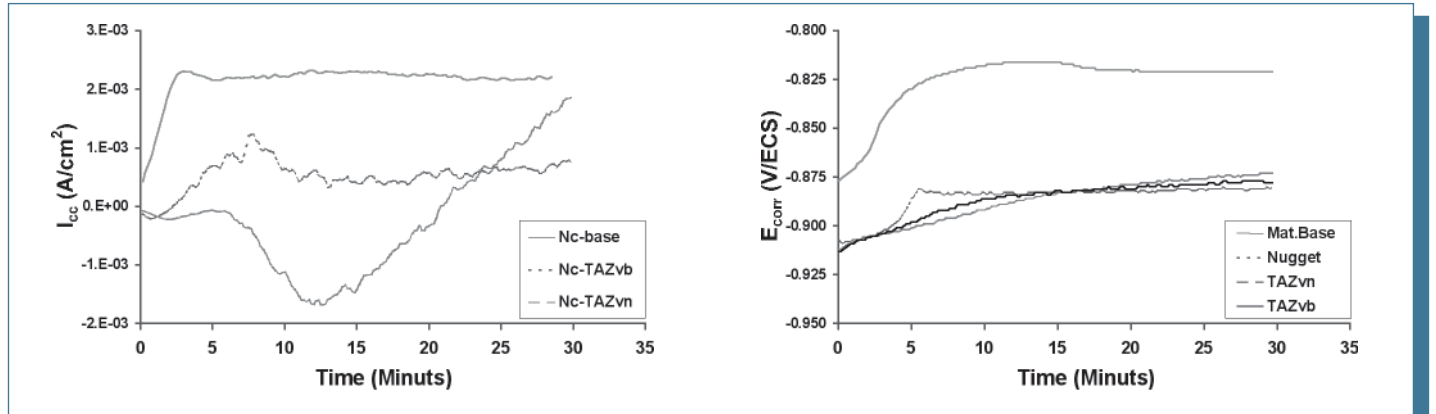
Fig. 5: Short-circuit currents and corrosion potentials of the characteristic zones of the W7A10A joint in EXCO solution

Figure 5 shows the corrosion currents related to W7A10A composite.

The behaviour of the nugget is anodic with respect to the base material.

In the nugget-base material galvanic coupling, after

a few minutes, the short-circuit current stabilises at  $2.5 \times 10^{-3} \text{ A/cm}^2$  and remains constant for the entire duration of the test.

The currents between the nugget and the thermally affected zone are considerably lower. The nugget behaves as an anodic area with respect to the TAZvb and for most of the time as cathodic

area when in contact with TAZvn.

$E_{\text{corr}}$  of the base material starts from  $-880 \text{ mV/ECS}$ , after ten minutes it reaches  $-820 \text{ mV/ECS}$ , then it remains constant until the end of the test. For the nugget, the potential starts from  $-910 \text{ mV/ECS}$  and stabilises at  $-890 \text{ mV/ECS}$  after ten minutes. The  $E_{\text{corr}}$  values of the thermally affected

zones, initially equal to that of the nugget, increase more slowly. Furthermore, at the end of the test,  $E_{\text{corr}}$  of the TAZvn was slightly more positive than that of the nugget.

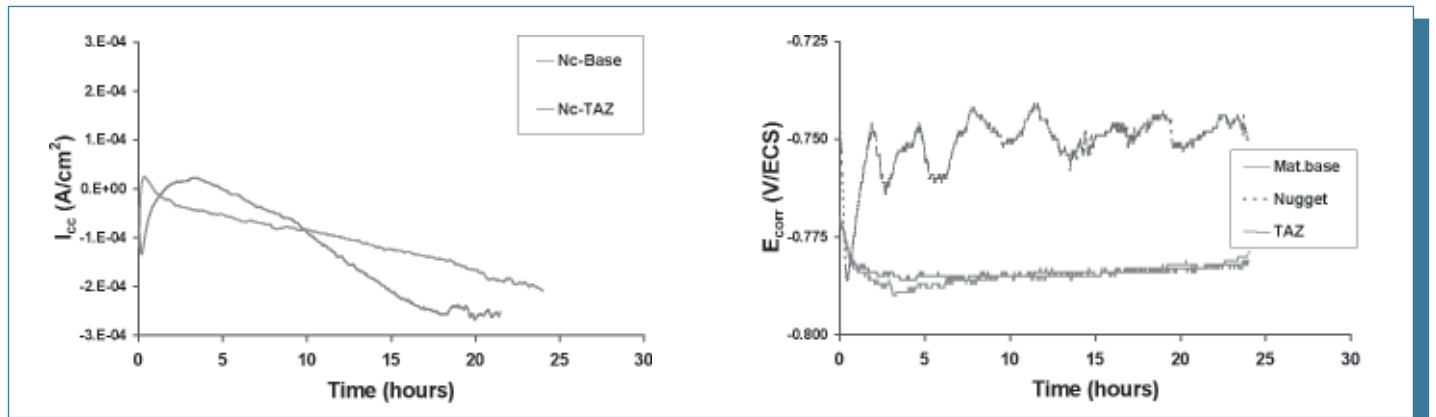
Fig. 6: Short-circuit currents and corrosion potentials of the characteristic zones of the W6A20A joint in EXCO solution

Figure 6 shows the trends of short-circuit currents and potentials of the single zones for W6A20A composite. After the first minutes in which the short-circuit currents show an anodic behaviour of the

nugget, with respect to both the base material and the thermally affected zone, an inversion is observed, in which the nugget behaves as a cathode.

The corrosion potentials confirm this trend. The nugget potential after the first moments stabilises at approximately  $-750 \text{ mV/ECS}$ , while the base material and the thermally affected zone potentials nearly coincide and are equal to approximately  $-780 \text{ mV/ECS}$ . The short-circuit currents are reduced and, at the end of the 24 hour test, they reach a value not greater than  $2.5 \times 10^{-4} \text{ A/cm}^2$ .

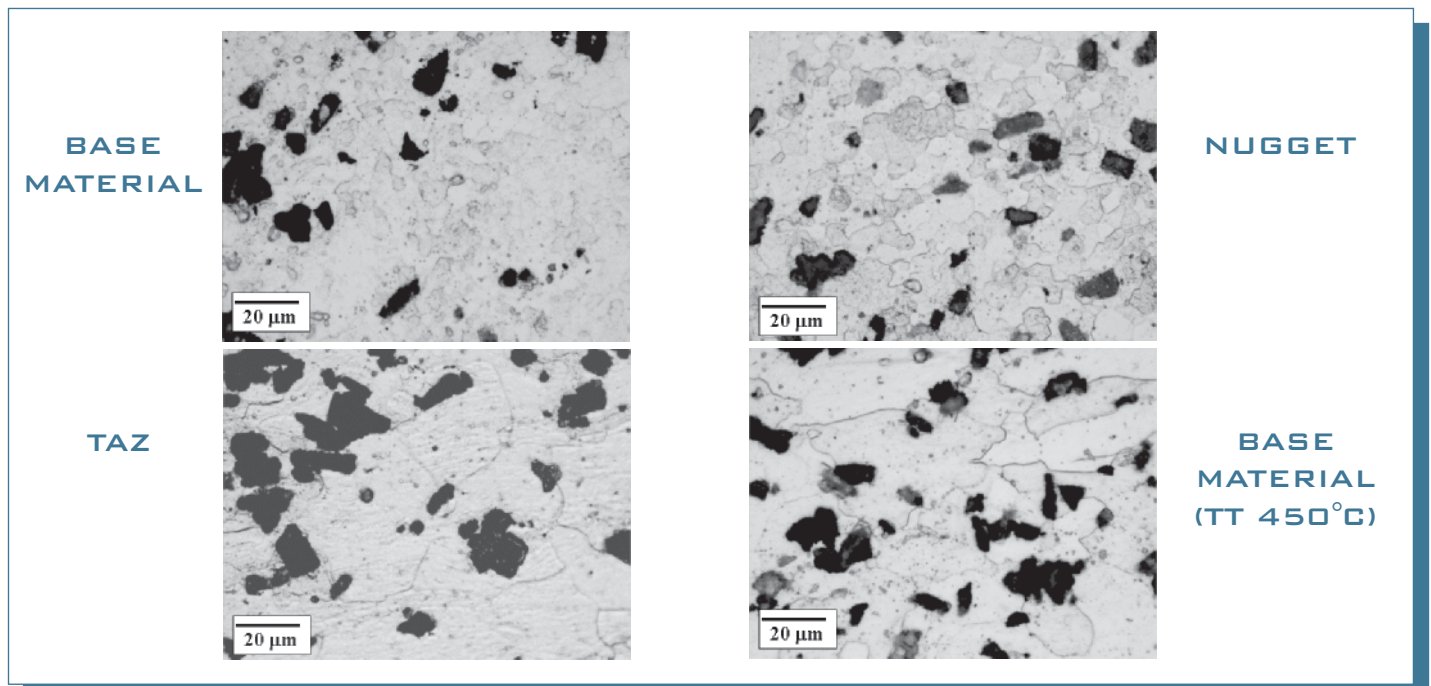
Fig. 7: Optical microscope micrographs of the base material, the nugget, the TAZ of the W7A10A joint and the base material after thermal treatment at 450°C

The micrographs in Figure 7 show the most interesting structure of the

W7A10A specimens, i.e., the base material, the nugget, the TAZ and the 450 °C thermally treated base material.

It can be observed a considerable increase in the size of the grains in the TAZ, due to heating, with formation of a nearly continuous series of precipitates at the grain boundary. A similar structure was reproduced by the thermal treatment at 450°C for two minutes.

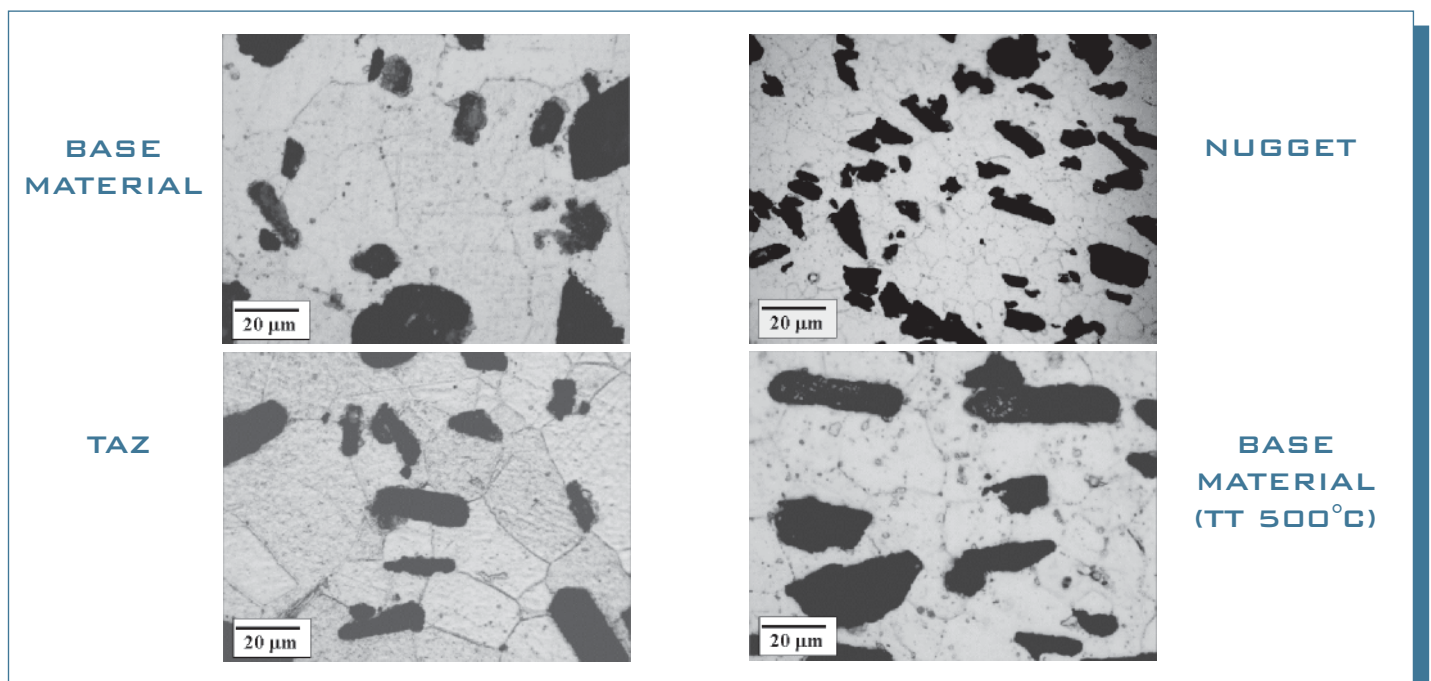
Fig. 8: Optical microscope micrographs of the base material, the TAZ of the W6A20A joint and the base material after thermal treatment at 500°C

more corrosion resistant than 7XXX alloys, the FSW process does not decrease so drastically the corrosion resistance, although the mechanical features of the joint are subjected to the same variations (hardness, fatigue strength, etc.) as the W7A10A joint. The micrographs in Figure 8 show the microstructure variations found in the TAZ and in the specimen thermally treated at 500°C as compared to the base alloy.

No modifications in the grain size were observed, but there was an increase of precipitates in the grain boundary zone of the thermally treated material. The nugget has grains of smaller size. The EXCO solution attack, as shown in the micrographs in Figure 9, is essentially intergranular. It can be hypothesized that the lower corrosion rate of the nugget. Is linked to a complete recrystallisation, with formation of very small crystals. The extended grain boundary area prevents the formation of a continuous network of precipitates in the grain boundary zone, so that the material results much less susceptible to intergranular corrosion.

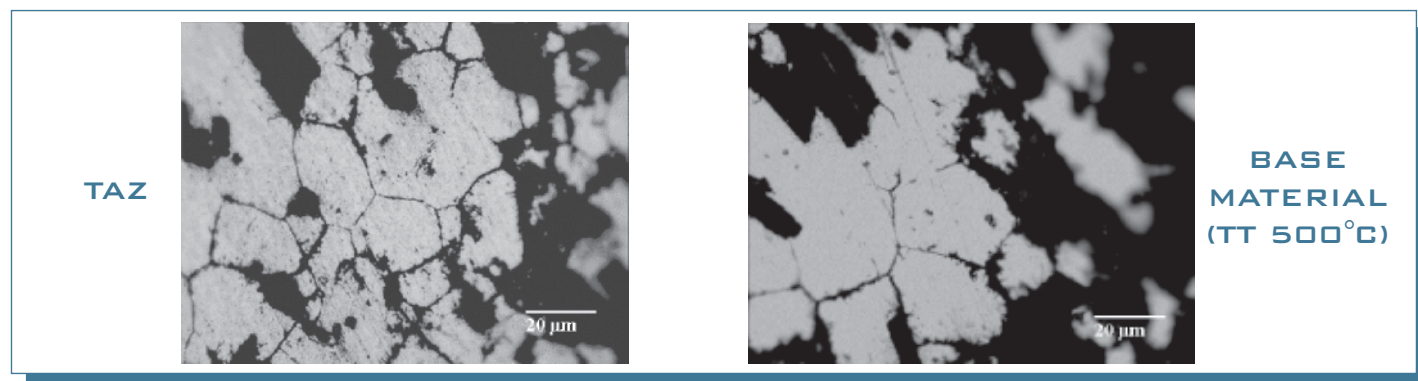
Fig. 9: Optical microscope micrographs of the TAZ and of the base material of the W6A20A joint after thermal treatment at 500°C and exposure to EXCO solution
