# INFLUENCE OF MICRO-SEGREGATION IN PB-S-ALLOYED FREE MACHINING STEELS ON THE SURFACE QUALITY OF THE ROLLED WIRE-ROD

U. Leuschke, N. Rajesh Puwada, D. Senk

*Free machining steel billets were manufactured at the continuous casting machine. The manufactured billets did not exhibit any kind of surface defects but surface cracks and slivers appeared when the billets were rolled into wires and rods at the wire-rod mill. The defects on rolled wire-rod have been detected by a hot eddy current system. Further investigations in these defects with the help of microprobe analysis system and scanning electron microscope equipped with image analysis system revealed micro-segregation of the elements manganese, sulphur and phosphorous in the interdendritic zones.*

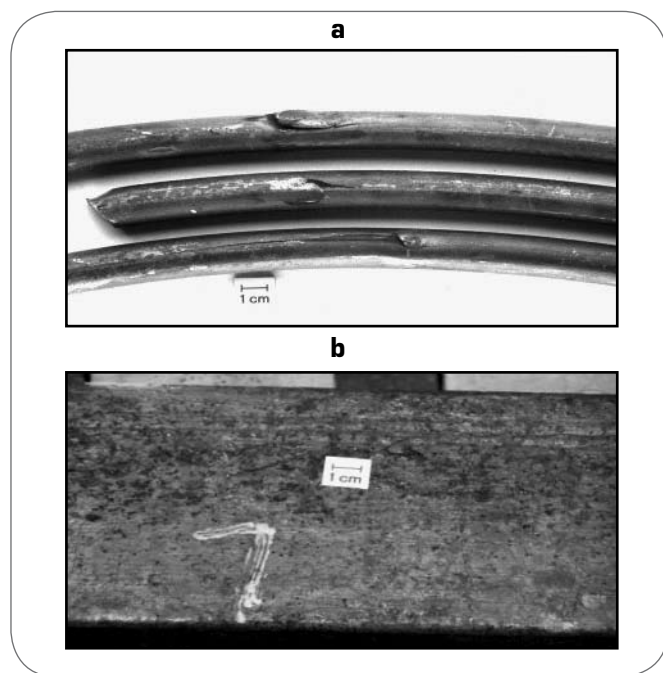
Fig. 2

(a) Slivers and cracks on the surface of the wire-rod. (b) Billet surface of free machining steel billet. (a) Scaglie e cricche sulla superficie della vergella. (b) Superficie della billetta di acciaio da lavorazione ad alta velocità.

Surface cracks and slivers (Fig. 2 (a)) appeared on the wire-rod when free machining steel billets were rolled into wires and rods at the wire-rod mill. Investigations made on the billet corner showed neither transverse nor longitudinal corner cracks. Also, presence of surface cracks and deep oscillation marks was not observed (Fig. 2 (b)).

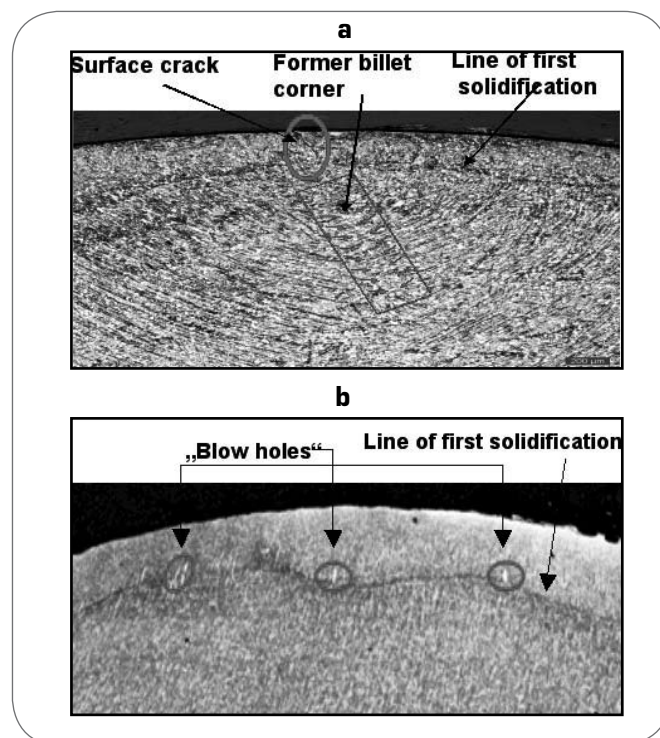
(a) A surface crack associated with a former billet corner and the line of first solidification. (b) Blowholes in and around the line of first solidification. (a) Una cricca di superficie associata al preesistente angolo della billetta e al linea di prima solidificazione. (b) Soffiature all'interno e intorno la linea di prima solidificazione.

Simultaneous investigations using an appropriate etching method made in the regions of slivers and cracks that appeared on the wire rod showed that, in most cases, the points of initiation of slivers and surface cracks were the former corners of the billet (Fig. 3 (a)). Further investigations showed that there was a concentration of the so-called blow holes around the line of first solidification. Fig. 3 (b) shows the so-called blow holes in and around the line of first solidification.

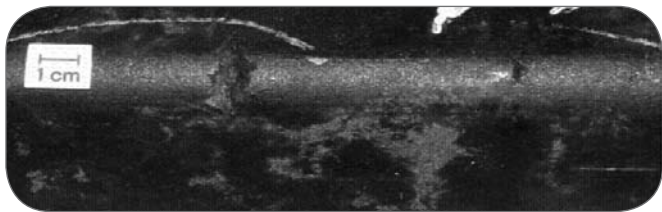
*Cricche agli angoli sulla billetta in rotoli dopo la prima serie di prove.*

After rolling at the bloom rolling mill, cracks appeared on the corners of the free machining steel billets. In the other case, i.e., unleaded free machining steel, no cracks were ob-

served. Fig. 4 shows the corner cracks that appeared after the first set of trials. This result was identical to the result of rolling of leaded free machining steel at the wire rod mill. Samples (with and without cracks) had been collected and the microstructure was investigated with the help of micro probe analysis system and a scanning electron microscope equipped with an image analysis system. Also, the primary and secondary structure investigations with the help of appropriate etching methods were carried out on these samples. The results of these investigations will be mentioned under results and discussion.

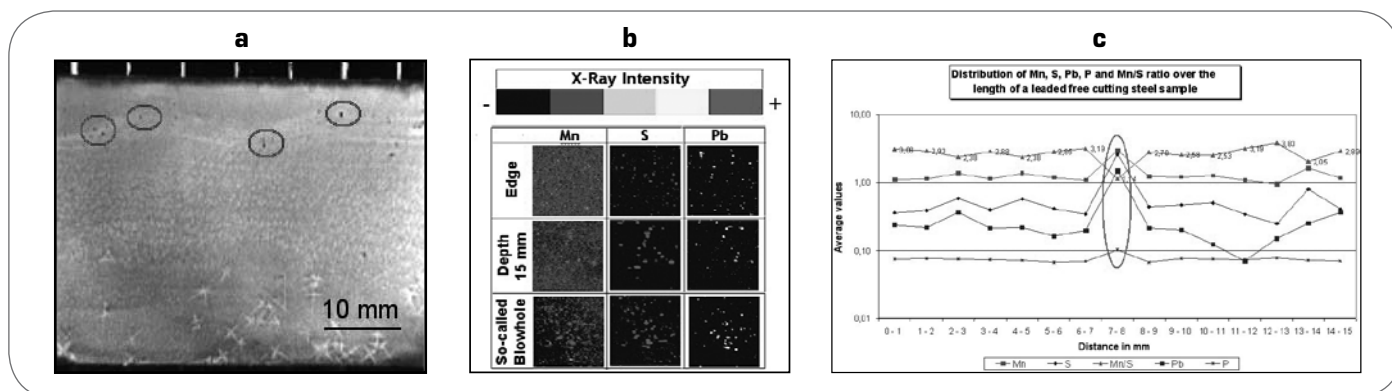
**(a) so-called blow holes (red circles) near the solidification line; (b) Microprobe mapping of elements Mn, S and Pb; (c) Concentration profiles of the elements Mn, S, Pb and P.**

In Fig. 5(a), the so-called blow holes in and around the solidification line have been illustrated. It can be observed that the solidification line is located at a distance of 4 – 8 mm below the surface and the blow holes lie

along the solidification line. The following is an explanation for Fig. 5 (b). A corner sample, with an approximate length of 20 mm has been investigated with the help of microprobe analyzer. This length was chosen so that the so-called blow holes lie within the sample. The microprobe mappings of the elements manganese, sulfur and lead have been illustrated in this figure. It can be observed that the position of manganese and sulfur overlap and the element lead is oriented at the edges of MnS inclusions. In the areas at the edge, the sulfides are fine in size and more in number. This can be seen in the first row of the Fig. 5 (b). An enrichment of all the three elements has been observed in a blowhole. It can also be observed that the MnS inclusions are coarser in size and less in number inside the blowhole. These great differences of the above mentioned elements probably relates to a variation of heat withdrawal in the mould. Interesting to observe is that the size of the MnS inclusions inside the blowhole is comparable to the size of the inclusions present at a distance of 15 mm from the surface although the blow holes are located at just 4 or 5 mm below the surface. The above phenomenon could probably be related to a local perturbation of heat withdrawal.

In Fig. 5 (c), concentration profiles of the elements manganese, sulfur, phosphorous and lead, across the sample have been illustrated. The region marked in red shows the concentration of the elements in a so-called blow hole. It can be observed that there exists an enrichment of the elements inside a blow hole. It is known that the interdendritic segregation behavior is influenced by the local solidification time [2]. A local perturbation of heat withdrawal in a billet corner leads to a difference (sometimes increase) in interdendritic spacing and therefore the elements in front of the solidification front i.e., the elements between the dendrite arms may have more time to agglomerate before this region solidifies. A supersaturation of sulfur leads to the precipitation of sulfur. Manganese dissolved in the matrix reacts with sulfur to form MnS. This reaction occurs at very high temperatures (around 1600°C). The so combined MnS inclusions probably have the possibility to accept and accommodate the liquid drop shaped lead at their edges. This possibility of association of lead with MnS has been shown in Fig. 5 and Fig. 9.

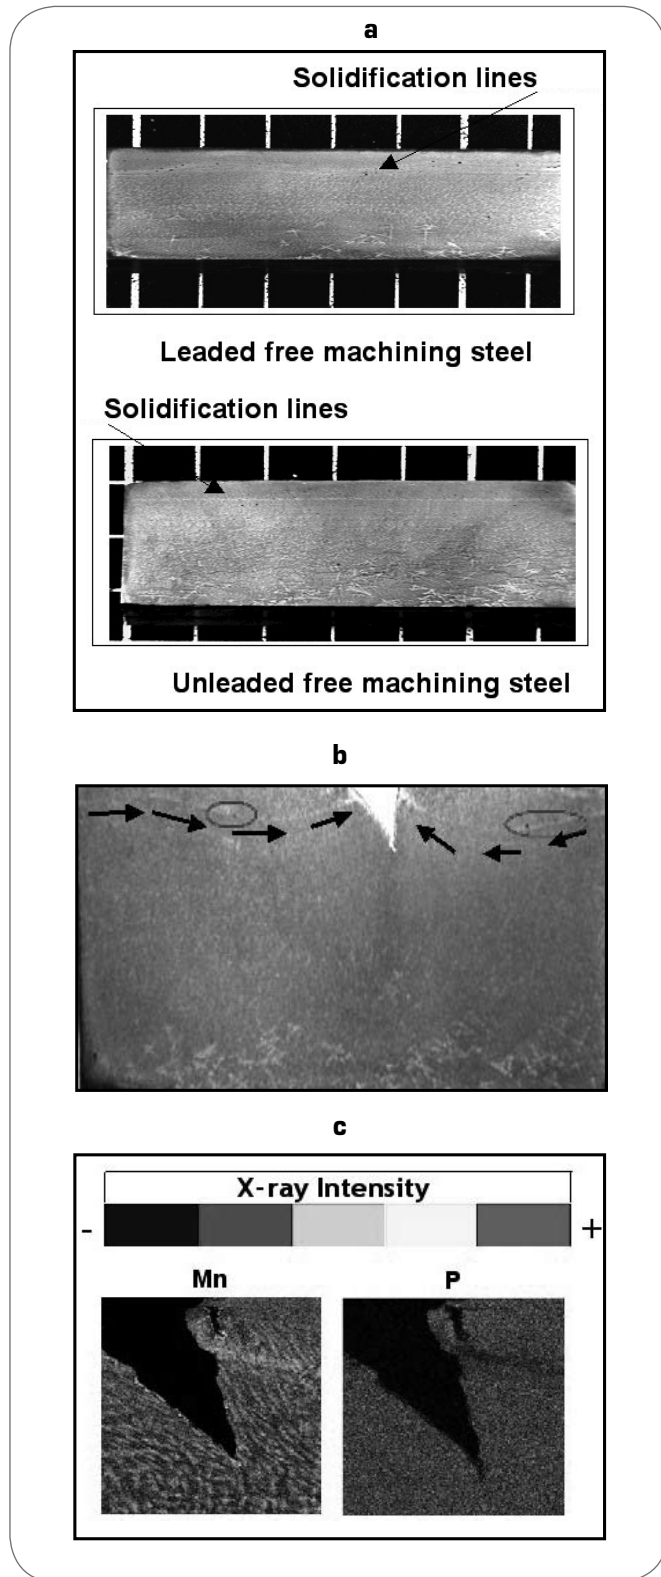
**Fig. 6**

**(a) Comparison between leaded and unleaded free machining steel (b) Solidification line reaches the surface (c) Microprobe mapping of the elements manganese & phosphorous.**

A second possibility for the origination of surface cracks and slivers is when the line of first solidification reaches the surface of the billet. A comparison between the solidification lines of the leaded and unleaded free machining steel samples has been shown in Fig. 6 (a). In the case of leaded free machining steel, the line of first solidification is wavy in nature and therefore sometimes reaches the surface (Fig. 6 (b)). In the other case, the line of first solidification of the unleaded free machining steel sample is relatively horizontal (Fig. 6 (a)). Relatively coarse MnS inclusions have been found at the point of crack initiation. Just a few micrometers away, in the areas near the cracks, fine sulfides have been found. It has also been observed that there is a sudden change in microstructure at the line of first solidification which can be associated to a perturbation in local heat withdrawal. Also, manganese enrichment and phosphorous depletion have been found in the area of the line of first solidification (Fig. 6 (c)).

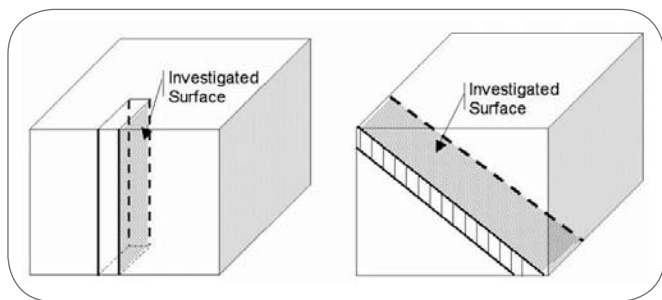
▲  
Fig. 7

**Schematic illustration of the longitudinal & transverse cross sections.**

MnS- and Pb distribution for the side and corner samples (longitudinal and transverse cross sections respectively) of the second set of trials (Tab. 2) have been determined by means of SEM / EDX. In Fig. 7, the samples and the investigated sections have been illustrated.

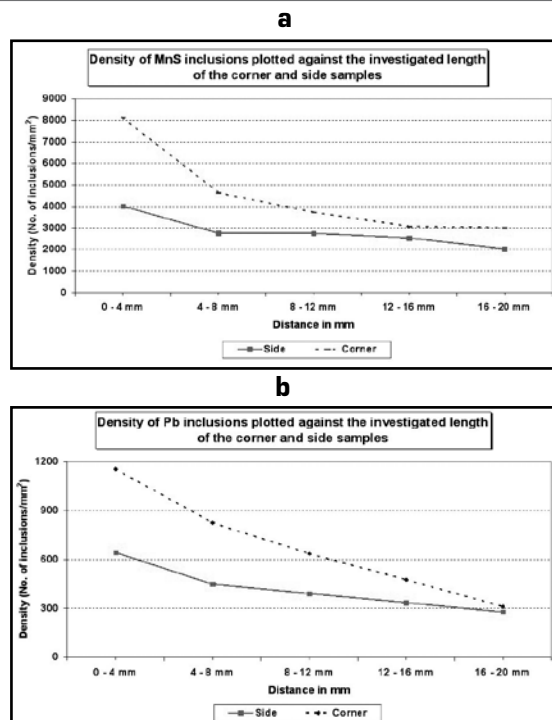
▲  
Fig. 8

The results of these investigations have been shown in Fig. 8 (a) and (b).

The dotted line represents the MnS density (number of MnS inclusions/mm<sup>2</sup>) of the corner sample and the solid line represents the MnS density (number of MnS inclusions/mm<sup>2</sup>) of the side sample. It can be observed that the density of MnS inclusions at the corner is higher than that of the side and also the density decreases with increase in distance from the surface (side sample) and the edge (corner sample). It can also be observed that the slope of the density line of lead is identical to that of MnS. From this result, it can be deduced that lead solidifies in combination with MnS. This

**(a) Investigation results of the distribution of MnS inclusions for corner and side of the billet. (b) Investigation results of the distribution of Pb particles for corner and side of the billet.**

Further, it is known that the precipitation behavior of particles and the secondary dendrite arm spacing are influenced by the heat withdrawal [4]. The precipitation behavior of MnS and Pb has been already illustrated in Fig. 8 (a) and (b).

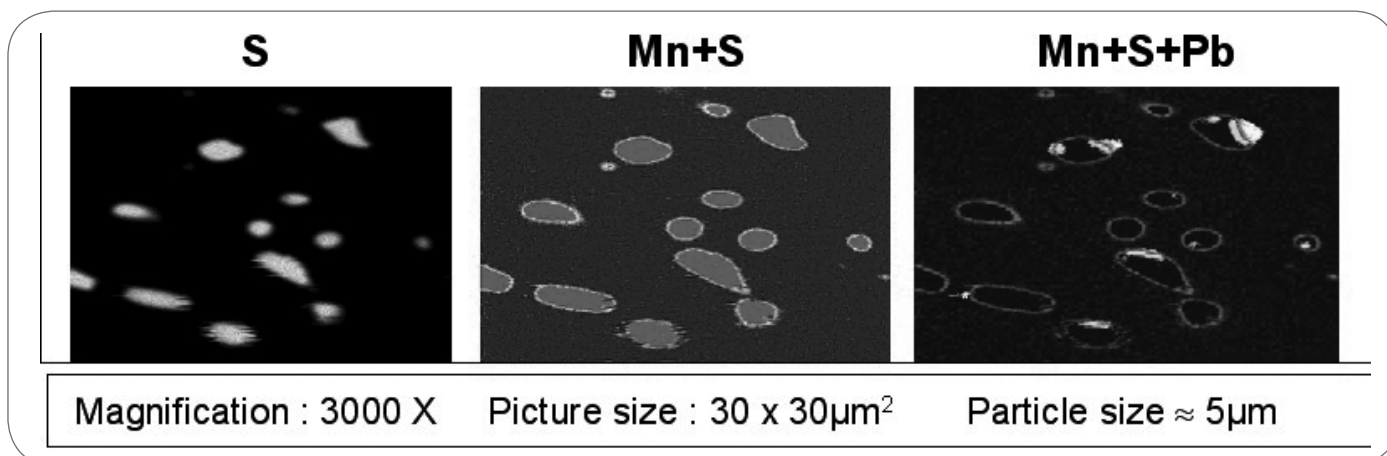
▲  
Fig. 9

assumption was confirmed with the help of the micro probe image in Fig. 9.

**Microprobe mapping of Mn, S and Pb.**

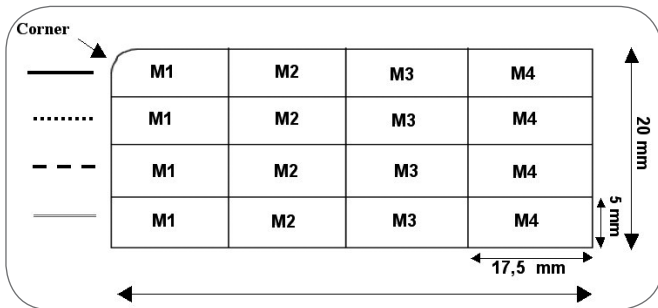
**Schematic illustration of the sample for SDAS measurements.**

A higher heat withdrawal at the corners than at the sides has been confirmed by measurements of the dendrite arm spacing [5],[6]. With the help of light microscopy, secondary dendrite arm spacing (SDAS) were measured. The procedure of the measurement has been illustrated in Fig. 10. The chosen patterns of the lines in Fig. 10 are identical to those of the lines in Fig. 11. The measured trend of the SDAS showed that the heat withdrawal varied with increase in thickness of the solidified strand shell. Less heat has been transported per unit time. The measured SDAS reconfirmed that a higher heat withdrawal was experienced at the corners.

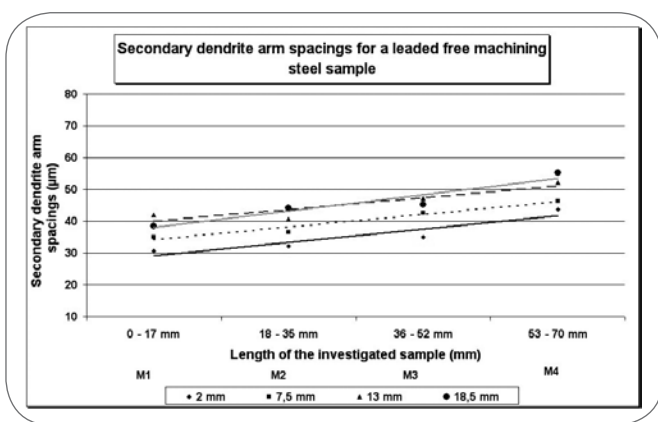
Fig. 11

**Illustration of the measured SDAS.**

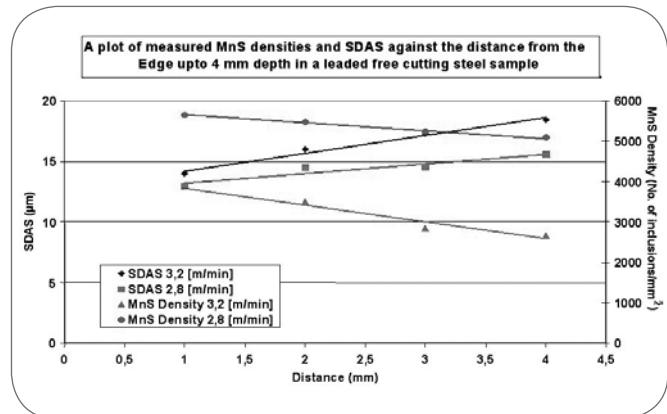
Fig. 12

**SDAS [μm] and MnS densities [No. of inclusions/mm²] for samples taken from billets cast with different casting velocities.**

son to that of the sample cast with 2.8 [m/min]. In co-relation to the above, a higher MnS density is expected in the former case. The inverse has been observed in Fig. 12. A probable explanation to the above observed phenomena could be a movement of the strand (horizontal in this case) inside the mould perpendicular to the casting direction. This relative movement of the strand is independent of the casting velocity and thereby can lead to a variation in the local heat withdrawal as shown in Fig 13. The MnS densities of all the four corners of the same cross section have been shown in this figure.

sults shown in Fig. 12. On the basis of these results and taking into consideration the slivers that arouse on the rolled wire-rod (associated with former corners of the billets), it must be determined whether these slivers could be intrinsically influenced. Further investigations have to be performed in order to determine this probable influence.

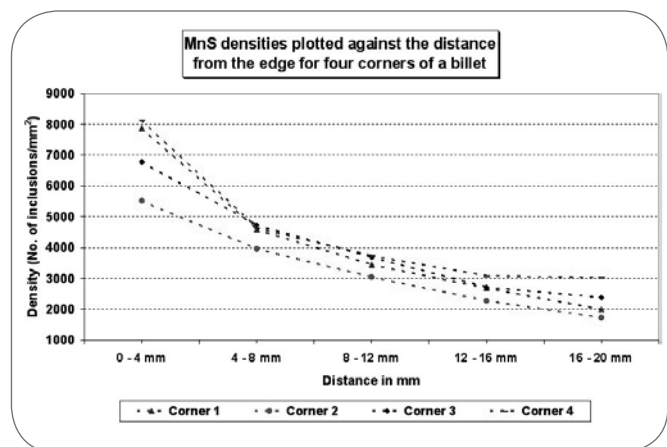
Fig. 13

It can be observed that the density of MnS inclusions have different levels in all the four investigated corners of the billet cross section, especially in the initial 4 mm (distance from the edge). It can be concluded that the heat withdrawal or the amount of heat transported had been different in the four corners. This could be a possible explanation for the unusual re-

**Density distribution in all the four corners of the same billet cross-sections.**
